Asbestos Refurbishment Survey

Emanuel House

18 Rochester Row

Report No: **L-389460 (Issue 1)**

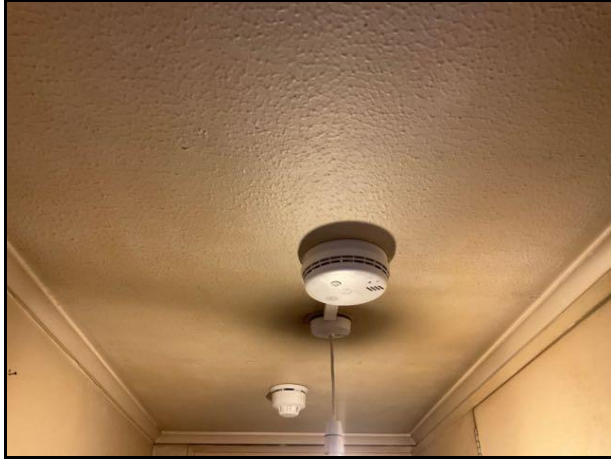
Inspection Ref:	S612628
Sample No.:	007
Building:	Emanuel House
Floor:	4th Floor
Area Ref:	04.004
Area Description:	Flat 47 - Entrance Lobby
Material Description:	Ceiling Textured Coating - covering to plasterboard ceiling throughout.
Quantity:	3m ²
Asbestos Result:	Chrysotile
Recommendation:	Manage

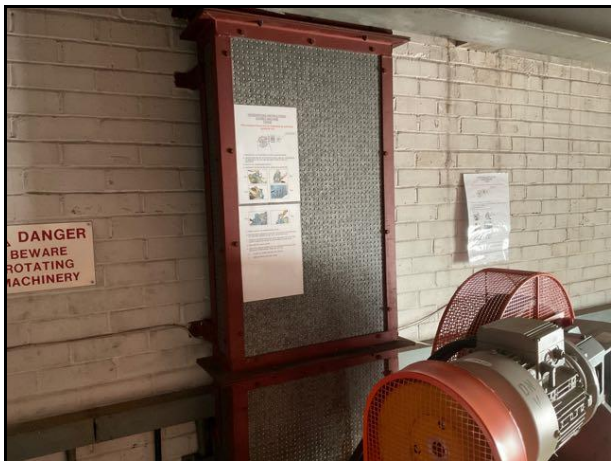
Inspection Ref:	S612654
Sample No.:	001
Building:	Emanuel House
Floor:	7th Floor
Area Ref:	07.001
Area Description:	Lift Motor Room
Material Description:	Boxing Insulating Board - durasteel boxing to wall.
Quantity:	2m ²
Asbestos Result:	Chrysotile
Recommendation:	Manage

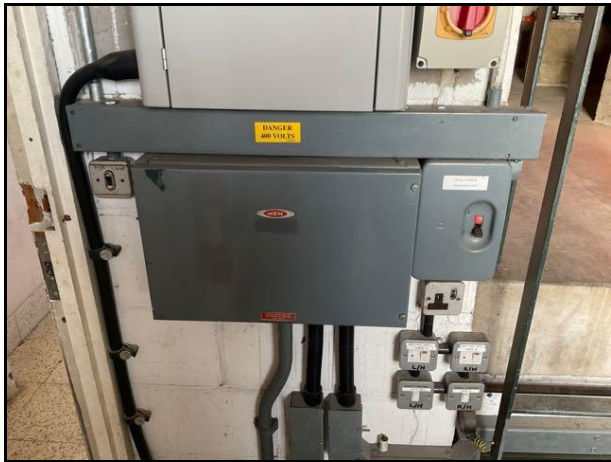
Inspection Ref:	SP612607
Sample No.:	
Building:	Emanuel House
Floor:	7th Floor
Area Ref:	07.001
Area Description:	Lift Motor Room
Material Description:	Wall Woven Product - presumed asbestos rope flash guards to electrical switch unit.
Quantity:	1no
Asbestos Result:	Chrysotile
Recommendation:	Manage

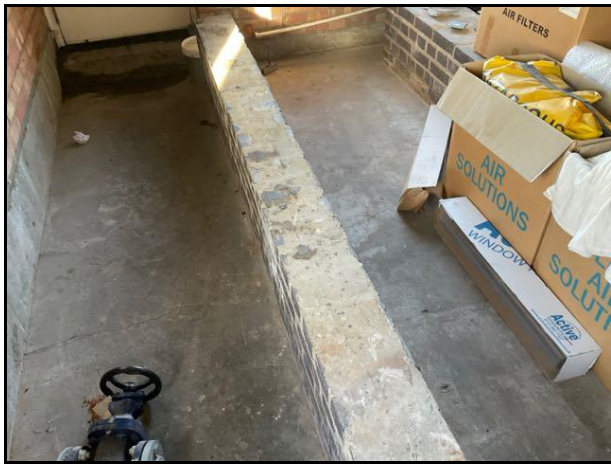
Inspection Ref:	S612622
Sample No.:	003
Building:	Emanuel House
Floor:	7th Floor
Area Ref:	07.003
Area Description:	Tank Room
Material Description:	Water Tank Bituminous Product - felt remains to brick plinths.
Quantity:	9lin m
Asbestos Result:	NADIS
Recommendation:	No recommendation required

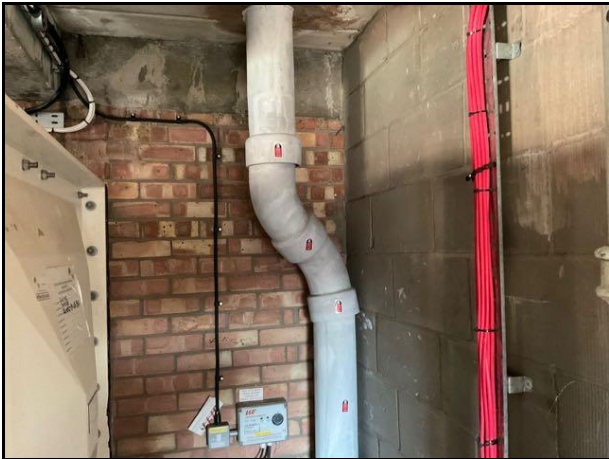
Inspection Ref:	SP612577
Sample No.:	
Building:	Emanuel House
Floor:	7th Floor
Area Ref:	07.003
Area Description:	Tank Room
Material Description:	Wall Cement Product - flue pipe in corner.
Quantity:	3lin m
Asbestos Result:	Chrysotile
Recommendation:	Manage

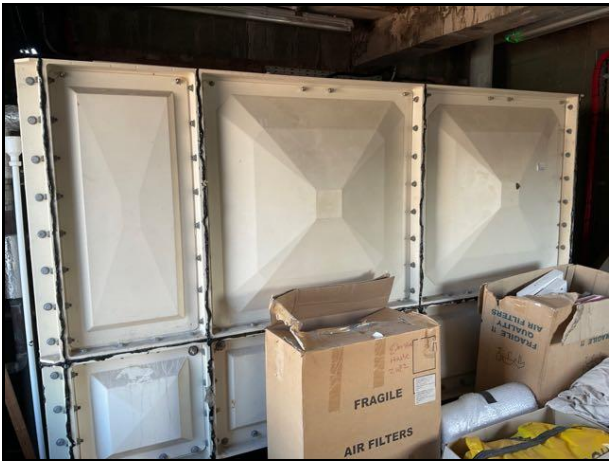
Inspection Ref:	S612616
Sample No.:	002
Building:	Emanuel House
Floor:	7th Floor
Area Ref:	07.003
Area Description:	Tank Room
Material Description:	Water Tank Putty - seals to joints in tank.
Quantity:	20lin m
Asbestos Result:	NADIS
Recommendation:	No recommendation required

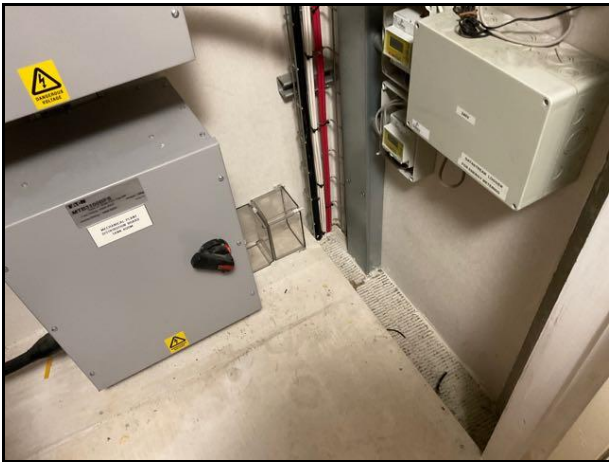
Inspection Ref:	S612572
Sample No.:	004
Building:	Emanuel House
Floor:	Riser
Area Ref:	R.003
Area Description:	Electrical Riser
Material Description:	Walls, Ceiling & Floor Insulating Board - supalux panels present throughout.
Quantity:	4m ²
Asbestos Result:	NADIS
Recommendation:	No recommendation required

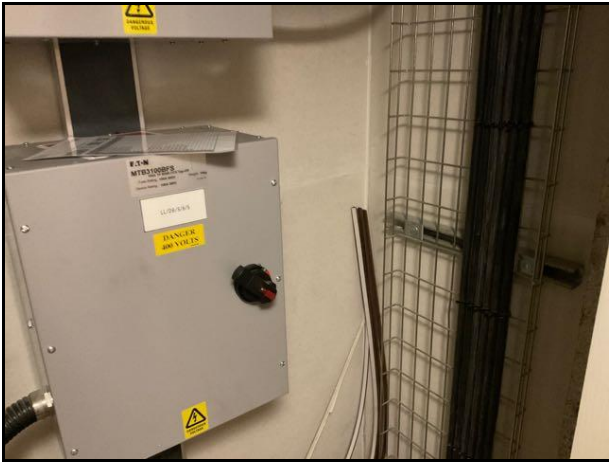
Inspection Ref:	X612653
Sample No.:	004/1
Building:	Emanuel House
Floor:	Riser
Area Ref:	R.006
Area Description:	Electrical Riser
Material Description:	Walls Insulating Board - supalux panels present throughout.
Quantity:	3m ²
Asbestos Result:	NADIS
Recommendation:	No recommendation required

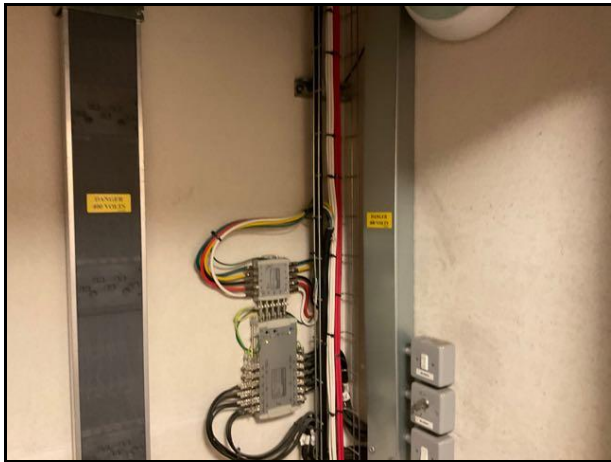
Inspection Ref:	S612584
Sample No.:	005
Building:	Emanuel House
Floor:	Riser
Area Ref:	R.010
Area Description:	Electrical Riser
Material Description:	Walls Insulating Board - supalux panels present throughout.
Quantity:	2m ²
Asbestos Result:	NADIS
Recommendation:	No recommendation required

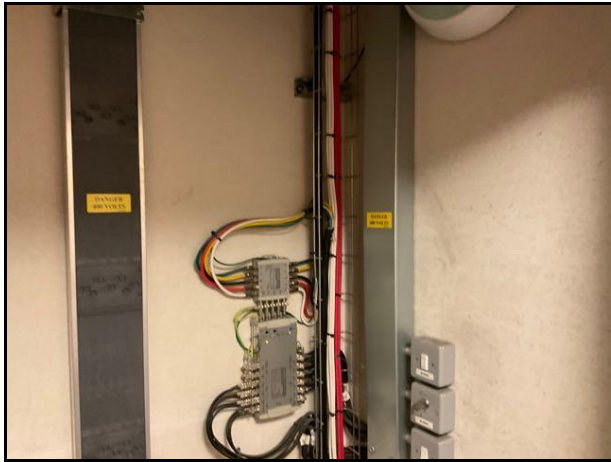
Inspection Ref:	X612636
Sample No.:	005/1
Building:	Emanuel House
Floor:	Riser
Area Ref:	R.013
Area Description:	Electrical Riser
Material Description:	Walls Insulating Board - supalux panels present throughout.
Quantity:	2m ²
Asbestos Result:	NADIS
Recommendation:	No recommendation required

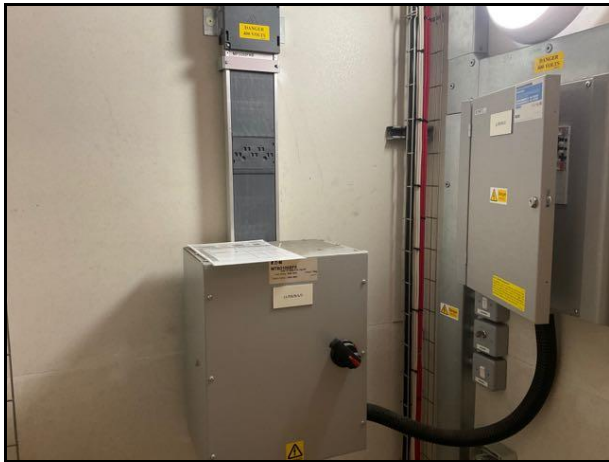
Inspection Ref:	S612614
Sample No.:	006
Building:	Emanuel House
Floor:	Riser
Area Ref:	R.017
Area Description:	Electrical Riser
Material Description:	Walls Insulating Board - supalux panels present throughout.
Quantity:	2m ²
Asbestos Result:	NADIS
Recommendation:	No recommendation required

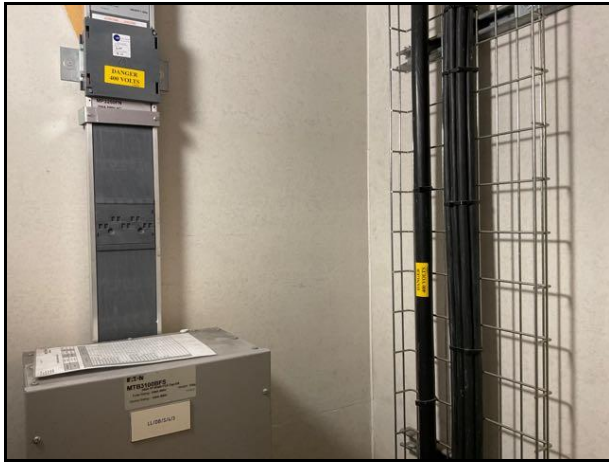
Inspection Ref:	X612575
Sample No.:	006/1
Building:	Emanuel House
Floor:	Riser
Area Ref:	R.020
Area Description:	Electrical Riser
Material Description:	Walls Insulating Board - supalux panels present throughout.
Quantity:	2m ²
Asbestos Result:	NADIS
Recommendation:	No recommendation required

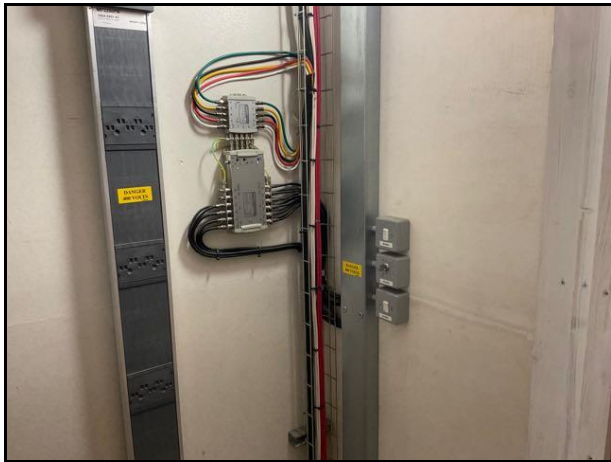
Inspection Ref:	X612603
Sample No.:	006/2
Building:	Emanuel House
Floor:	Riser
Area Ref:	R.024
Area Description:	Electrical Riser
Material Description:	Walls Insulating Board - supalux panels present throughout.
Quantity:	2m ²
Asbestos Result:	NADIS
Recommendation:	No recommendation required

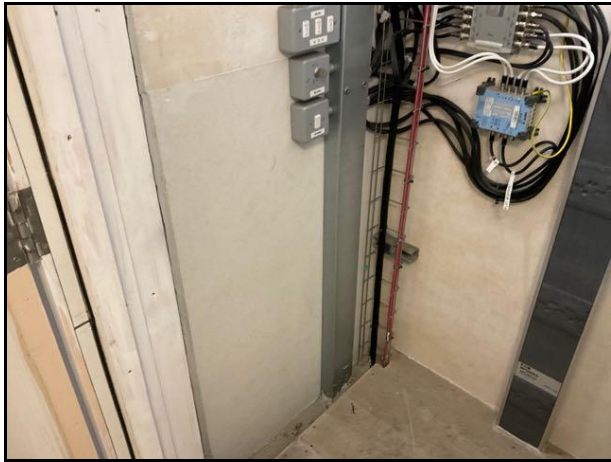
Inspection Ref:	X612573
Sample No.:	006/3
Building:	Emanuel House
Floor:	Riser
Area Ref:	R.027
Area Description:	Electrical Riser
Material Description:	Walls Insulating Board - supalux panels present behind light switch.
Quantity:	1m ²
Asbestos Result:	NADIS
Recommendation:	No recommendation required

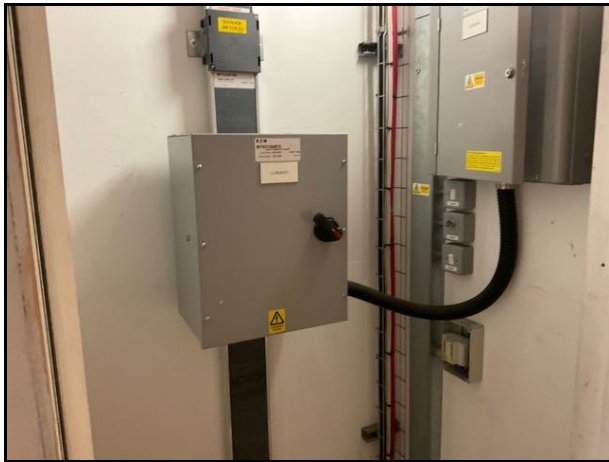
Inspection Ref:	S612641
Sample No.:	008
Building:	Emanuel House
Floor:	Riser
Area Ref:	R.031
Area Description:	Electrical Riser
Material Description:	Walls Insulating Board - supalux panels present throughout.
Quantity:	3m ²
Asbestos Result:	NADIS
Recommendation:	No recommendation required

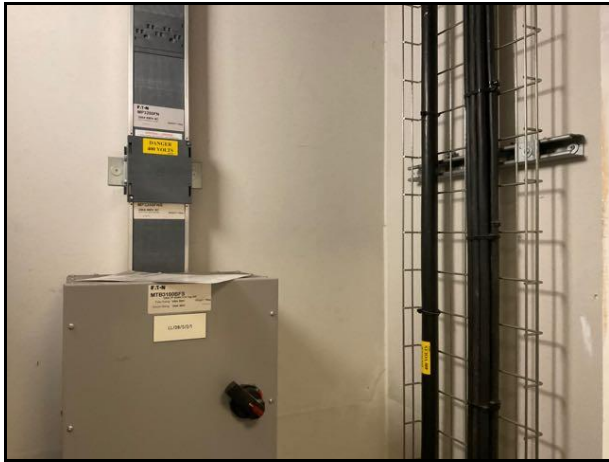
Inspection Ref:	X612612
Sample No.:	008/1
Building:	Emanuel House
Floor:	Riser
Area Ref:	R.034
Area Description:	Electrical Riser
Material Description:	Walls Insulating Board - supalux panels present throughout.
Quantity:	9m ²
Asbestos Result:	NADIS
Recommendation:	No recommendation required

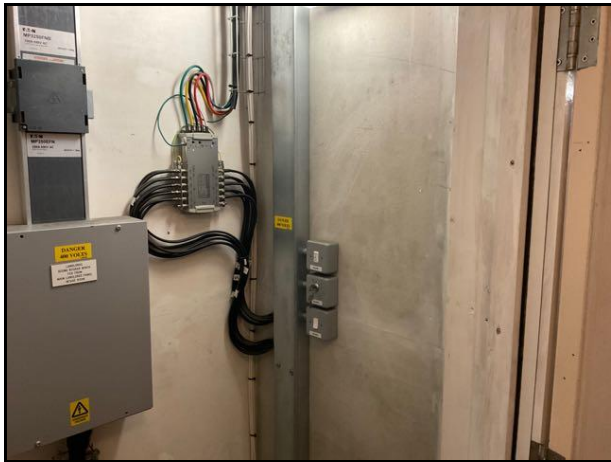
Inspection Ref:	S612594
Sample No.:	009
Building:	Emanuel House
Floor:	Riser
Area Ref:	R.038
Area Description:	Electrical Riser
Material Description:	Walls Insulating Board - supalux panels present behind light & light switch.
Quantity:	3m ²
Asbestos Result:	NADIS
Recommendation:	No recommendation required
