**Frankham Consultancy Group  
Building Services Engineering  
Martlett Court  
Water Services Condition Survey  
Report**

**City of Westminster**

Frankham Consultancy Group  
Building Services Engineering  
Martlett Court Water Services Survey Report

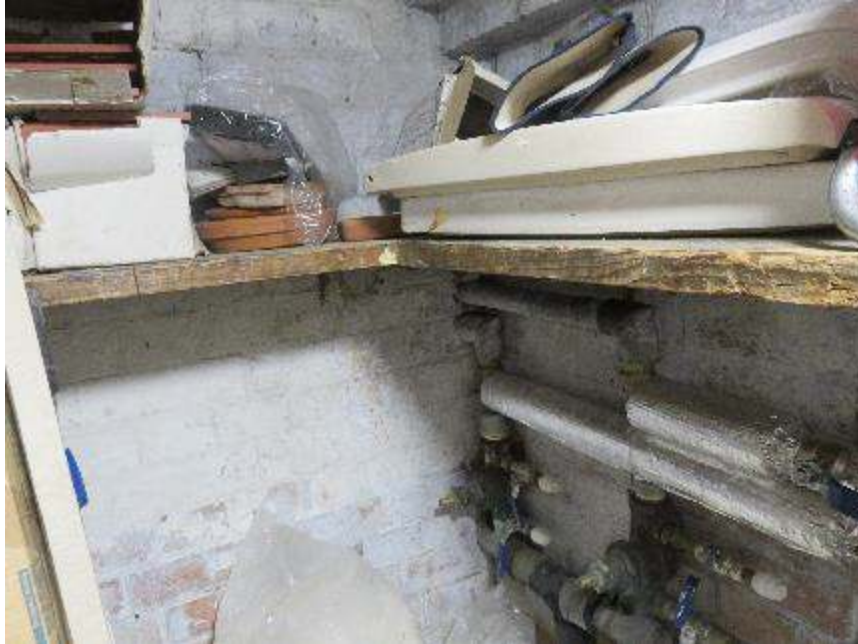
Each of the three blocks has a dedicated main supply from its own dedicated Thames Water stop cock external to the site, but close to the perimeter fencing. A feed from this stop cock is fed to a distribution rising main within a service area below the main stairway, from where water is routed to the storage tanks in the relevant roof space. In the case of Beaumont Buildings, this rising main was visible as it ran up the rear wall of the stairwell. With the other two buildings it could not be viewed as it was concealed within the building fabric. What pipework could be viewed was in poor condition and had exceeded its nominal life expectancy.

Incoming Water supply in Beaumont Buildings

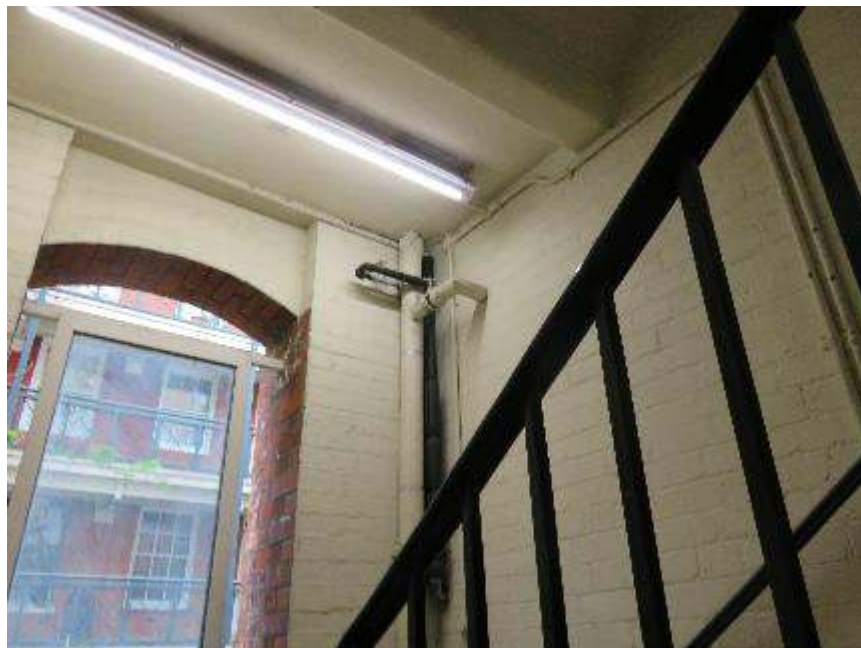
It was apparent during the survey, that there are branches off the rising mains at each floor level which provides potable water supplies to the kitchens of each of the flats. The bathrooms and toilets of the flats are fed from a down service from the roof storage tanks.

As a result, both the rising mains, including potable branches, and the down service pipework has generally exceeded its anticipated life span and will need to be considered for replacement.

Rising Main with Potable branch in Beaumont Buildings

It has already been indicated that the rising mains need to be replaced, but it is also necessary that the internal distribution service should also be replaced at the same time.

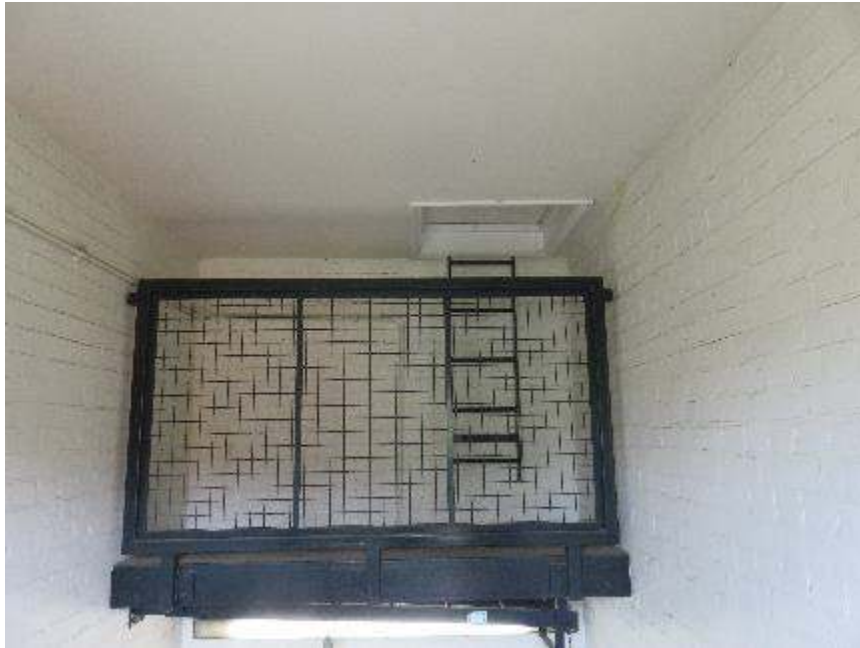
The access in Fletcher Buildings is the best, as an attempt has been made to improve access by installing a steel framework with a drop down ladder below the hatch. This however is inadequate, as the drop down ladder terminates too far from floor level.

Arrangements for gaining access to roof space in Fletcher Buildings

It is clear that extensive works are required, dependent upon the final scheme adopted, which could involve replacing tanks, and that safe access in accordance with current guidelines is established to the roof/tank voids.

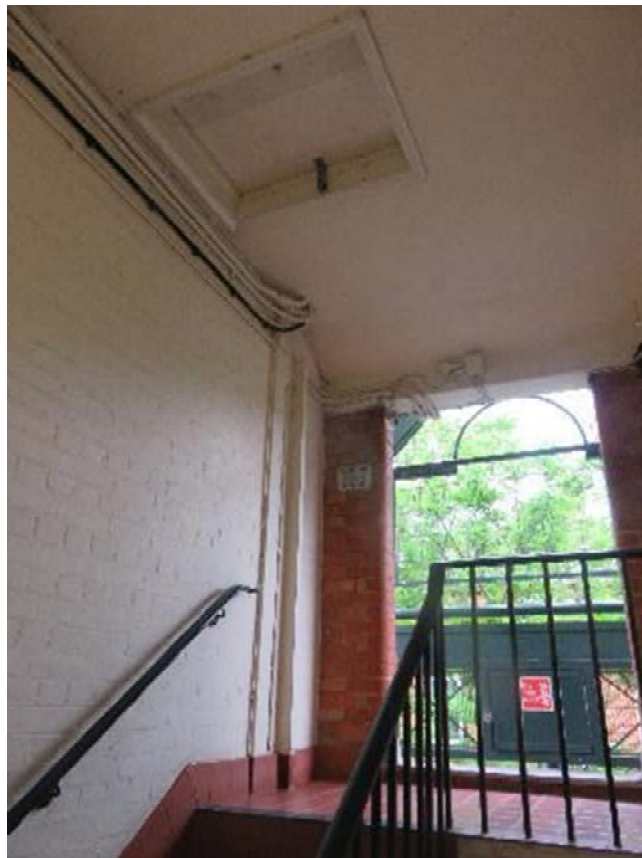
The access in Sheridan Buildings is slightly better, as the access hatch is above the top landing, However, we understand that the accepted method of opening the hatch is to sand the ladder on its side, with the end pushed through the stair railings, to stand on it to open the hatch prior to locating the ladder in the correct position. We also feel that this is unacceptable, as it is an accident waiting to happen.

Access hatch over stairs in Sheridan Buildings

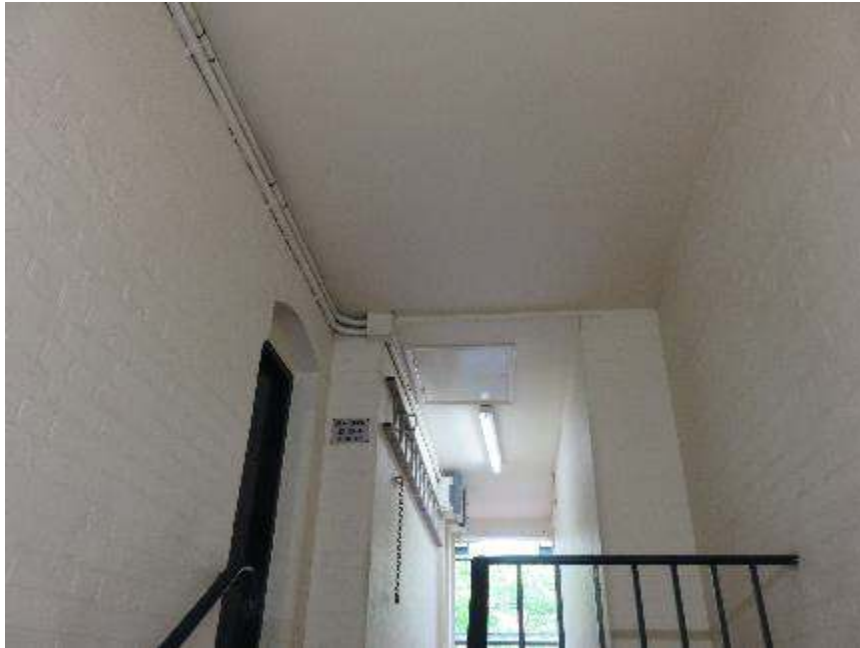
The access hatch in Beaumont Buildings is directly above the stairs, and to access, it is necessary to hook a ladder on the underside of the hatch with the bottom of the ladder resting on the top landing, and then climbing above the descending stairs to unlock the hatch. In our opinion, this was unacceptable and the risk of falling is high.

Access hatch to roof space in Beaumont Buildings

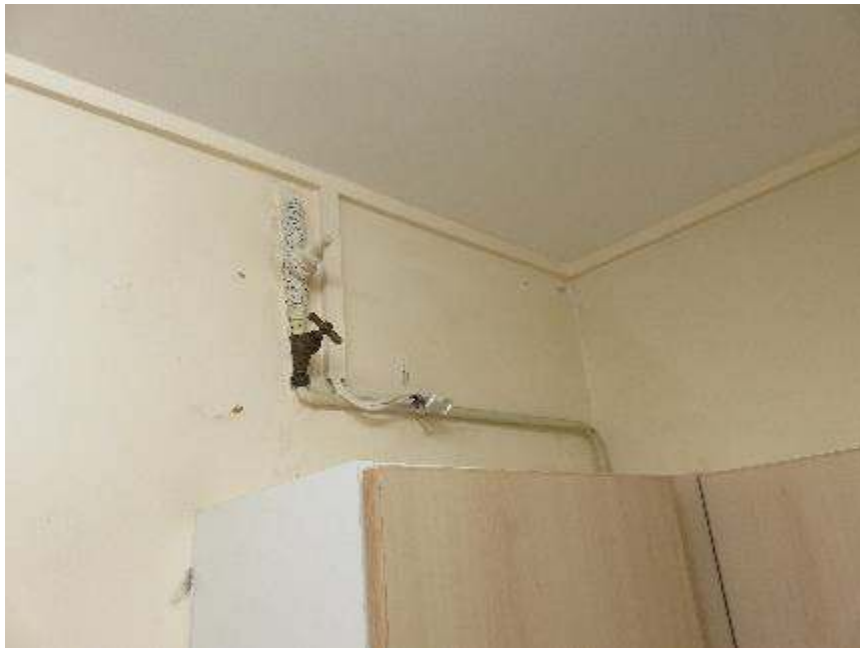
Very little information was gained as regard to the pipework as most of it was concealed within the fabric, what was exposed was generally unsatisfactory, time expired and in need of replacement.

Some internal Pipework in Beaumont Buildings

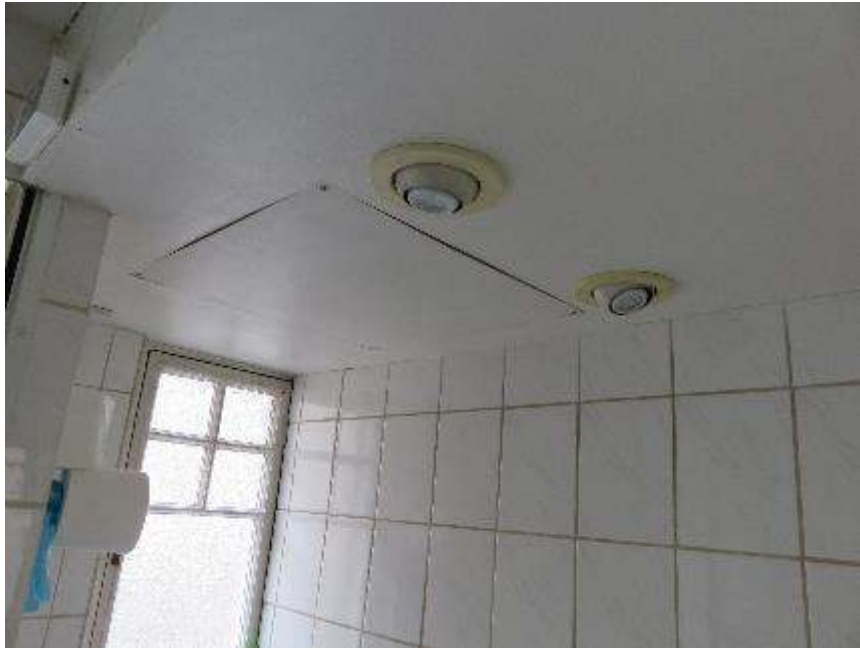
Hatch to access pipework above ceiling in flat in Sheridan Buildings.

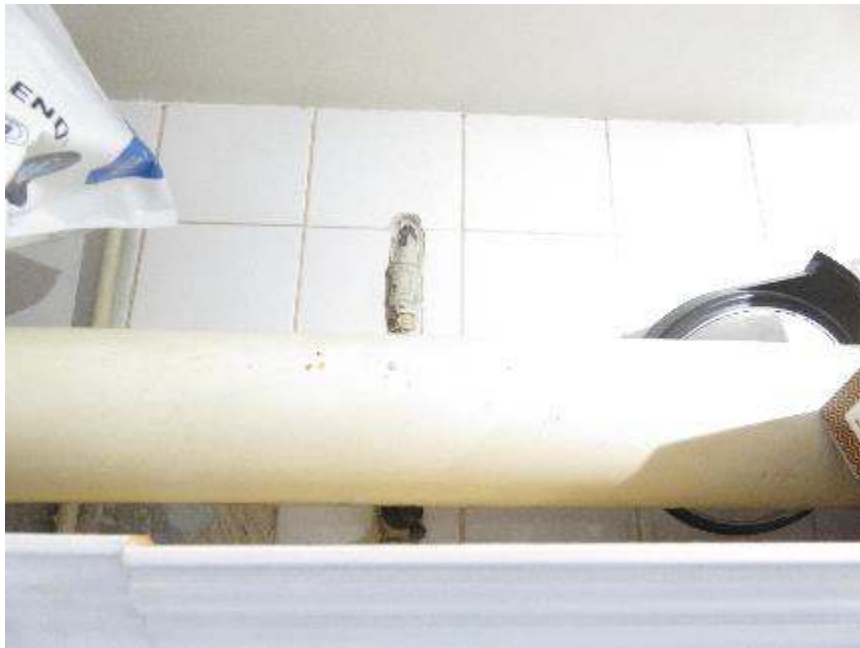
Some internal pipework in flat in Sheridan Buildings.

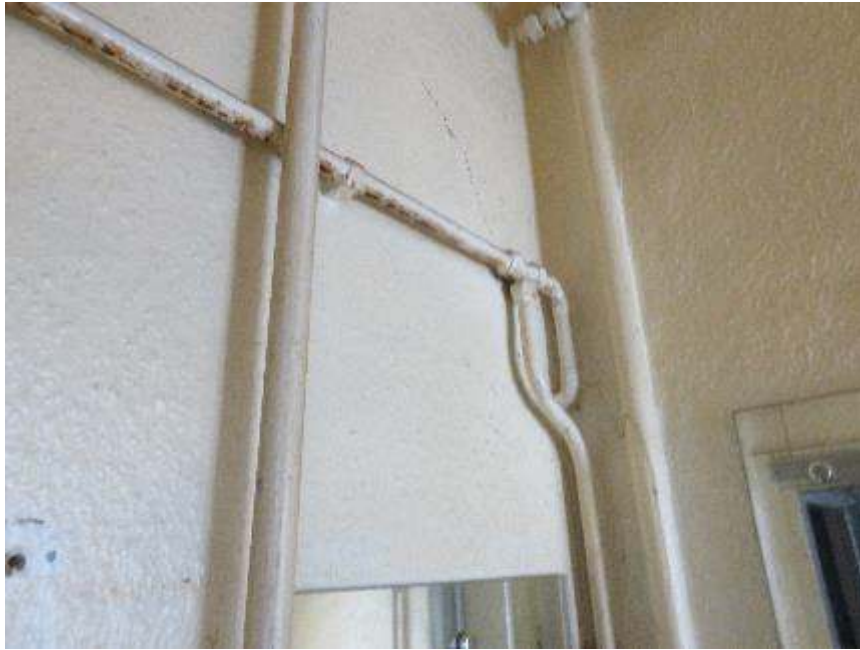
More internal pipework in flat in Sheridan Buildings.

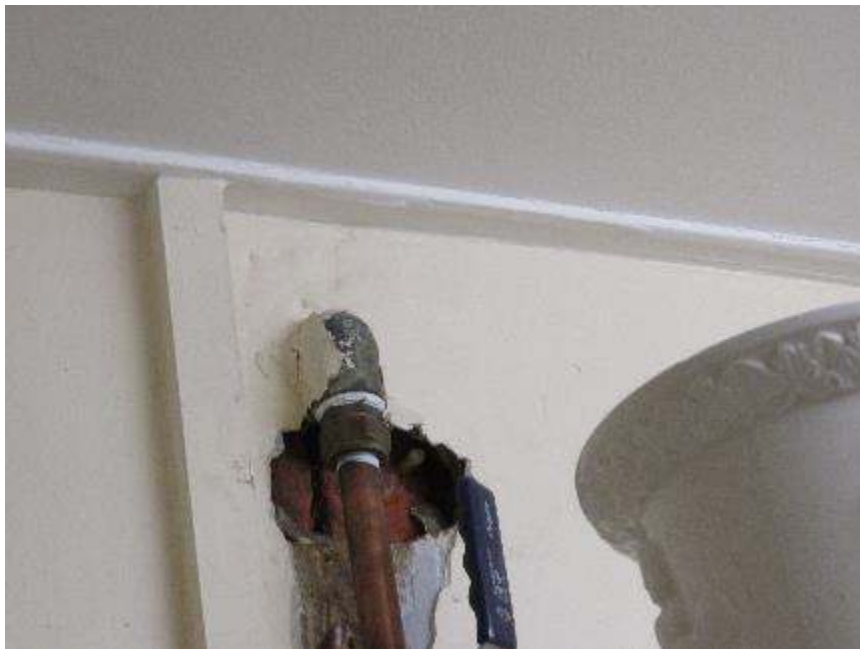
Some internal pipework in flat in Fletcher Buildings
