# Roof Survey Report

Sullivan House  
Churchill Gardens, LONDON  
SW1V 3BP, England

18 February 2021  
Project Reference: B202478/1

**PREPARED FOR:**  
Richard Ndudi  
Westminster City Council

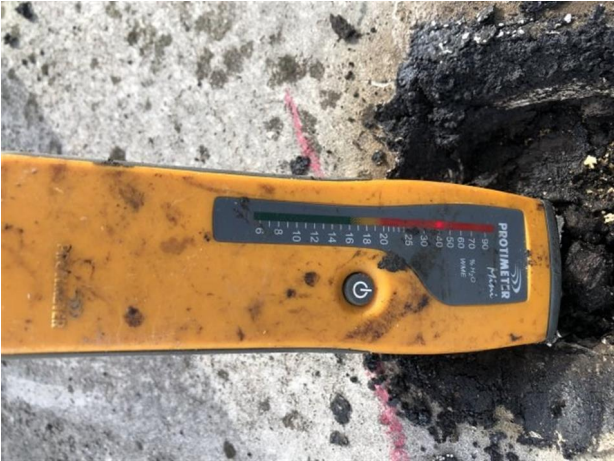
<b>No. of core samples taken:</b>	4
<b>Construction Type:</b>	Warm Roof
<b>Surfacing:</b>	Various Repairs
<b>Waterproofing:</b>	Mastic Asphalt
<b>Insulation:</b>	Tapered Cork/PIR board
<b>Vapour Control:</b>	Aluminium lined bituminous vapour barrier
<b>Screed:</b>	Sand/cement screed
<b>Roof Deck:</b>	Concrete
<b>Condition of core sample:</b>	Insulation is wet.

Core Sample - Wet

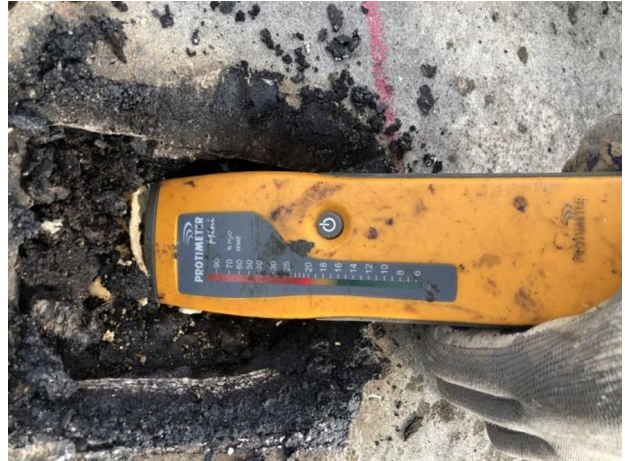
Core Sample - Wet

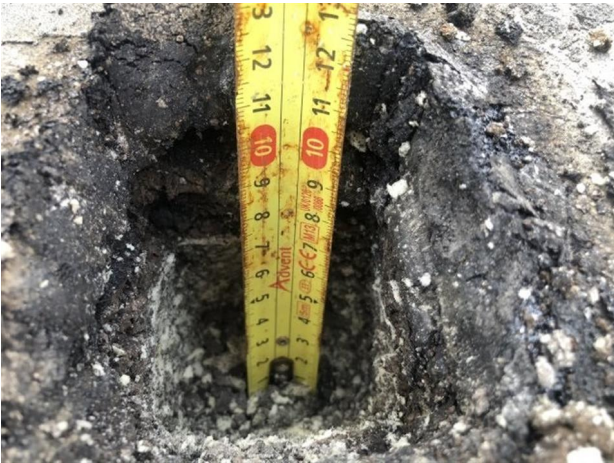
Existing insulation cut-to-falls.

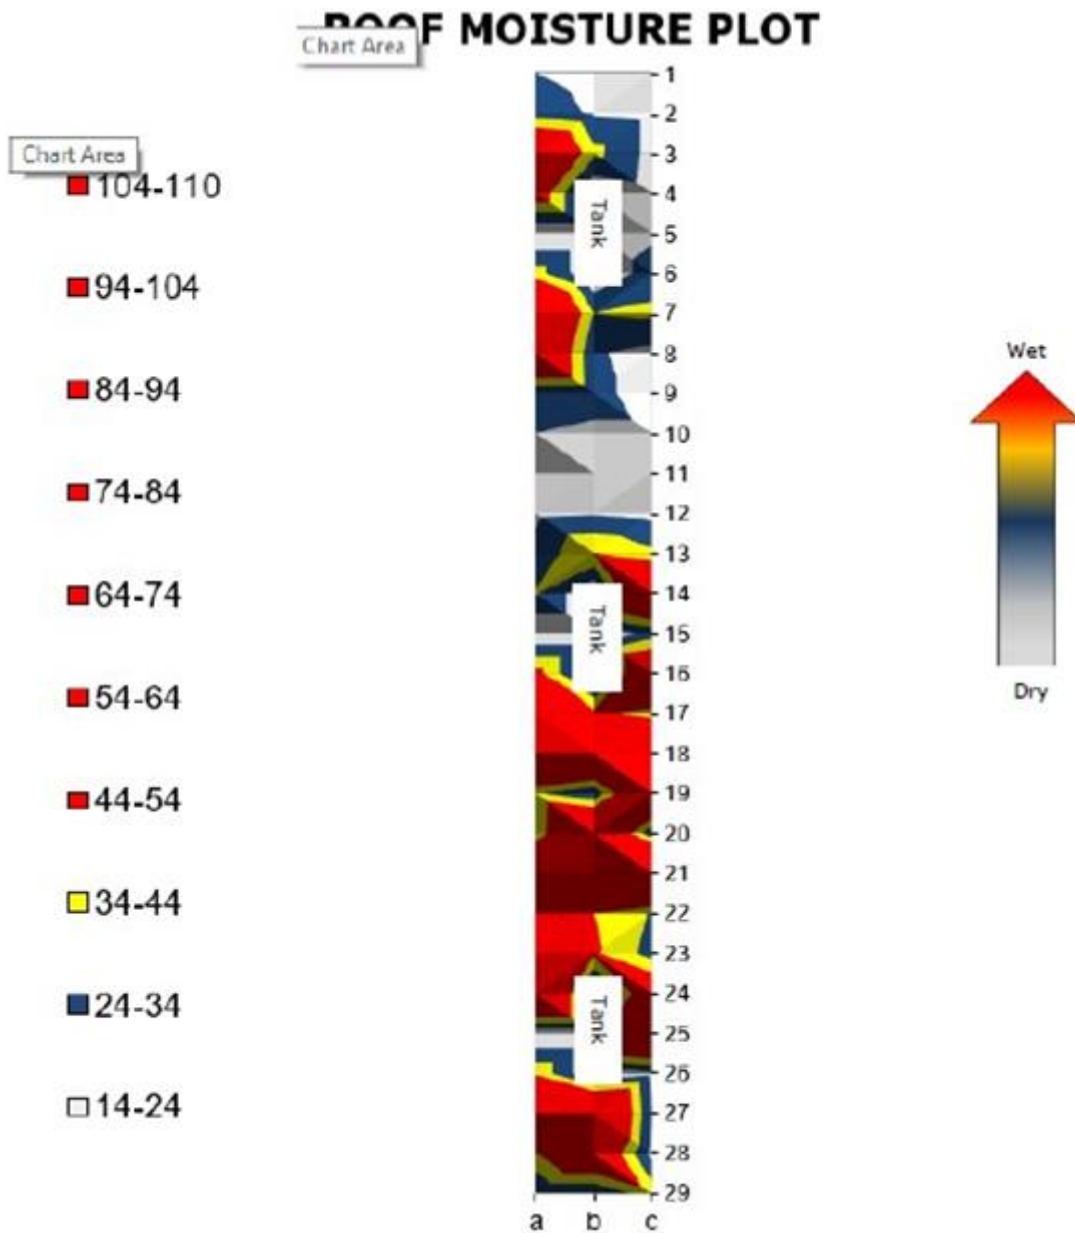
Bauder's moisture mapping nuclear density gauge survey provides evidence of water ingress that has contaminated and degraded the existing insulation. This will impact upon the thermal performance of the system and potentially the resistance to wind uplift if the adhesion between the waterproofing and insulation components have become impaired.

Roof Moisture Plot demonstrates extent of water ingress into existing build-up. A large proportion of the insulation is wet and compromised.

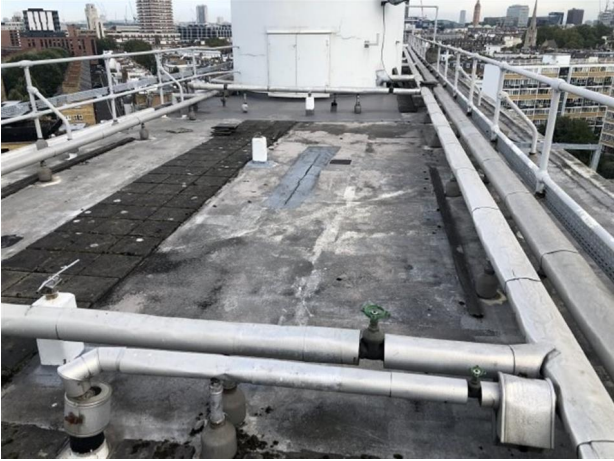
**Overview of main roof.**

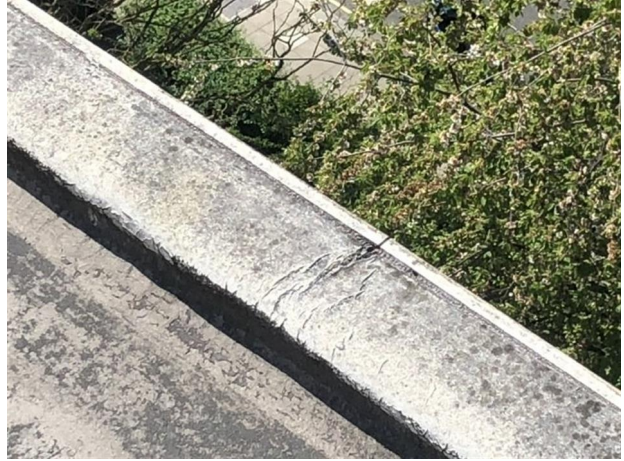
The asphalt is showing all the typical defects consistent with a covering of this age including; surface oxidation, cracks, splits, blows, slumping and signs of repair.

**Cracks and splits are occurring in the asphalt.**

- Due to its condition, the existing waterproofing system should be completely removed and replaced.

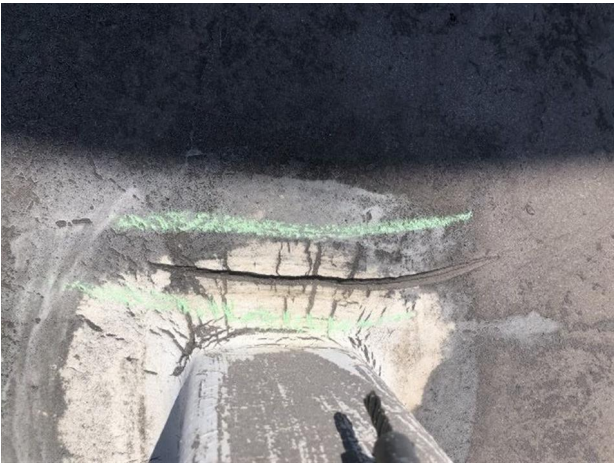
**Further evidence of defects in the existing asphalt.**

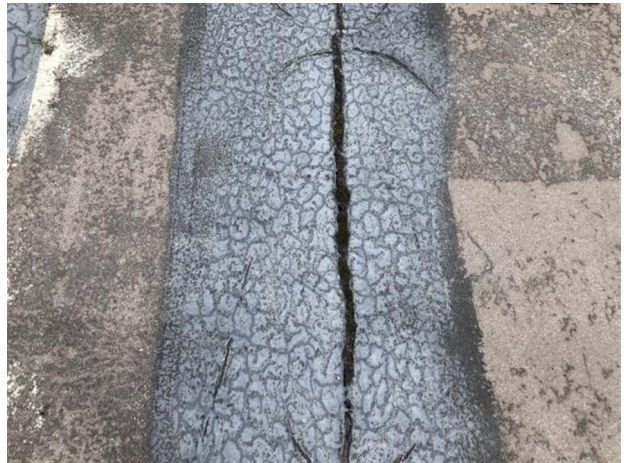
**Defects in the asphalt will let water by.**

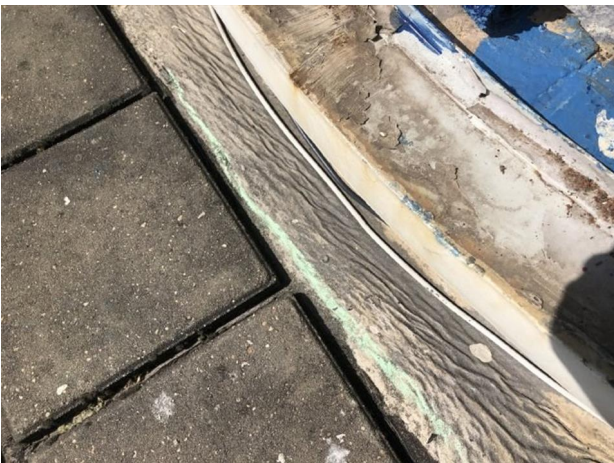
**The asphalt is rippled and slumped, it has reached the end of its life.**

The condition of the existing waterproofing is extremely poor and is worthy of concern. There is extensive evidence of water ingress, due to advanced deterioration. As such, the existing system is beyond salvage and should be removed and replaced, using this opportunity to thermally upgrade the replacement system to comply with current Building Regulations.

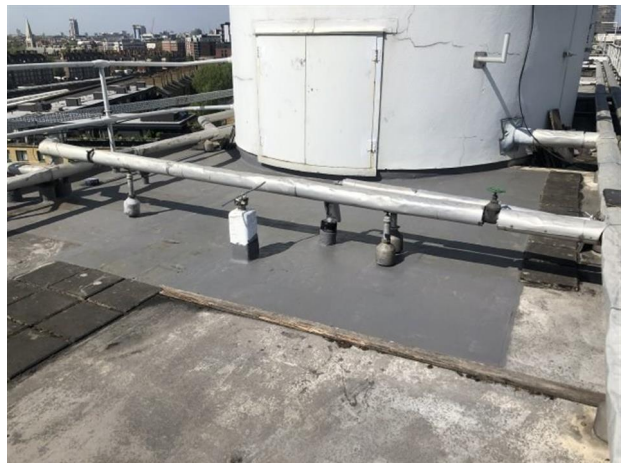
**Evidence of previous repair suggests historic issues and reports of water ingress.**

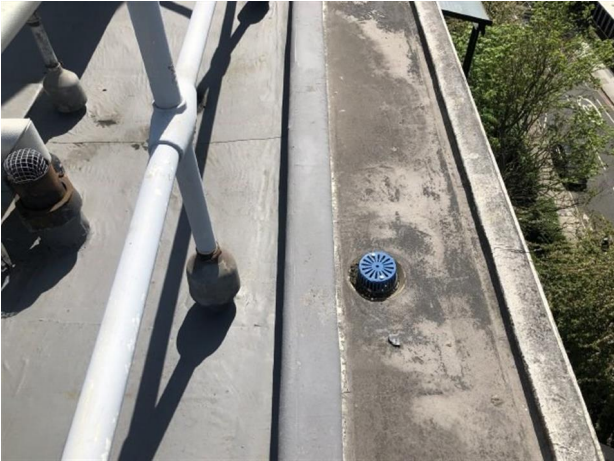
**Consideration to replacing fixed handrail with freestanding unit to eliminate penetrations. Internal outlets to be replaced with refurbishment units.**

- We propose that a new free-standing guard rail system is installed to provide and meet safe access and egress requirements for this roof. We would suggest specialist advice is obtained to provide a suitable specification for these items.

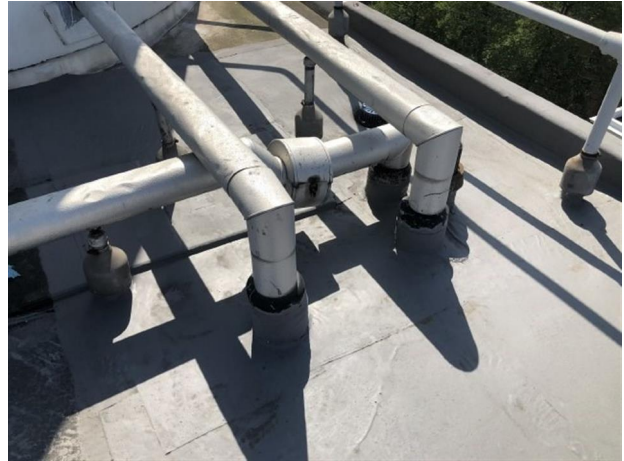
**Vertical and horizontal pipe penetrations to be weathered with site fabricated code 4 lead collars and sleeves. Some pipework may require modification / repair - M&E to confirm.**

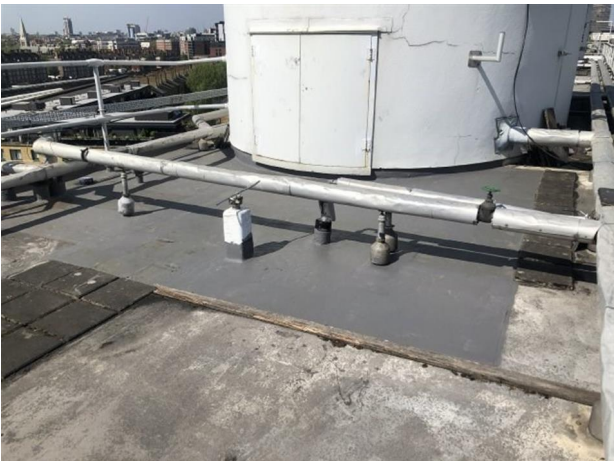
**Consideration to be given to replacing fixed pipework supports with freestanding units to design out penetrations.**

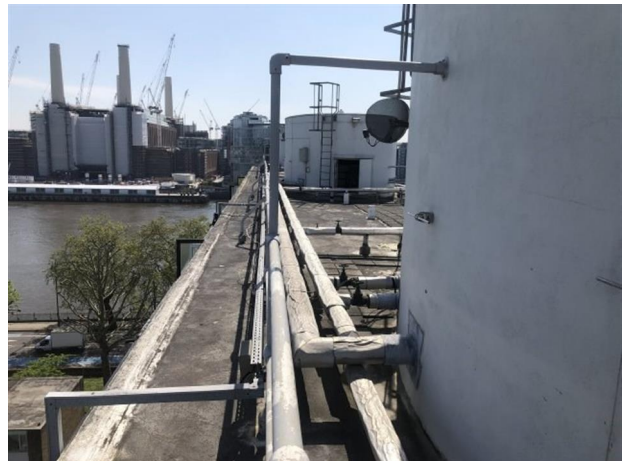
**Consideration to be given to terminating perimeter edge with GRP Trim.**

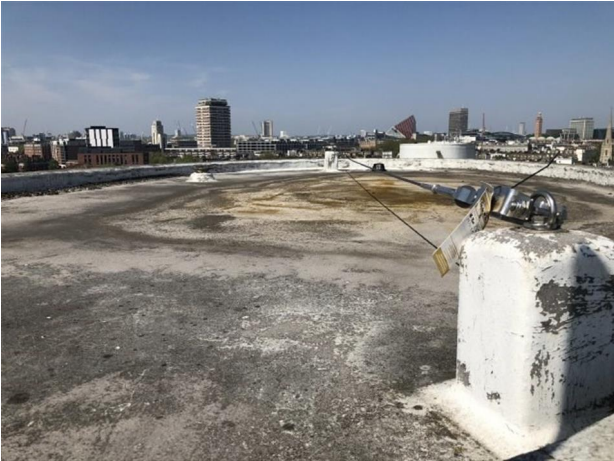
**Overview of tank roof. Safety line fixings will be difficult to weather in situ, consideration should be given to renewing the post with a Latchways or similar unit with a base and flange that can be robustly waterproofed.**

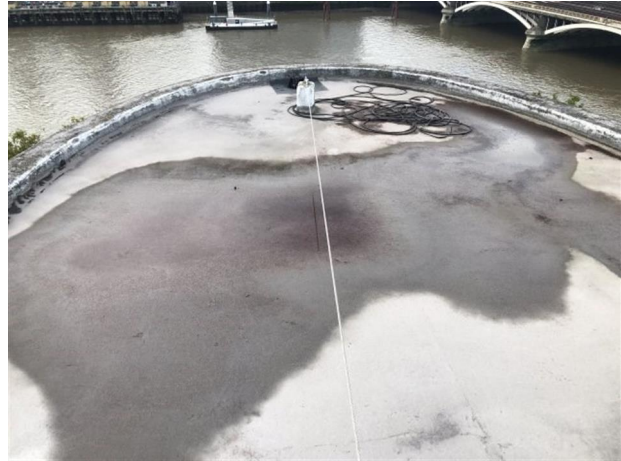
**The existing asphalt waterproofing has defects and is reaching the end of its serviceable life. It is currently considered to be in a suitable condition to overlay. There is some evidence of standing water, this will not be detrimental to the system performance or guarantee.**

The condition of the existing waterproofing is of concern. The material covering is coming to the end of its serviceable life and demonstrating signs of age, fatigue and fragility that could lead to serious failure.

- The condition of the existing waterproofing is considered suitable for receiving an overlay system.

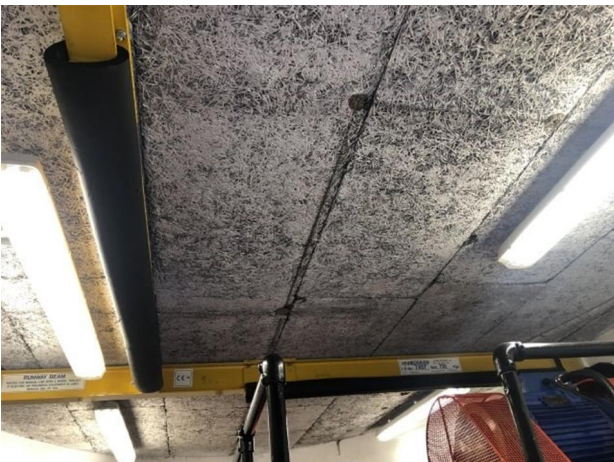
**The tank house deck is woodwool which is assumed to be finished with a screed. Overlaying the asphalt will mitigate risks associated to stripping up in this area.**

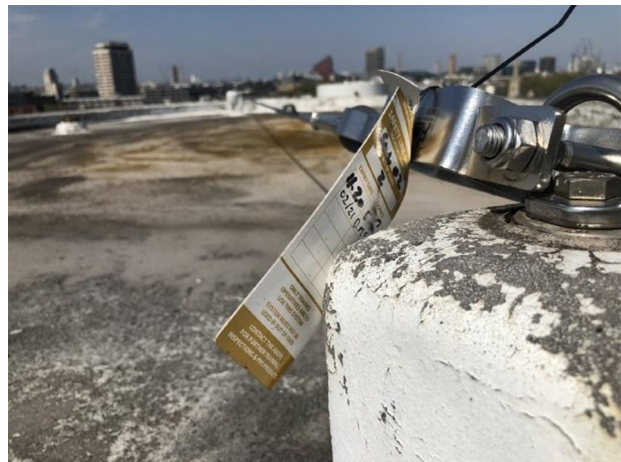
**Fixings will be difficult to weather.**
