Earl Kendrick
Building Surveyors

Condition Report

Emanuel House
18 Rochester Row
London
SW1P 1BS

7 April 2022

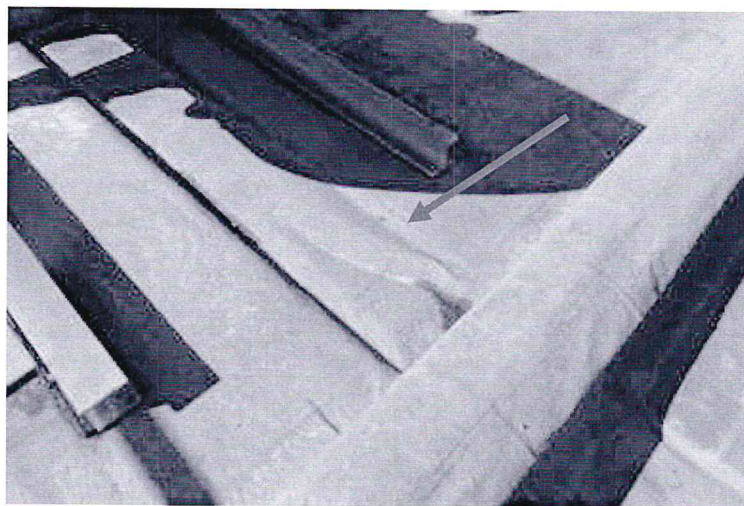
The roof membrane is largely in good condition and also appears to have had a further waterproof liquid coating installed. Areas of small patch repairs are visible throughout the roof areas and there is one section to the centre of the east block roof where water is visible beneath the membrane (see photo below):

We would recommend this area is cut out and replaced in the short term to prevent a potential localised roof leak in this area.

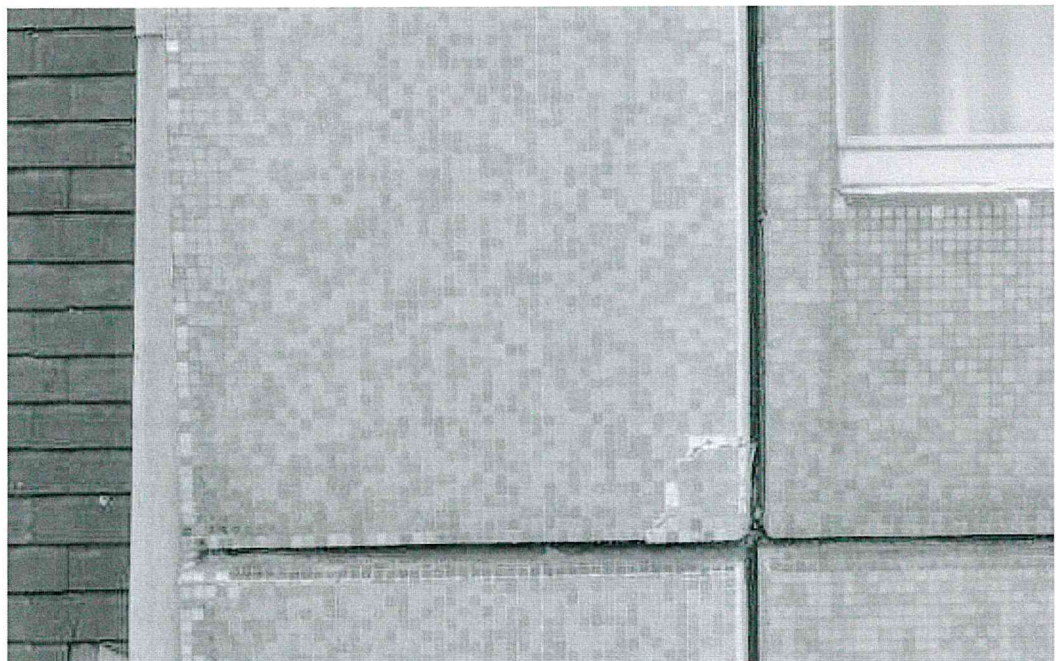
There are some areas of damage to the concrete panels which require remedial repairs in the short term to ensure that no concrete comes loose from the building. The worst area of damage noted was to the left hand panel to the fourth floor of the east block (see below):

In the short term we would recommend that an abseil inspection is undertaken to repair the damaged section of concrete panel to the east block detailed above. The survey would also help identify if there are any other loose areas of concrete and allow a better understanding of how the panels are fixed to the structure of the building and if the joints between the panels are integral to structural make up or weatherproofing of the façade. This would allow a more detailed specification for any required repair works and allow for more cost certainty for the repair works prior to any scaffold that is installed for the planned works to the windows (detailed in the section below).

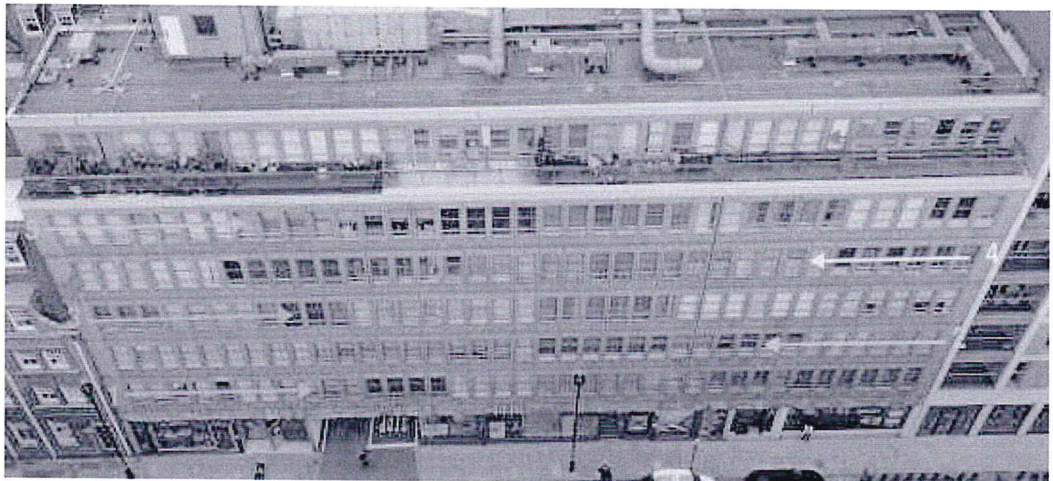
The location of the loose section of concrete is indicated by the red star below:
