Window Condition and Feasibility Report

Emanuel House
18 Rochester Row
London SW1P

1 October 2021

EKA210778

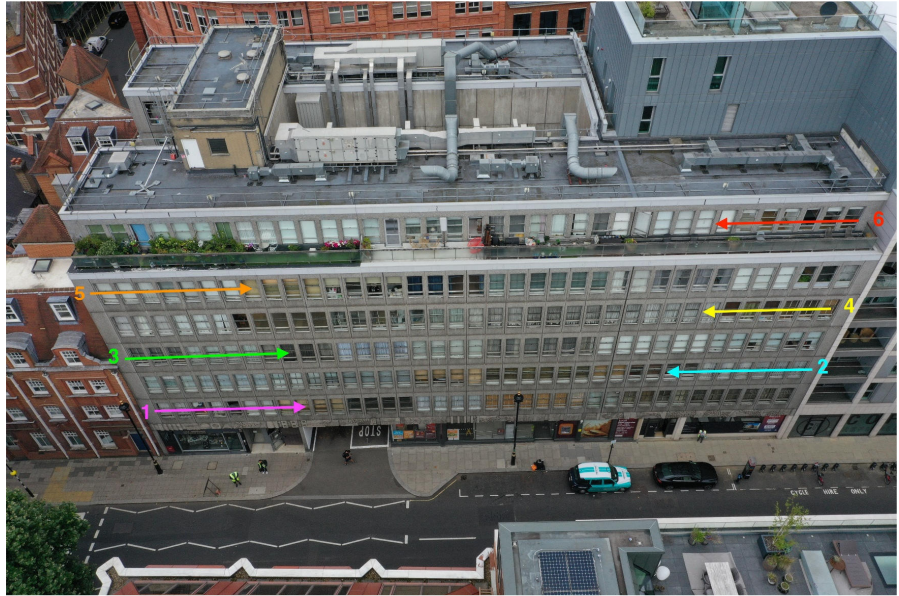
Photograph: East Elevation Rochester Row comprising 222No. windows

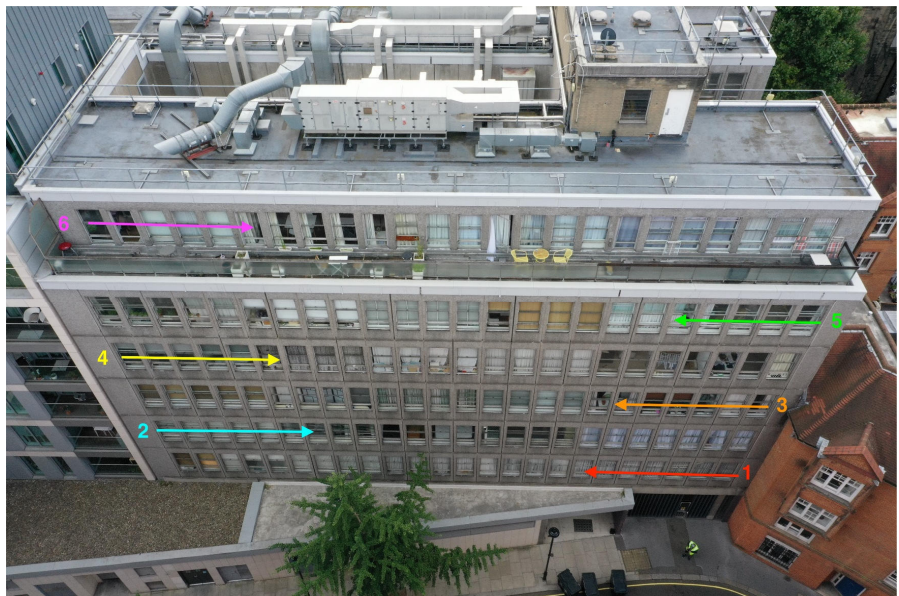
Photograph: West Elevation Greencoat Place comprising 144 windows (lightwells another 45 windows)

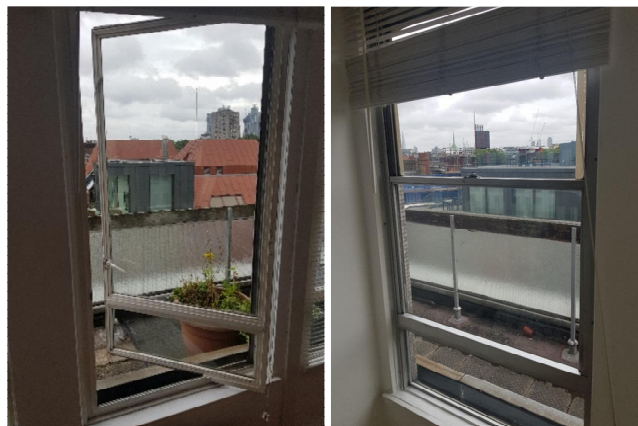
Photographs Windows internal 6th floor Offset pivot and sash

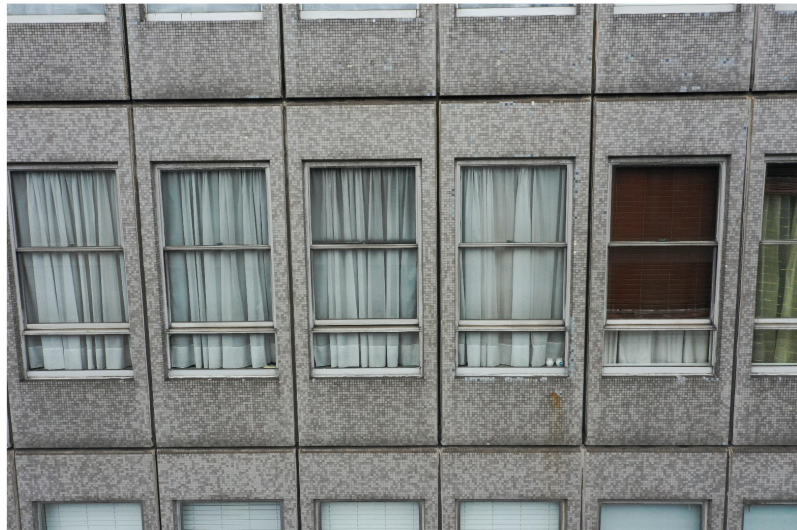
Photograph: Generic external view of Emanuel House East and West facades 1st-5th floors.

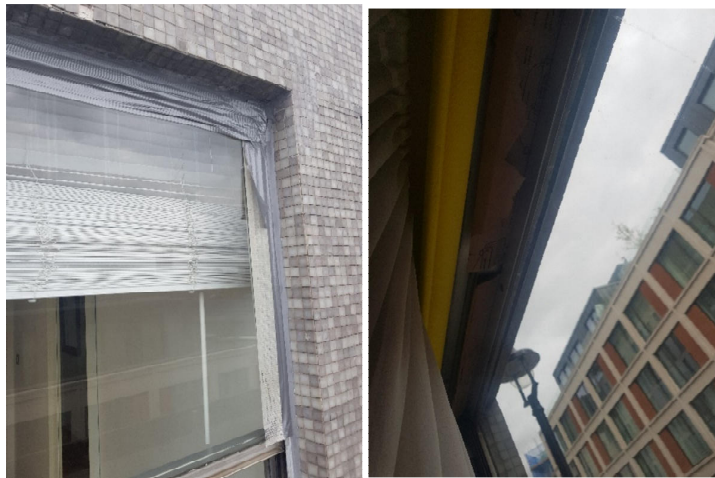
- f. The rubber seals to the windows are in a deteriorated condition;
- g. Improvised window draughtproofing are being used such as duct tape where windows no longer meet the frame;

Photographs improvised draught proofing to sash windows duct tape and card board

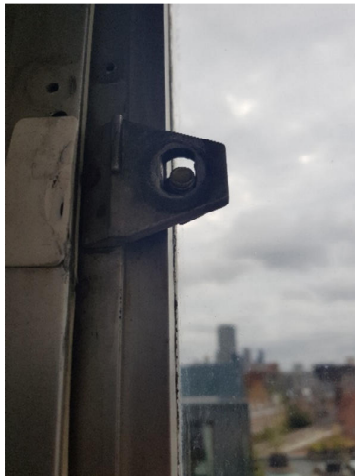
- d. Some of the catches and window ironmongery are broken/missing.
- e. A consistent/frequent defect to the window systems is that the window latches do not fit into the keep and have/are causing damage to the window frame.

Photograph broken catch to offset pivot windows
