**Blandford Estate
Harewood Avenue
London
NW1**

Client Ref: Y100 – Blandford Estate

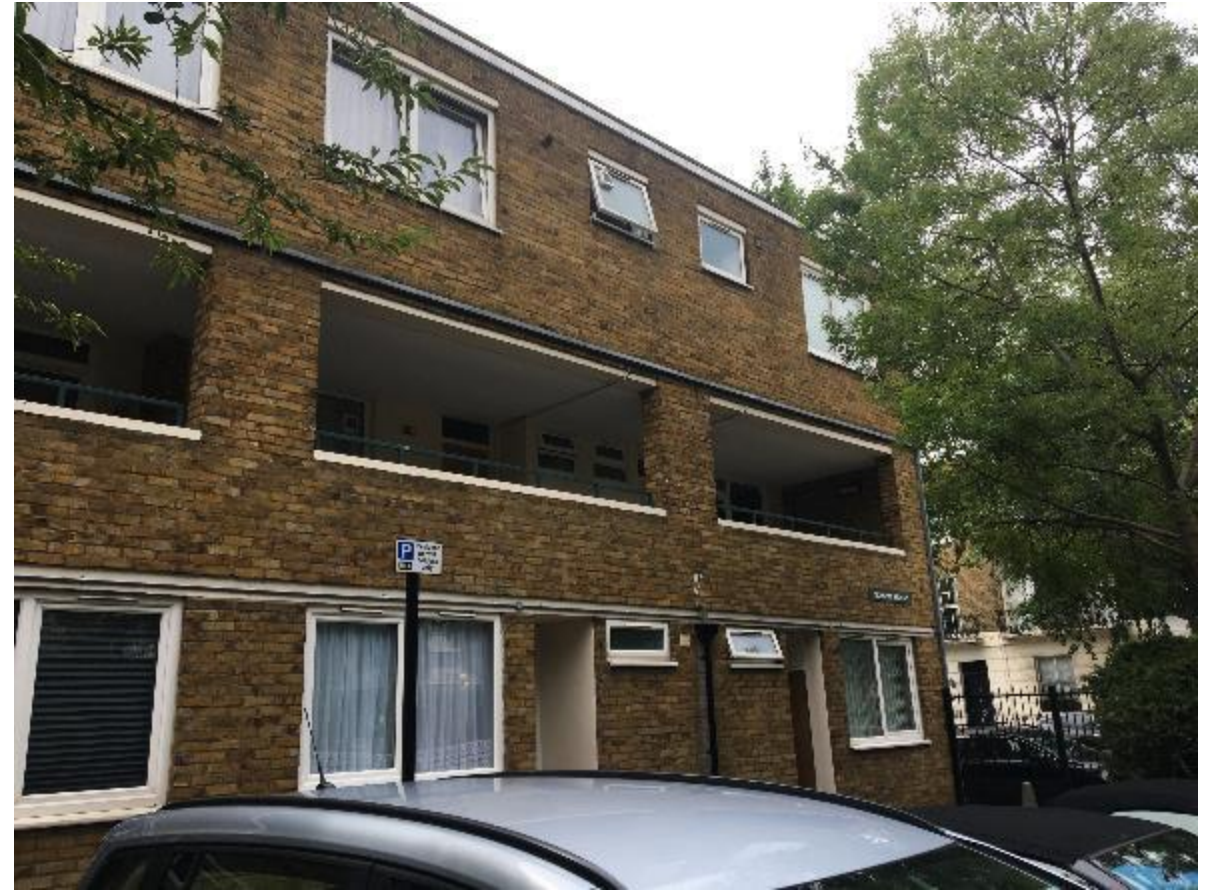
Photo 2. Front elevation fascia boards, the Council's brief states that no roofing works are planned in its next cyclical decoration programme. However, at Modern Hse despite the assumed PVCu or possibly aluminium powder coated boards to the main roofs being in good condition, consideration should be given to their cleaning.

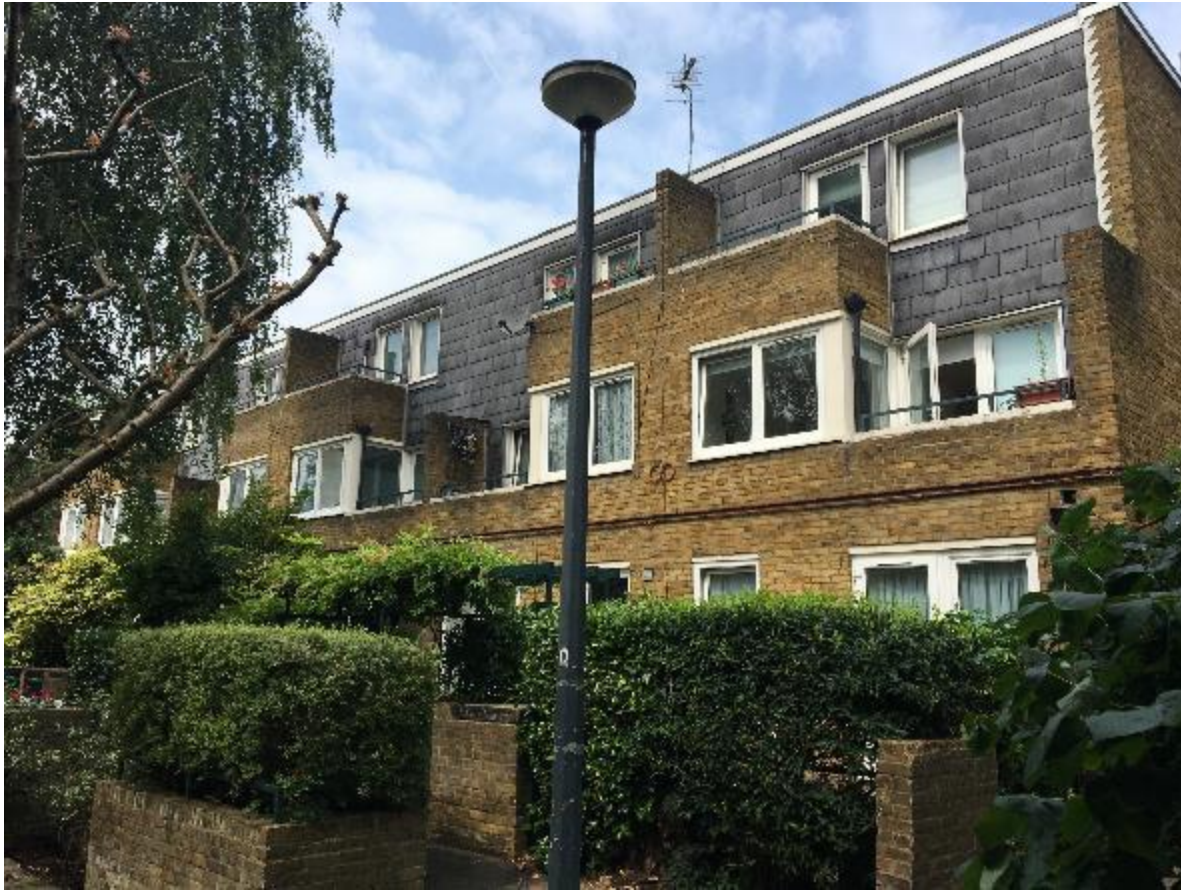
Photo 3. Rear elevation fascia boards.

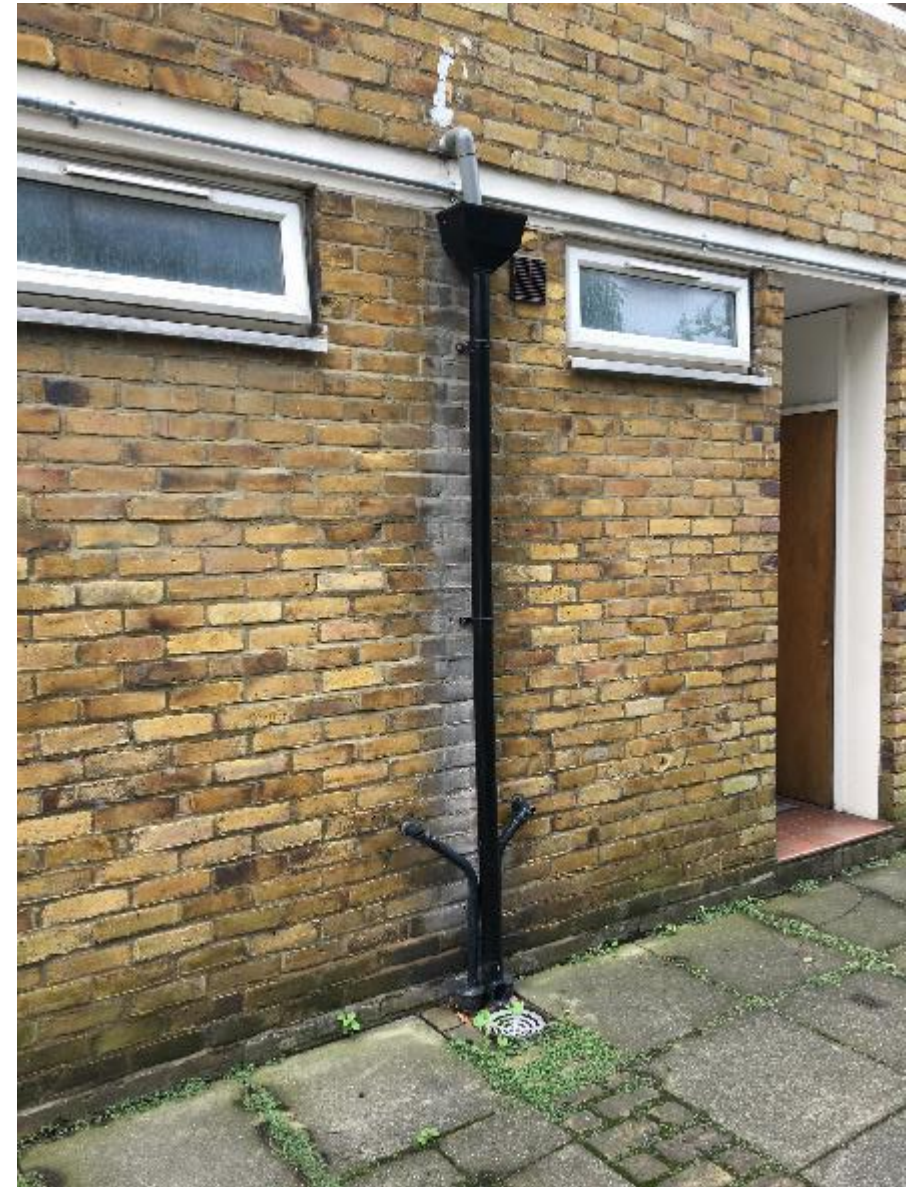
Photo 4. Front elevation rainwater goods serving communal walkways considered to be in good condition as they appear to be relatively new. However, consideration should be given to the removal of historic limescale build-up on the brickwork typically found across the Blocks.

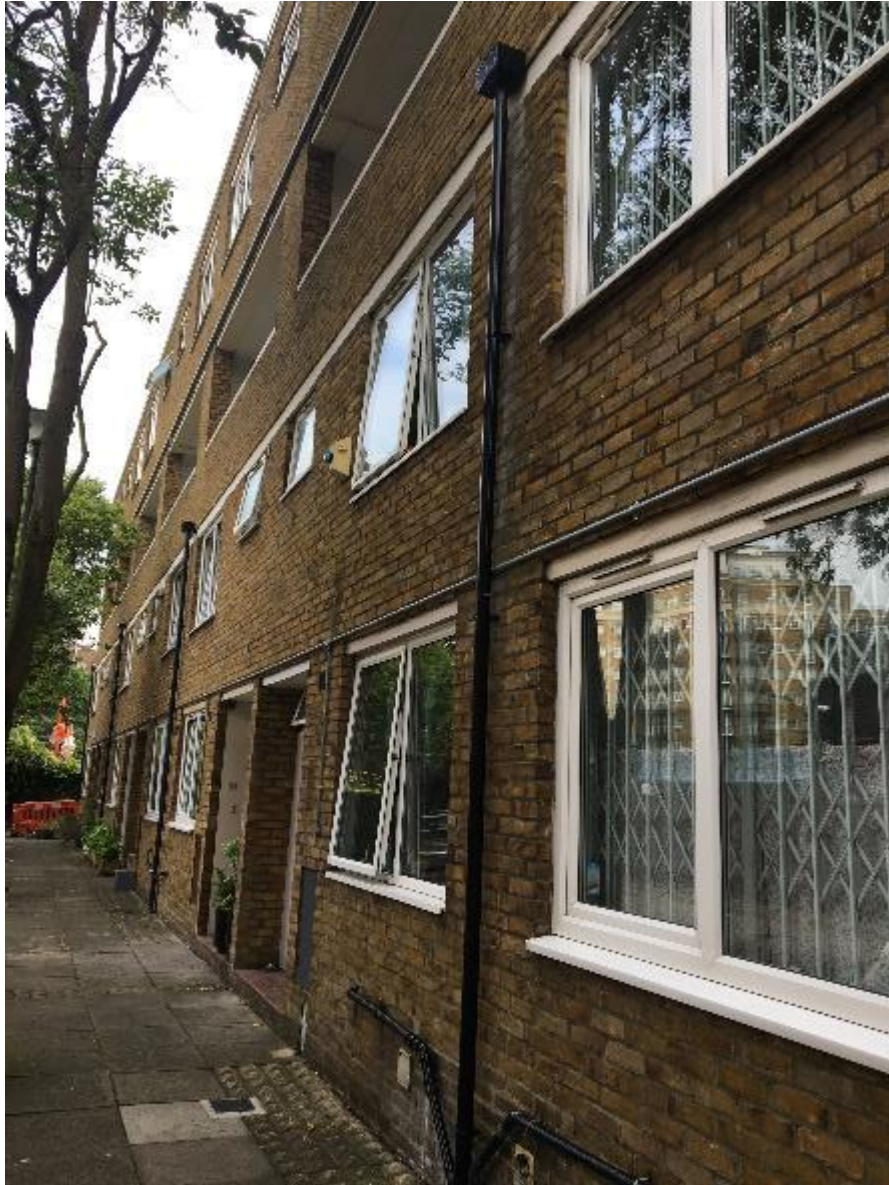
Photo 5. Again, showing front elevation rainwater goods serving communal walkways which are considered to be in good condition as they appear to be relatively new.

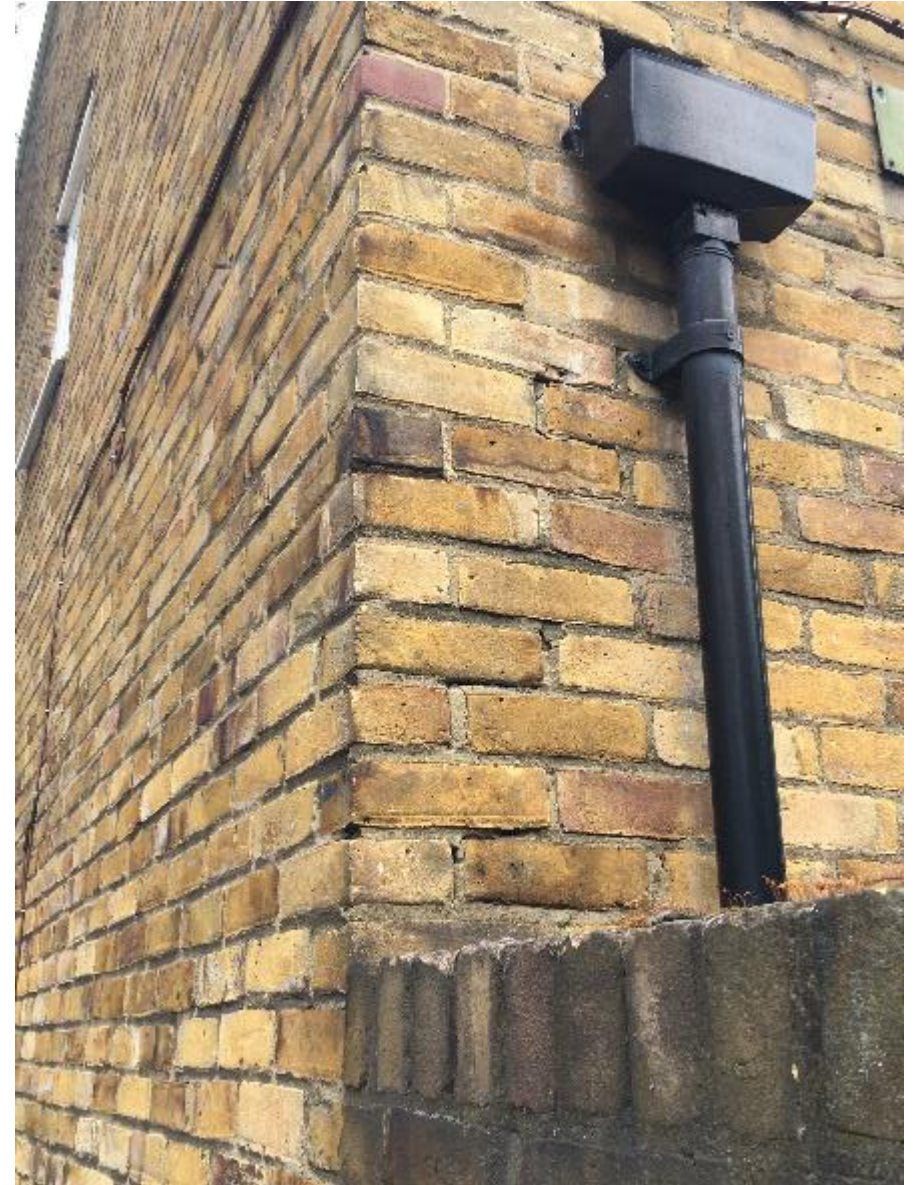
Photo 6. Across the Blocks, PVCu rainwater goods serving the rear 1st and 2nd flr private balconies are in fair condition. They are a mix of old and new however, some have been painted and as such consideration should be given to their redecoration.

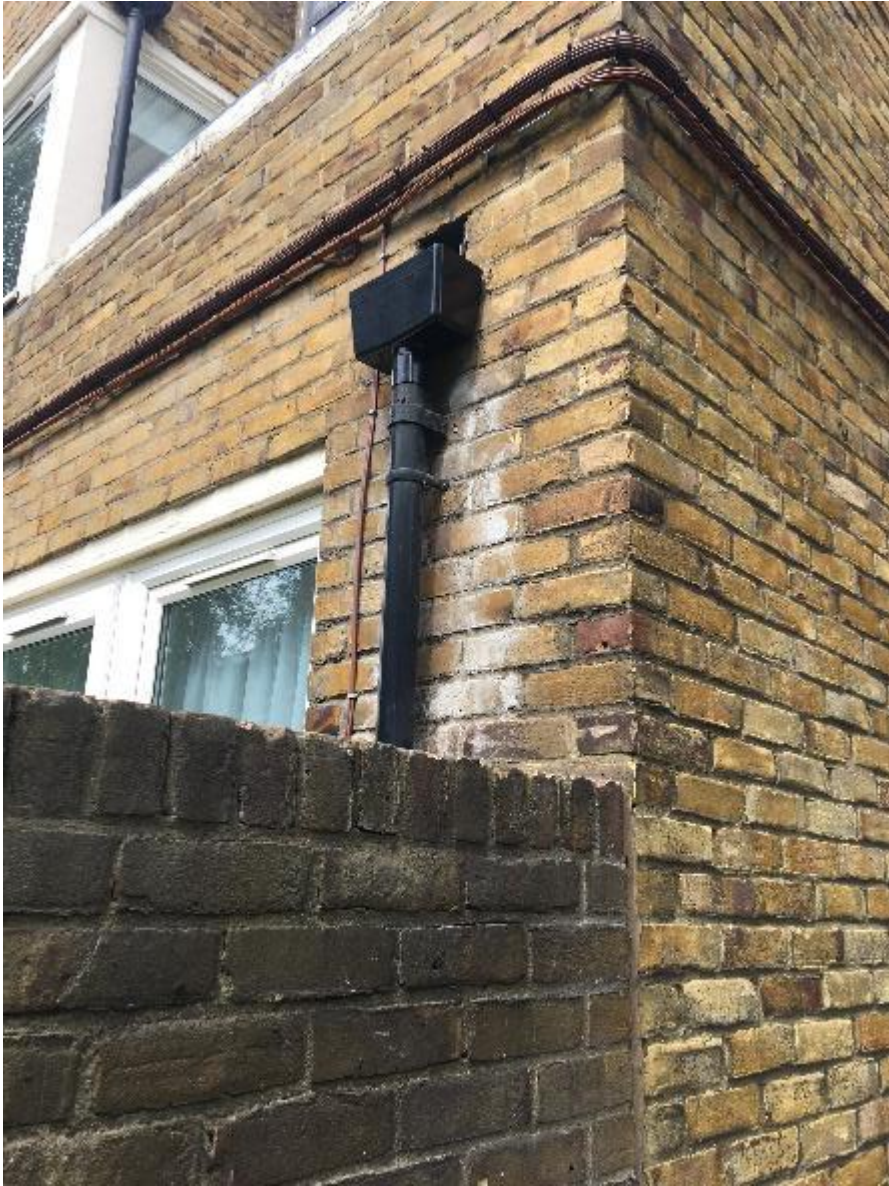
Photo 7. Example as per previous photo.

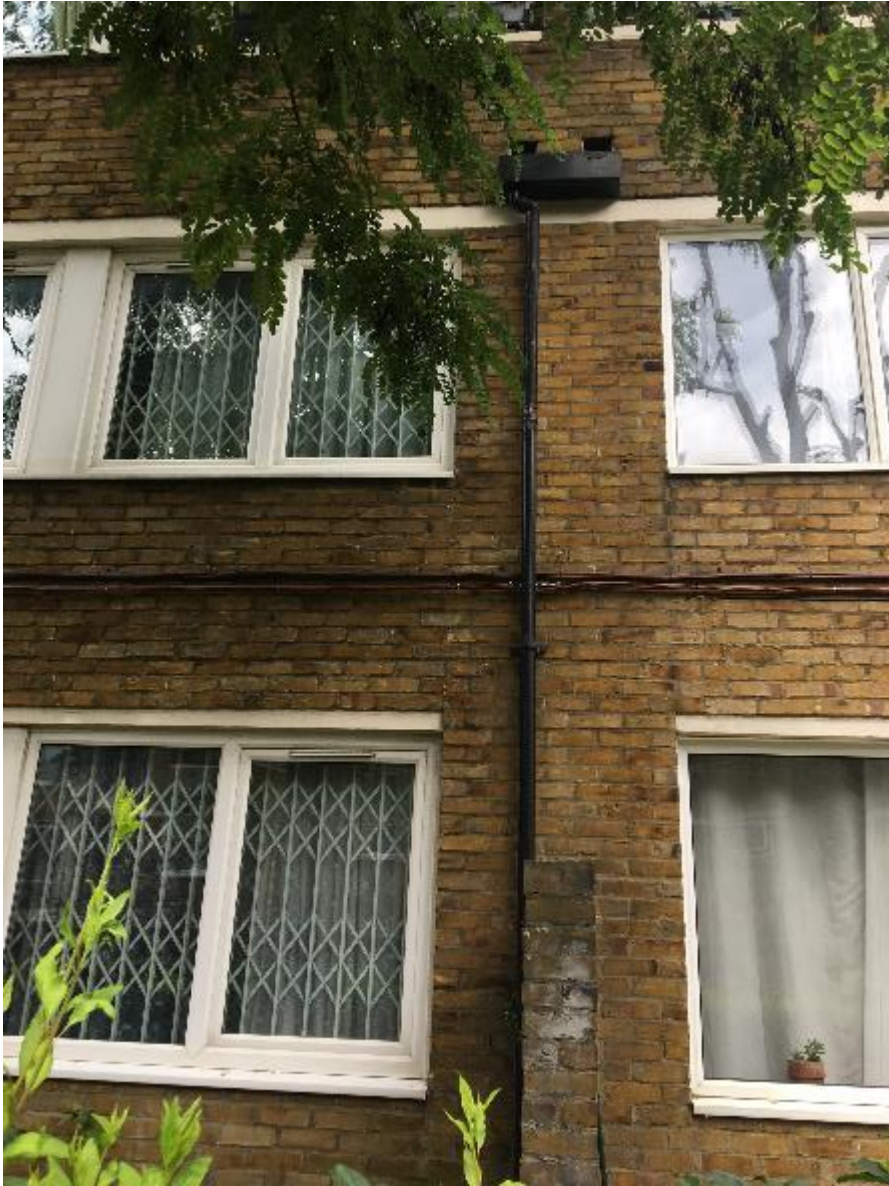
Photo 9. Across the Blocks, the painted and assumed cast-iron or galvanised steel rainwater goods serving the 2nd flr private balconies to the four storey Blocks are in fair condition but will require rust treatment and redecoration.

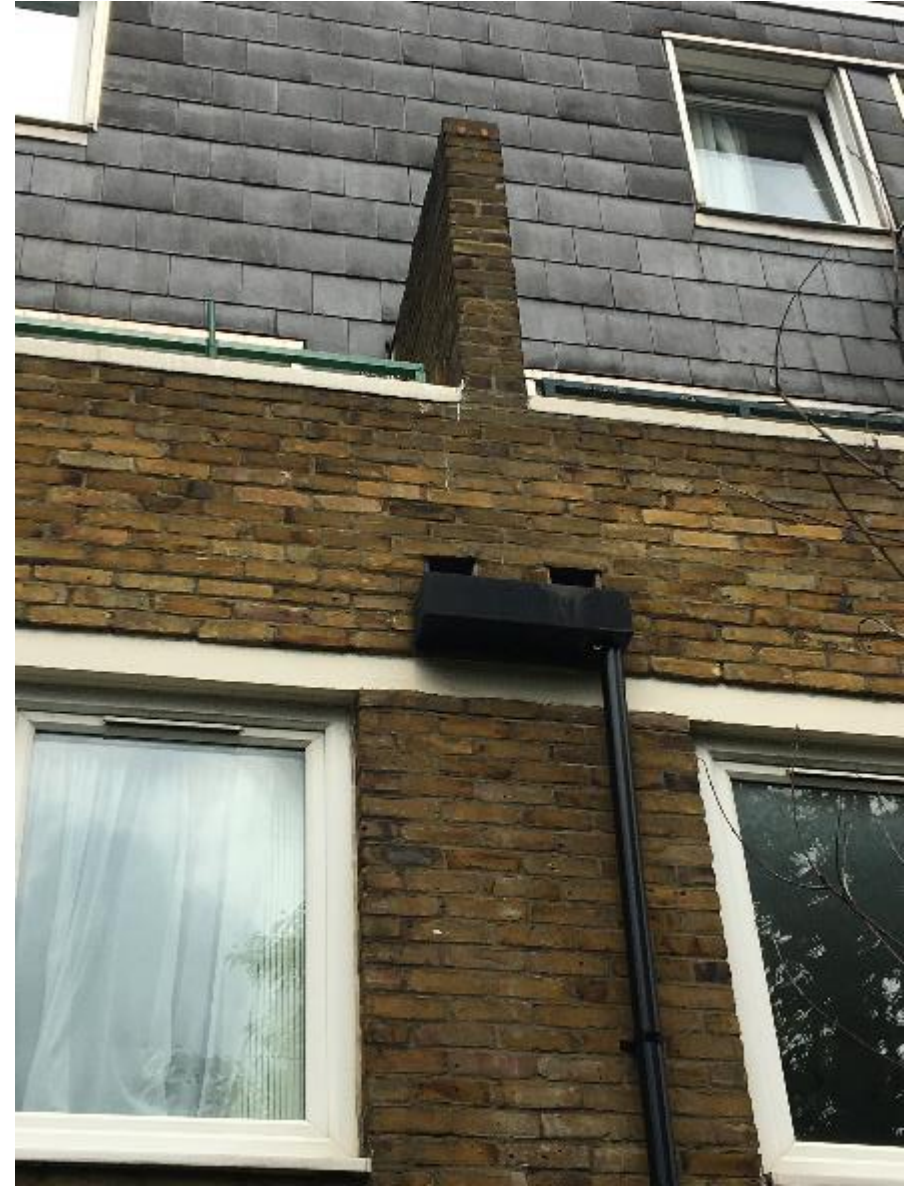
Photo 10. As per previous photo.

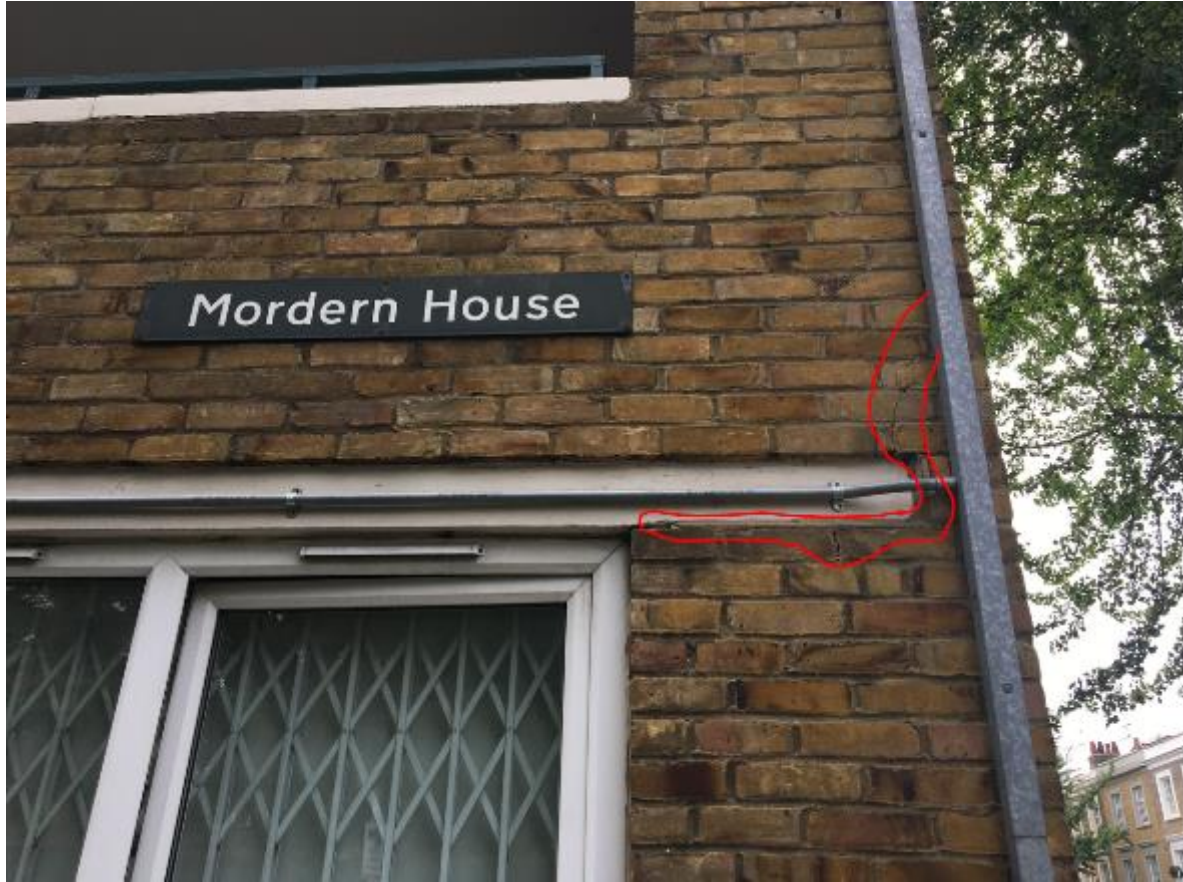
Photo 11. Evidence of localised settlement cracking to front RHS corner of Block. Nearby is a mature Ginkgo tree however, given the hairline width of the cracking it is considered not to be significant enough to warrant monitoring, at least for the present.

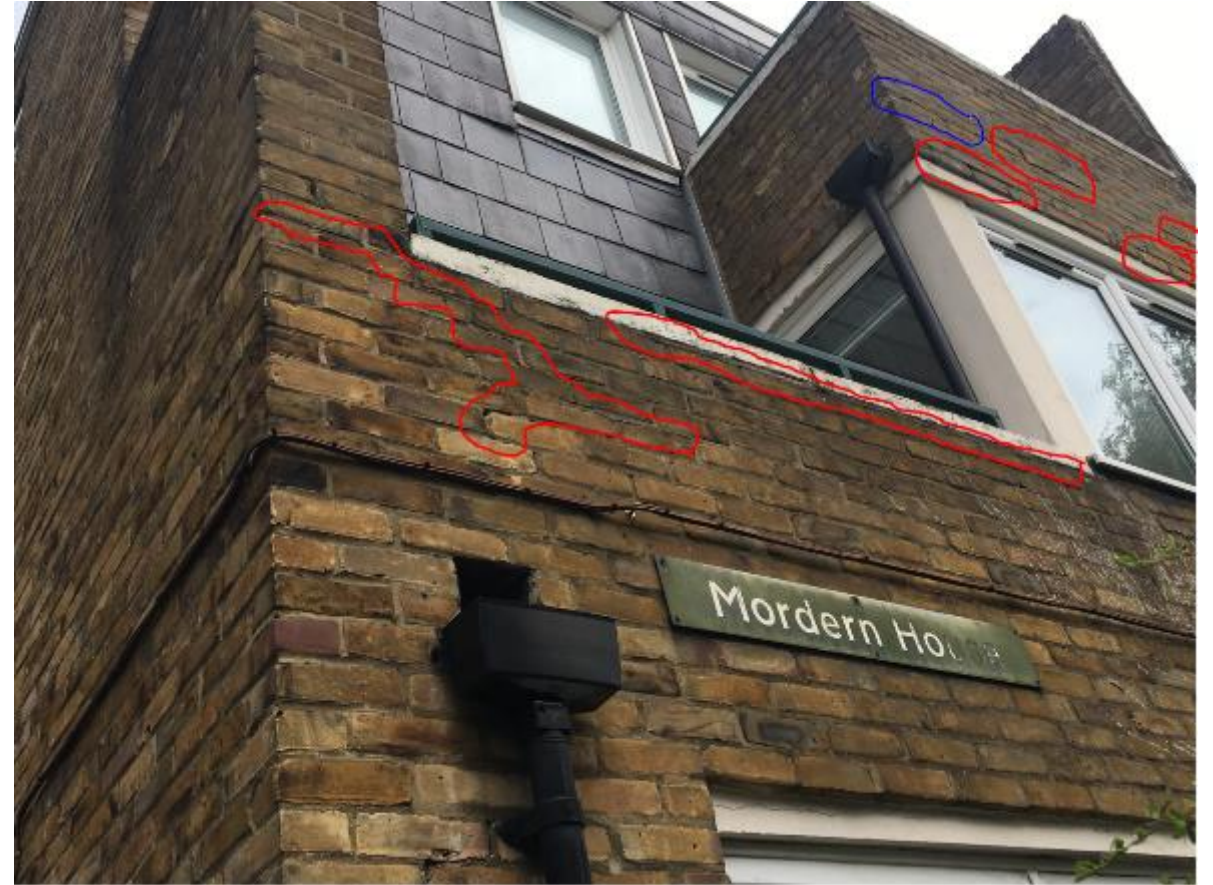
Photo 12. A generic defect to all Blocks is this localised defective pointing (red) to the 1st and 2nd flr rear private balcony parapets. Note the exposed DPC (blue) and the signage ought to be replaced.

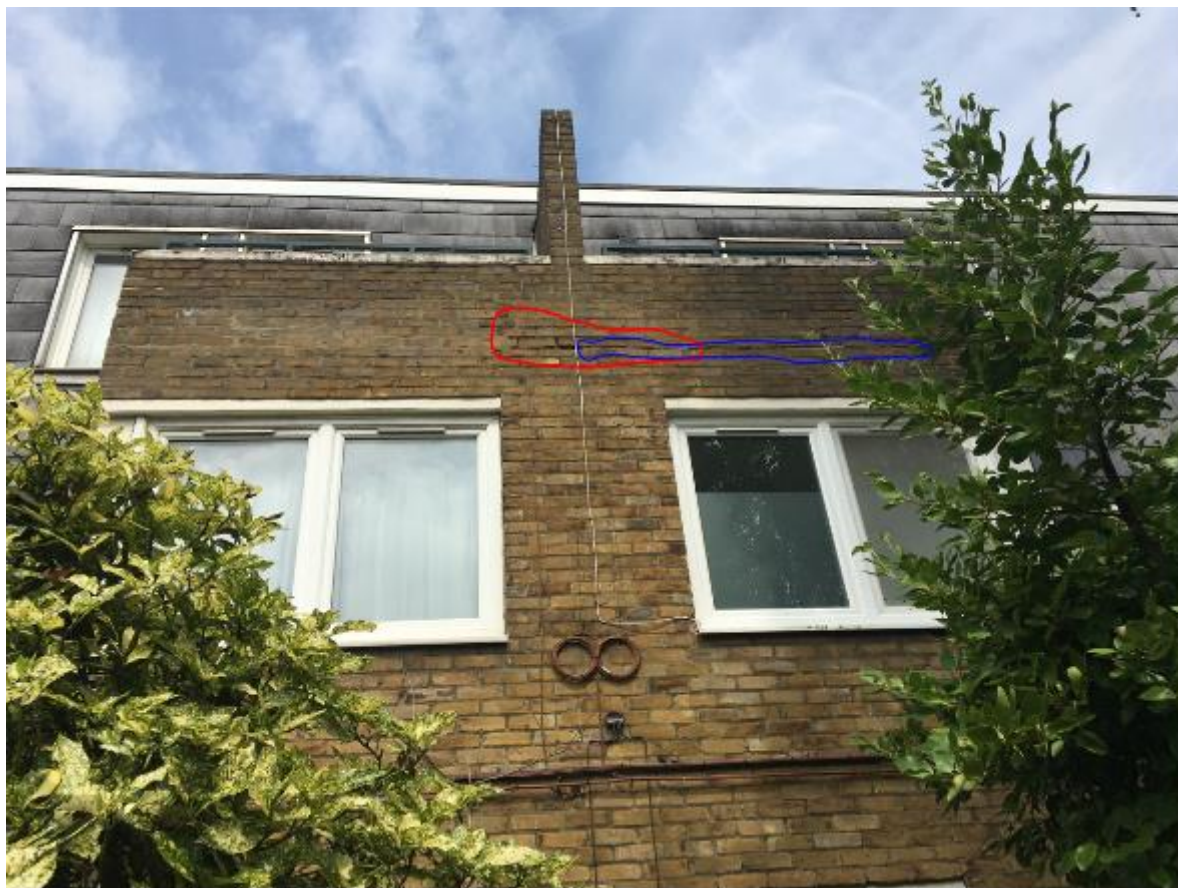
Photo 13. A generic defect found on all Blocks of localised defective pointing (red) to 2nd flr rear private balcony parapet, note exposed DPC (blue).

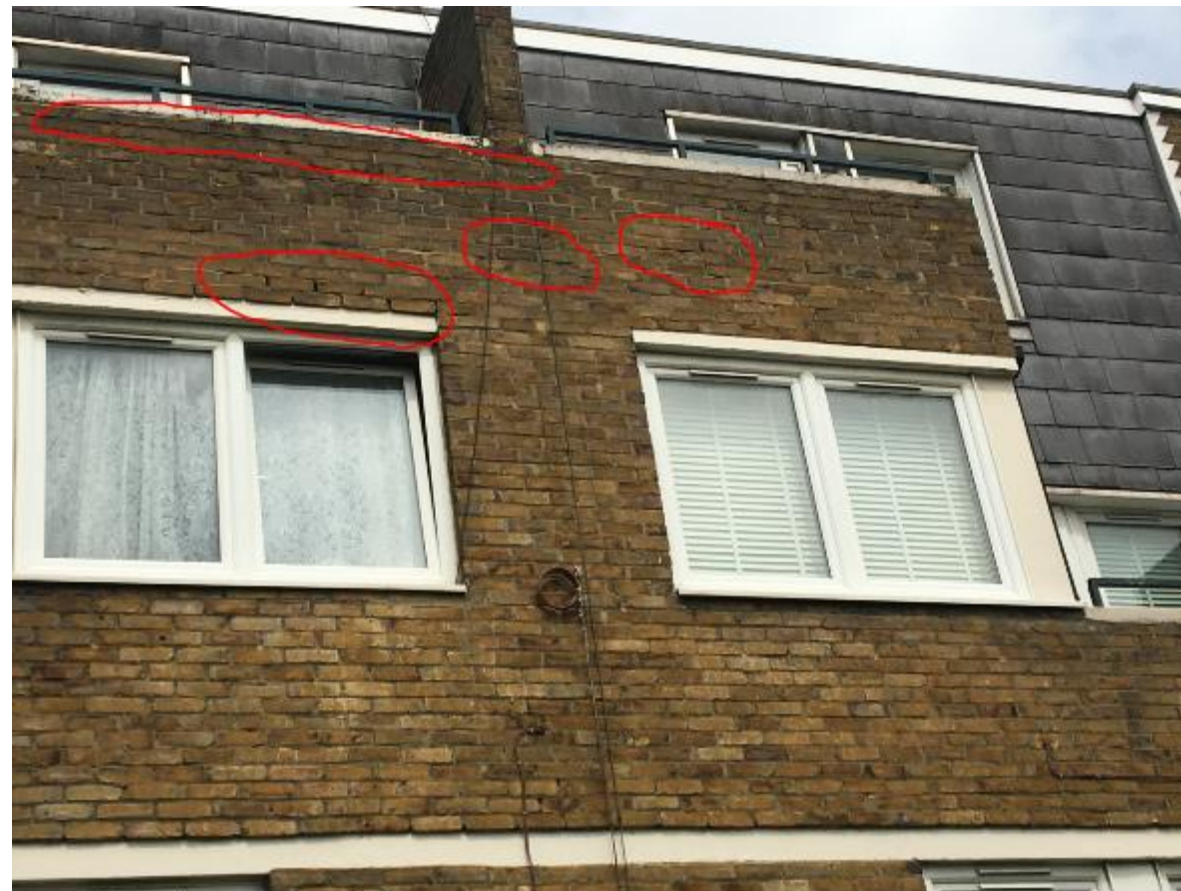
Photo 14. Again on all Blocks, there is defective pointing (red) to private balcony parapets. Note the need to repoint between copings and brickwork.

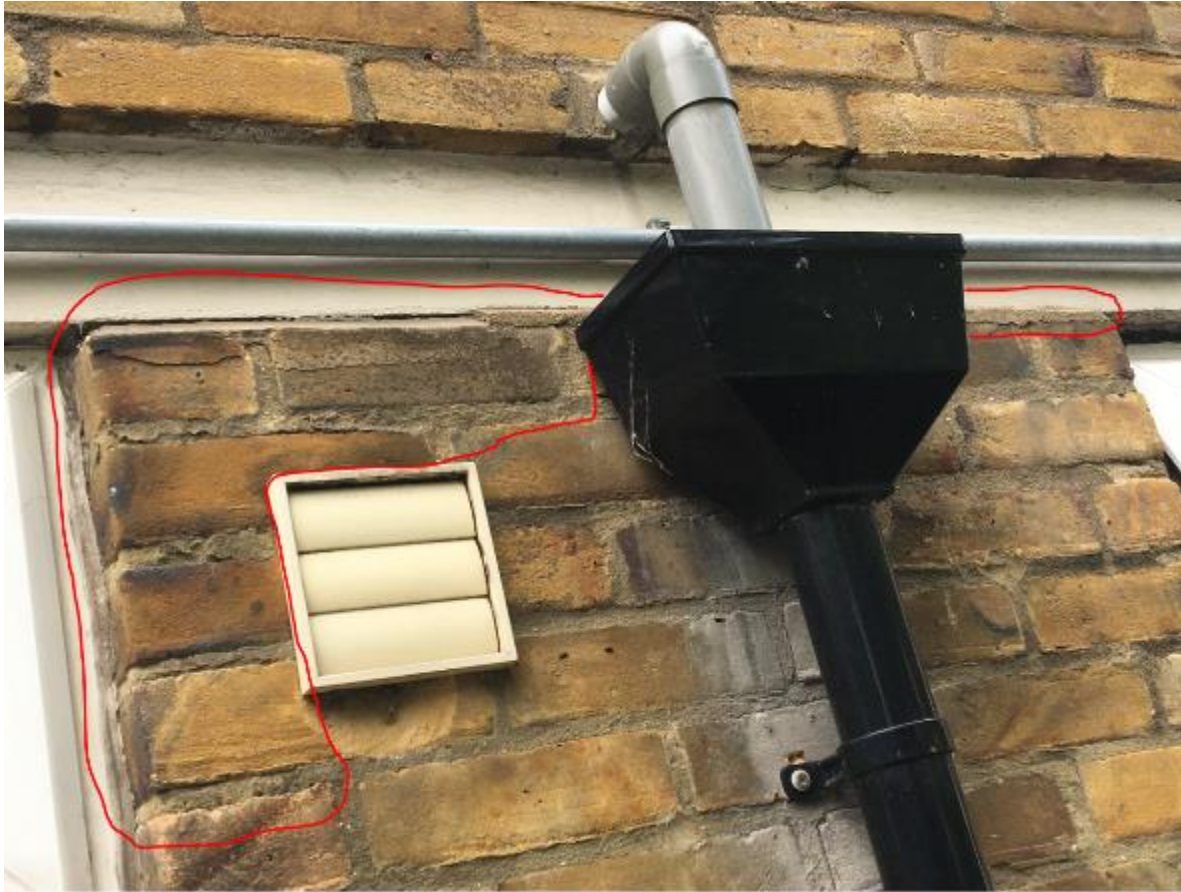
Photo 15. Likely to be a generic defect found on all Blocks of localised defective pointing to top corners of grd flr front window openings where there appears to be some minor, assumed thermal movement cracking.

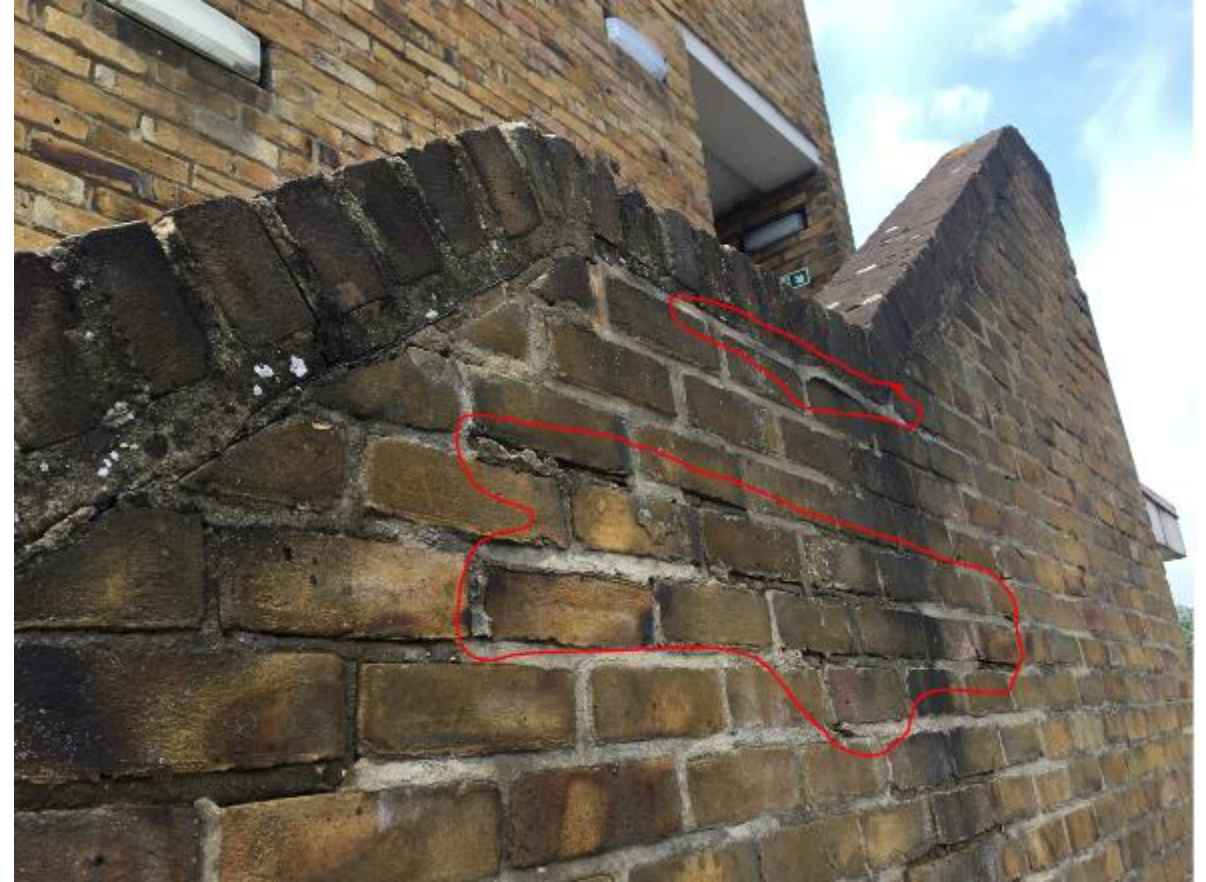
Photo 16. A generic defect found across all Blocks of localised failed pointing (red) to parapet guarding of steps adjacent railway. Note the black staining of the brickwork corresponding to the change in slope of the solid course coping.

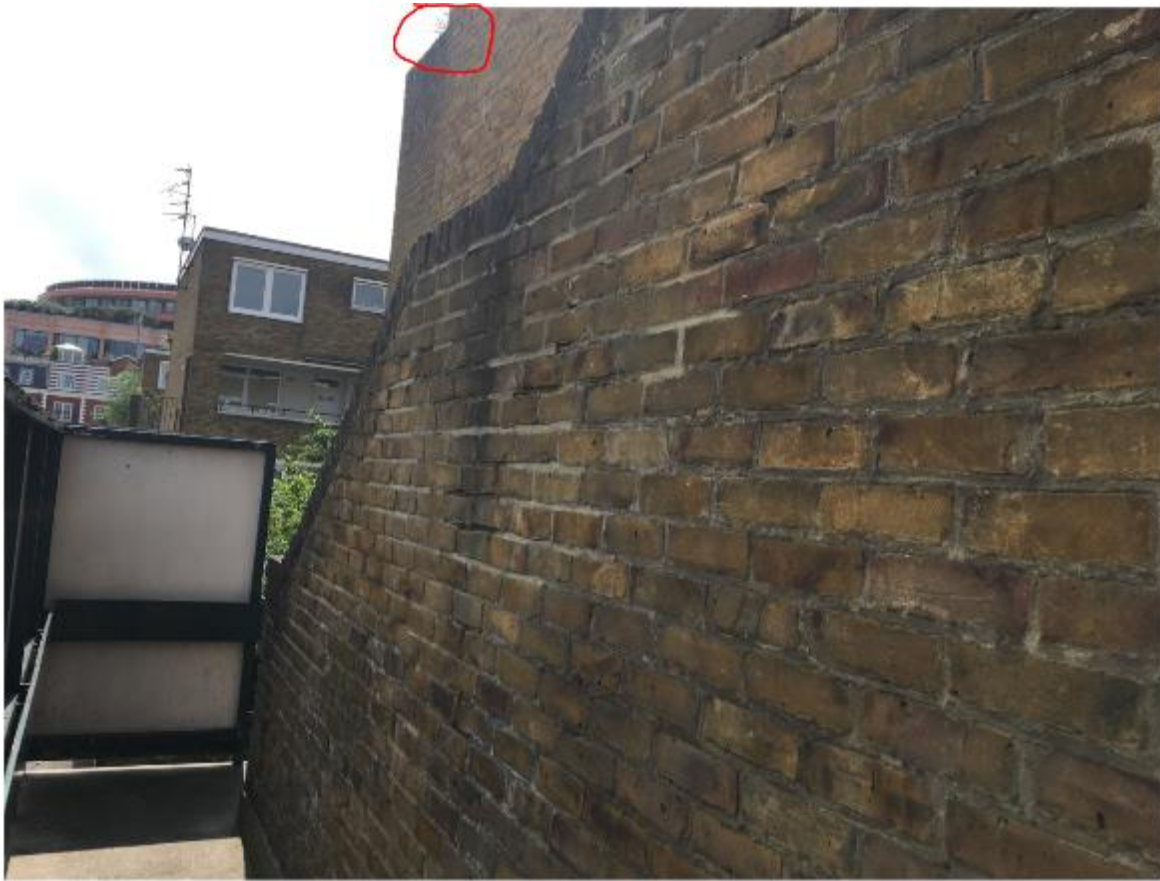
Photo 17. Same wall, different view and note the self-seeded vegetation (red) growing out of the private balcony parapet higher up the building; this is almost generic across all four Blocks.

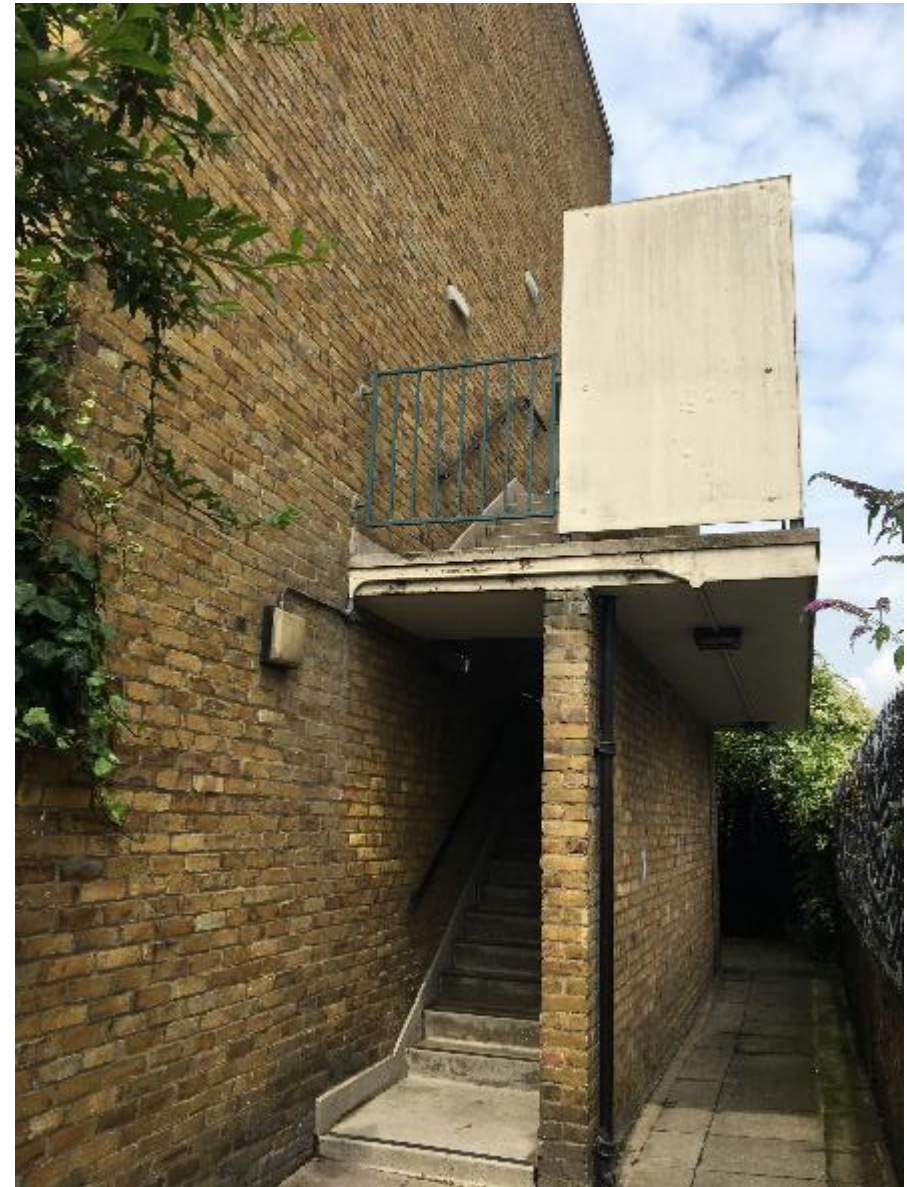
Photo 18. Same steps, note the failed decorations to the concrete landing and assumed cement board guarding.

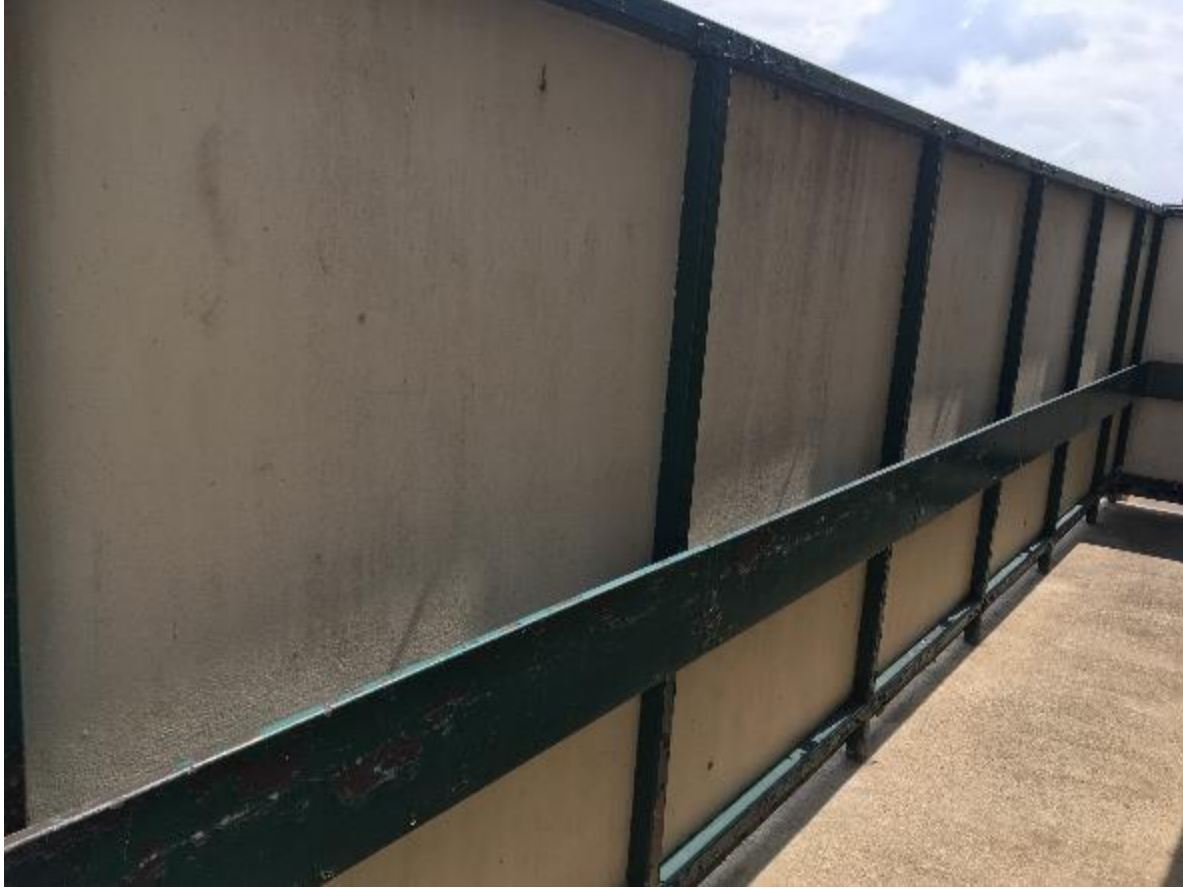
Photo 19. Failed paintwork to guarding of same steps.

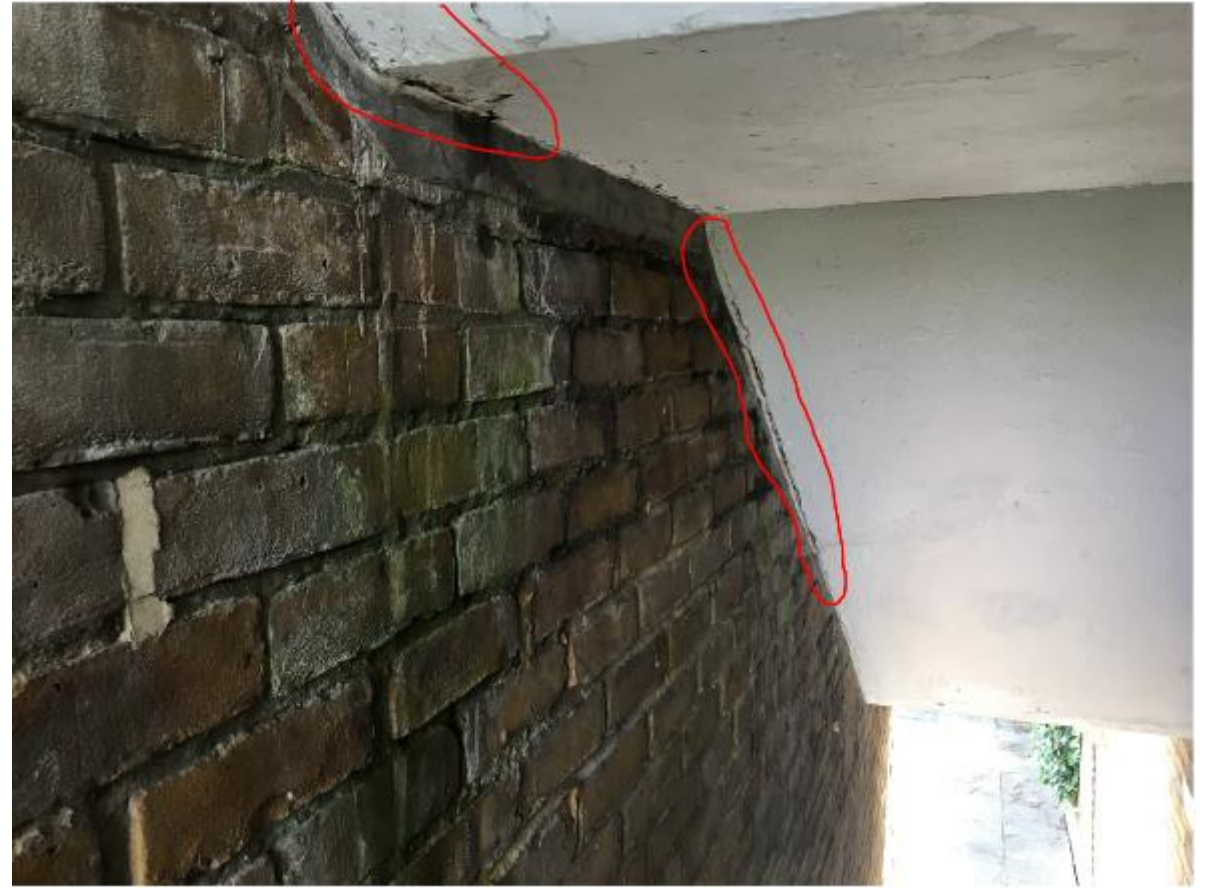
Photo 20. Evidence of water penetration between soffit and wall of same steps, either the outer face of the brickwork needs repointing and/or the riser and tread skirting above has failed.

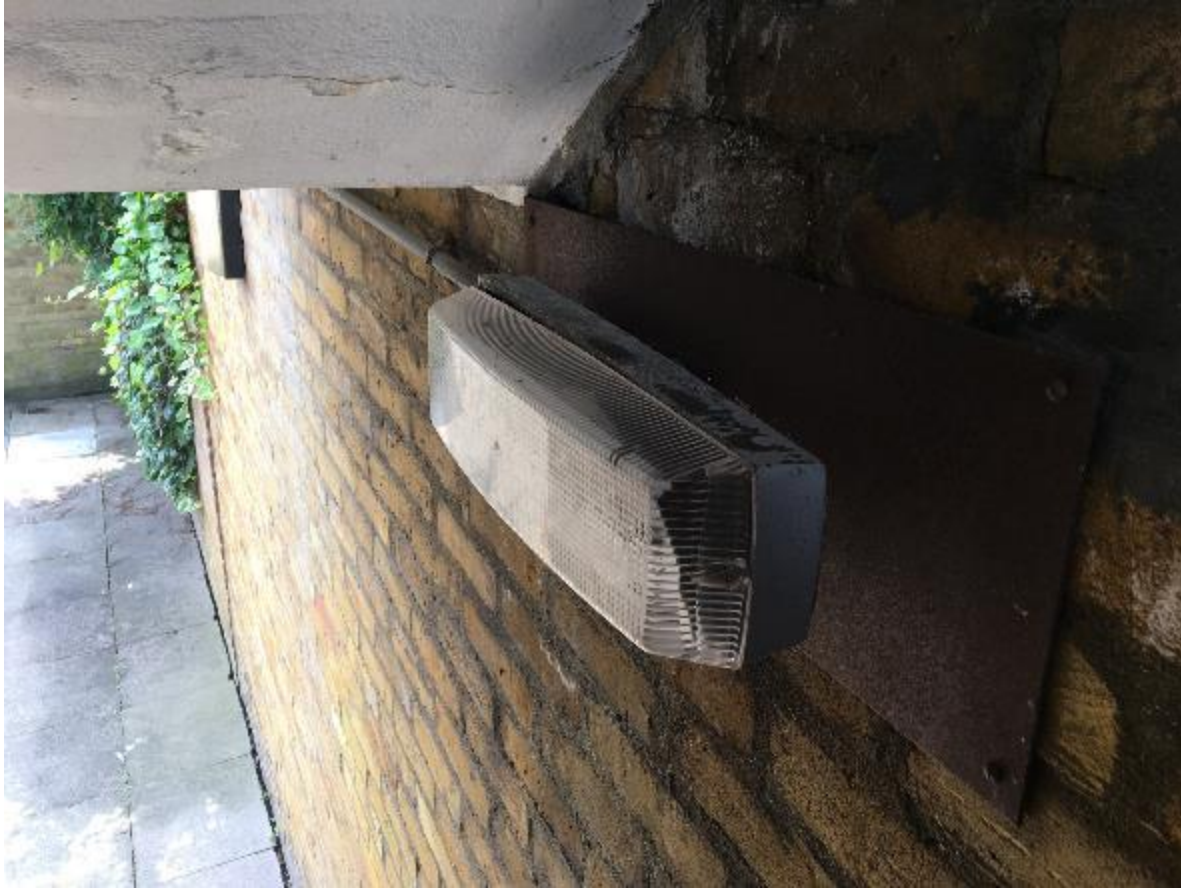
Photo 21. Same defect on other side, here the skirting above is defective.

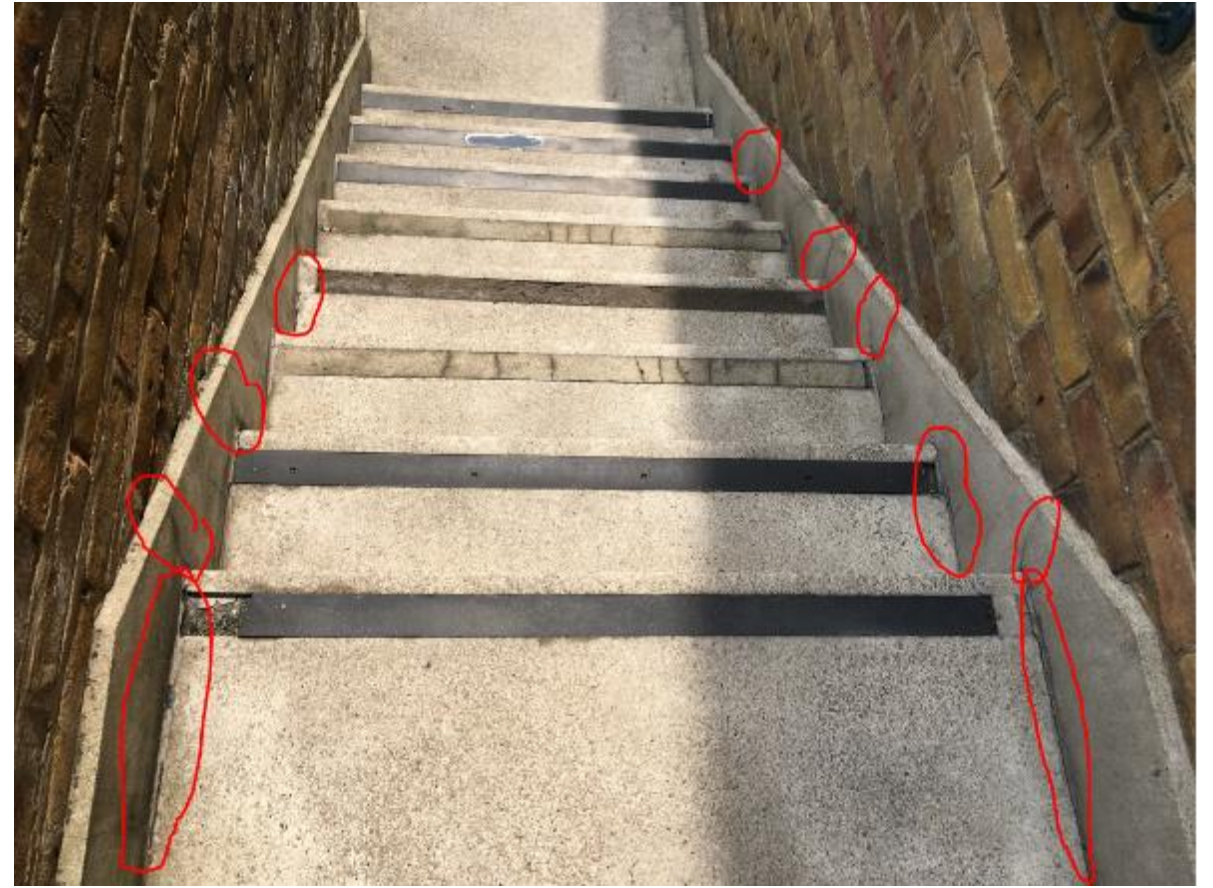
Photo 22. Same steps with highlighted cracking which could conceivably be points of rainwater penetration causing problem below.

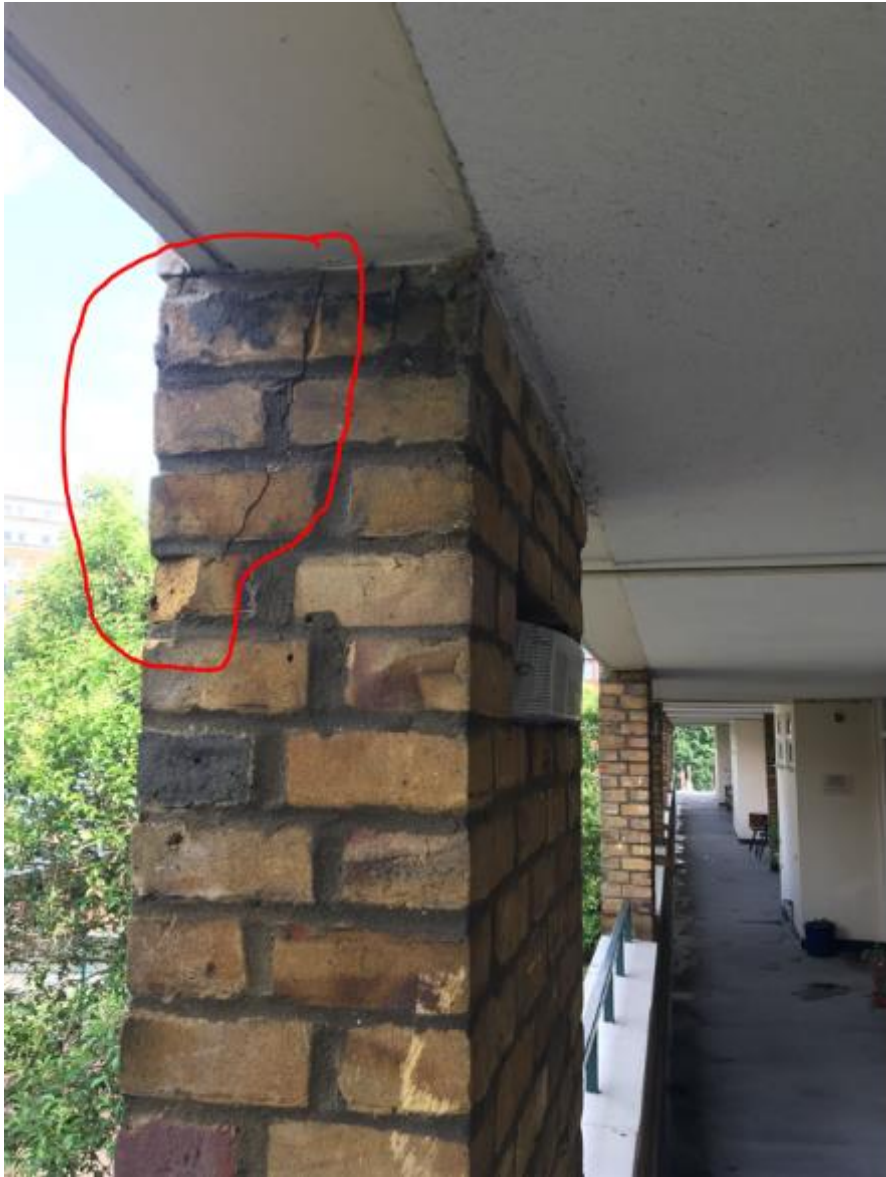
Photo 23. Cracking to brick pillar of communal walkway at Mordern Hse, possibly caused by vertical compression. Note the width of the historical repointing mortar.
