**Blandford Estate
Harewood Avenue
London
NW1**

Client Ref: Y100 – Blandford Estate

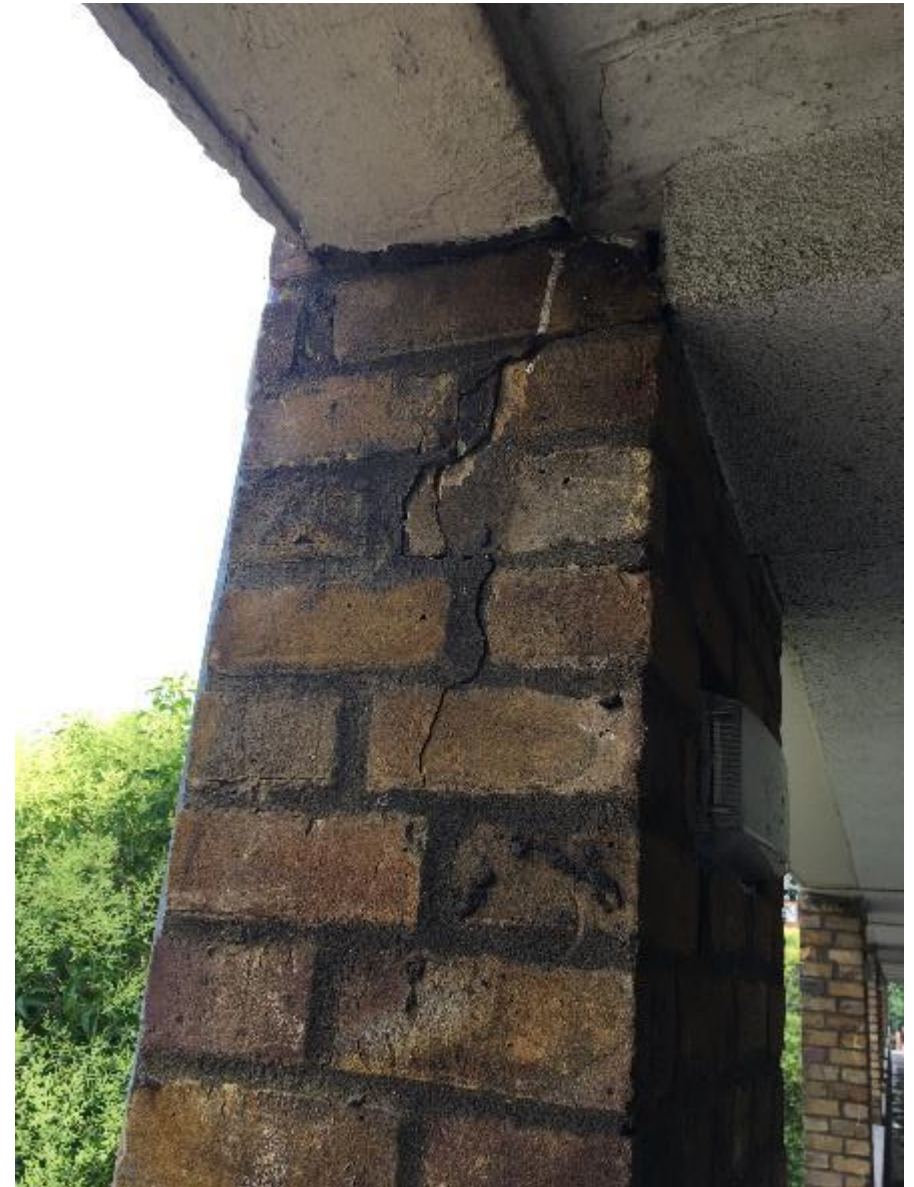
Photo 24. Same defect, different pillar.

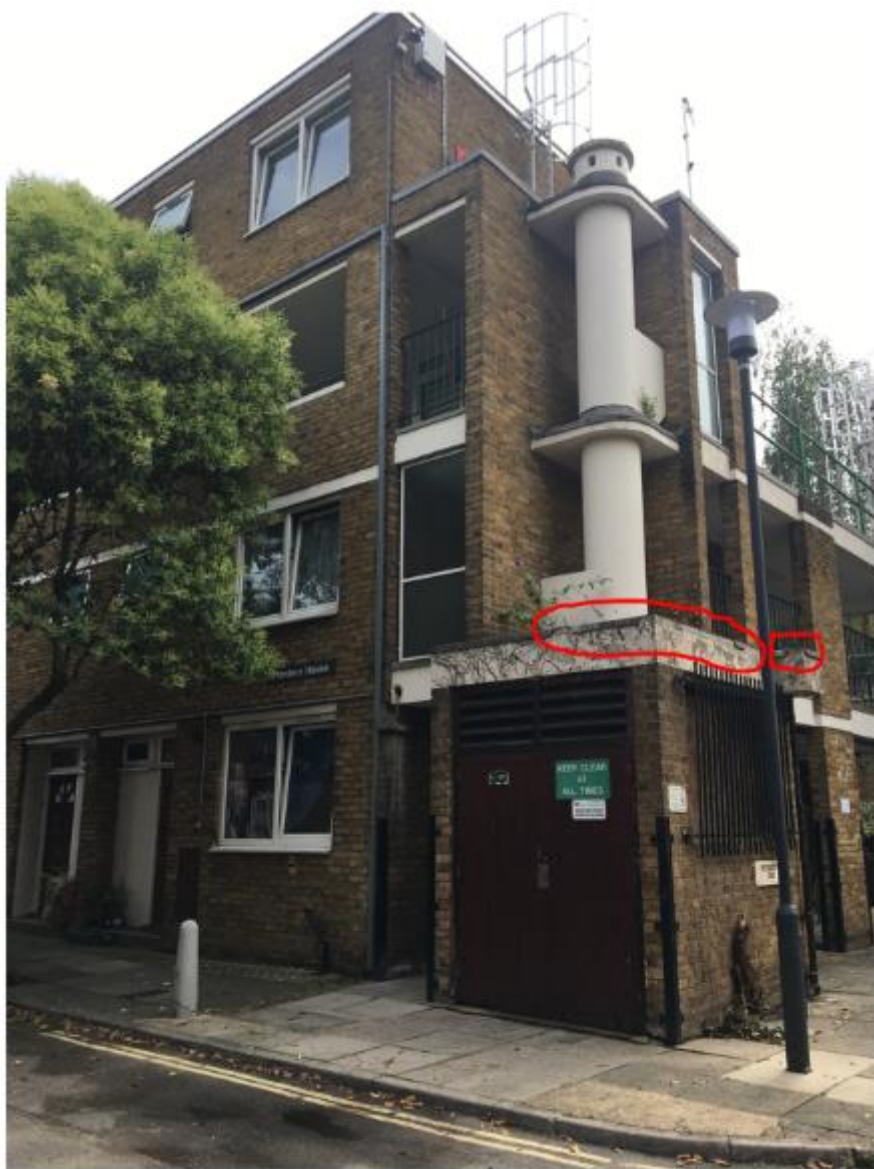
Photo 25. Showing open stairwell with bin store and chute. Note the failing mastic asphalt covering and self-seeded vegetation.

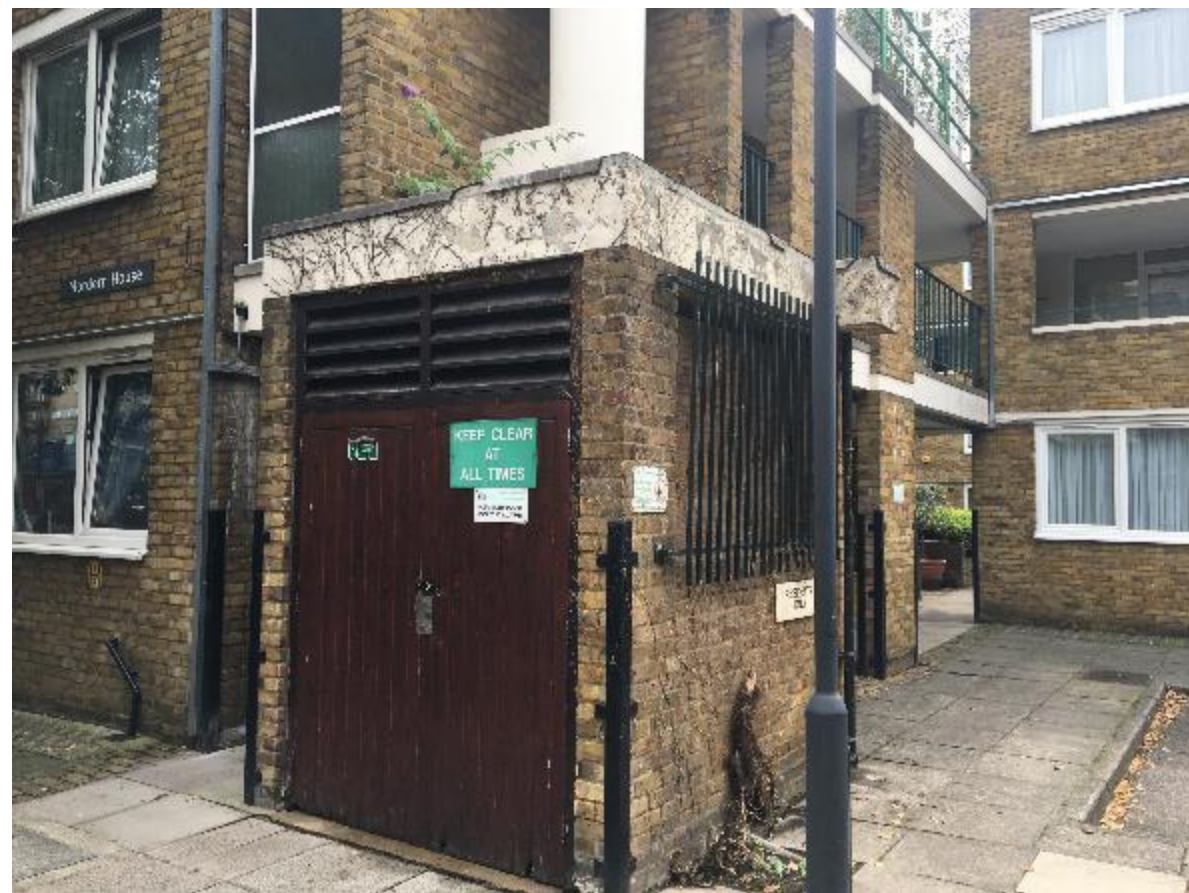
Photo 26. Close-up of bin store, doors of which in need of repair and redecoration.

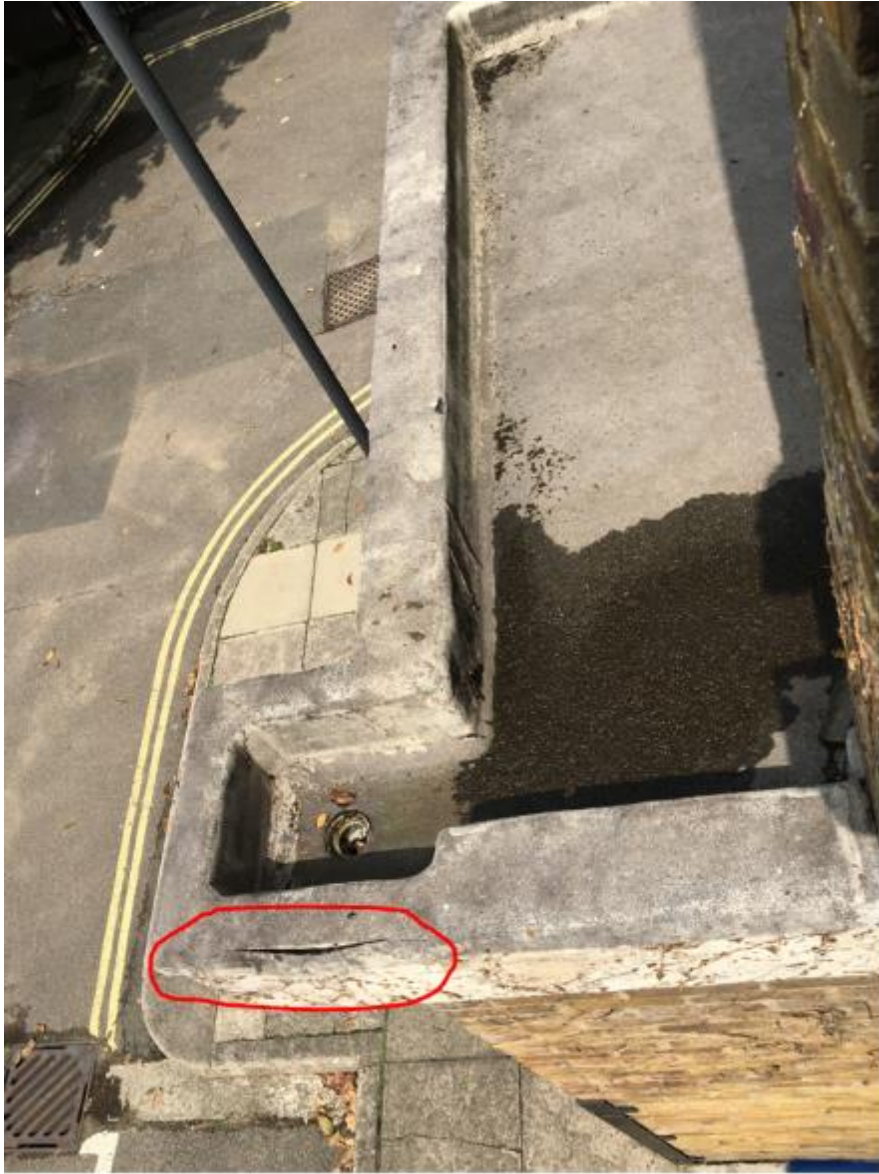
Photo 27. Defective mastic asphalt covering to bin store roof.

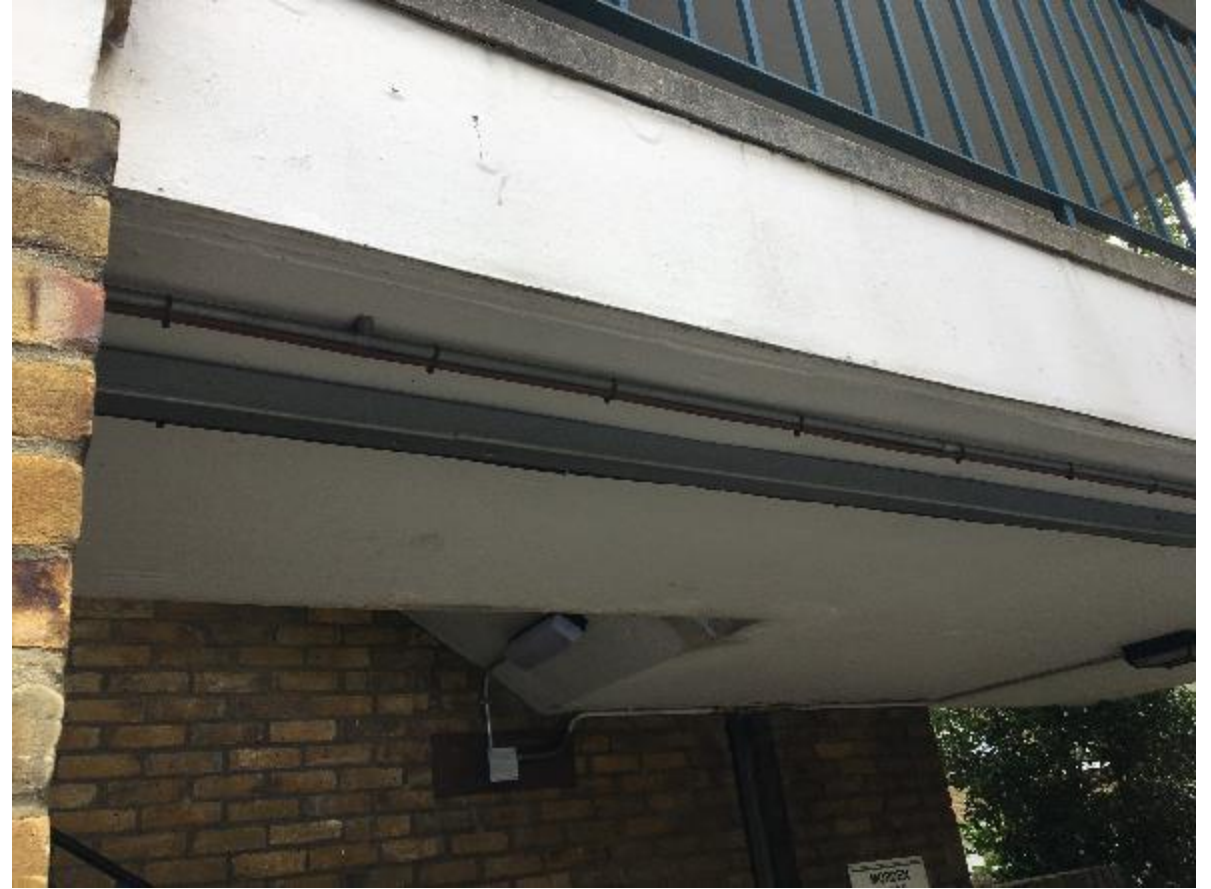
Photo 28. Stairwell soffit requiring redecoration.

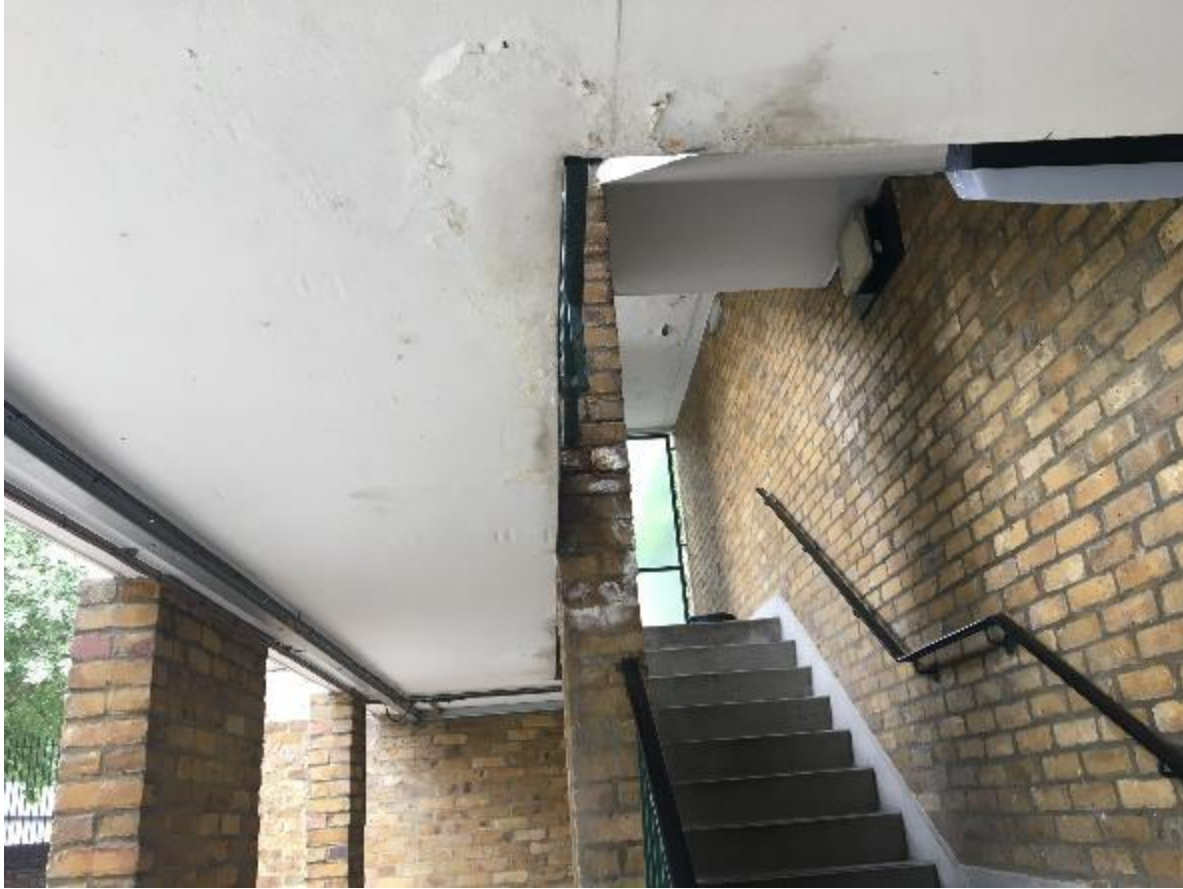
Photo 29. Evidence of water damage to decorations of soffit.

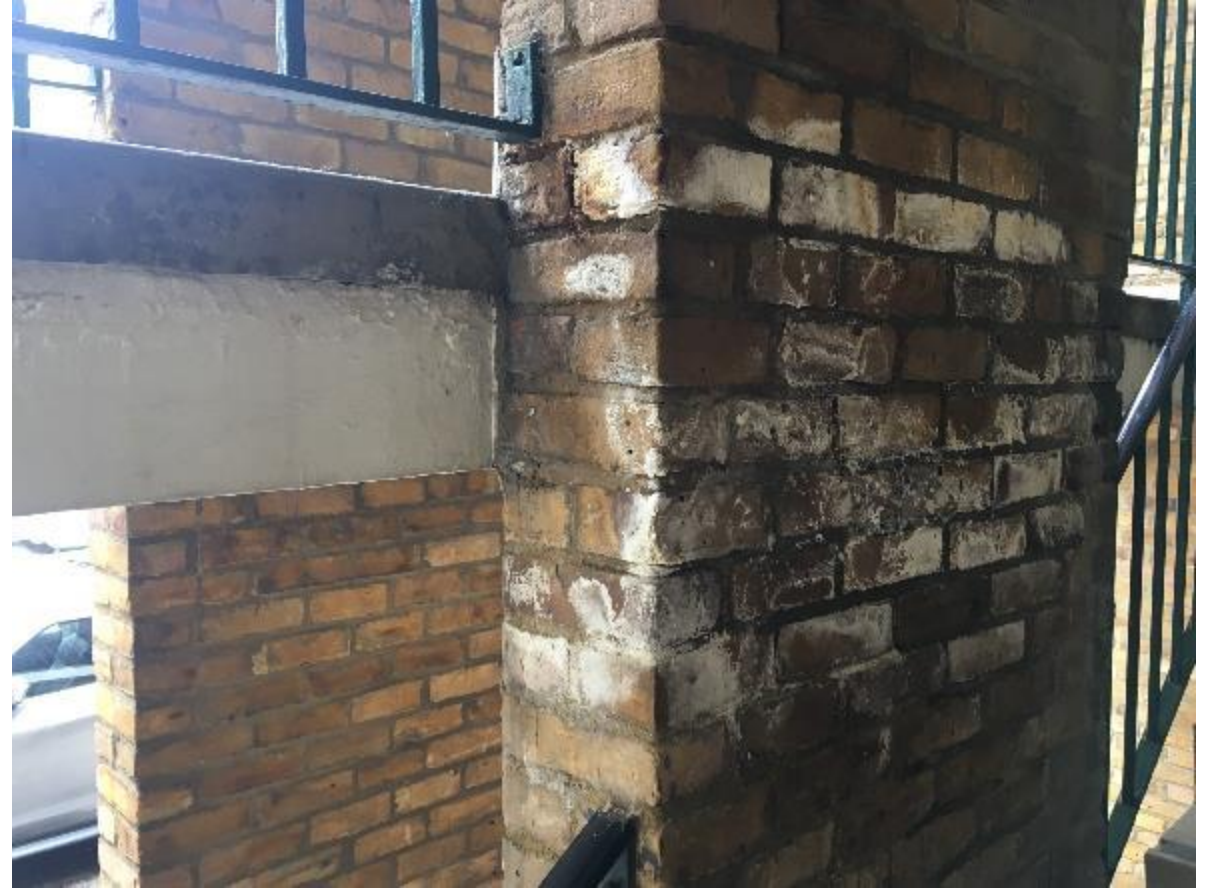
Photo 30. Evidence of damp in the form of hygroscopic salts on surface of stairwell pillar.

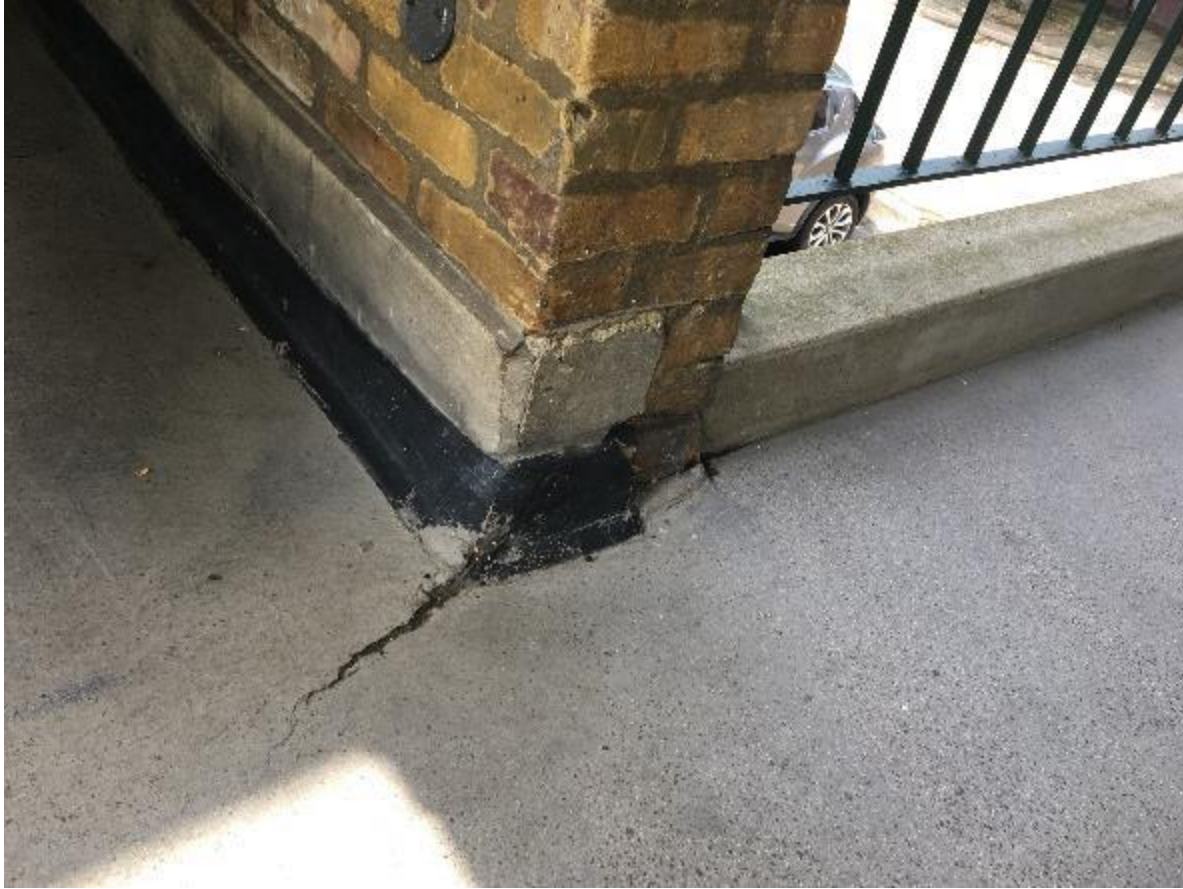
Photo 31. Showing splits to mastic asphalt covering of stairwell landing which could cause penetrating damp when area is washed down.

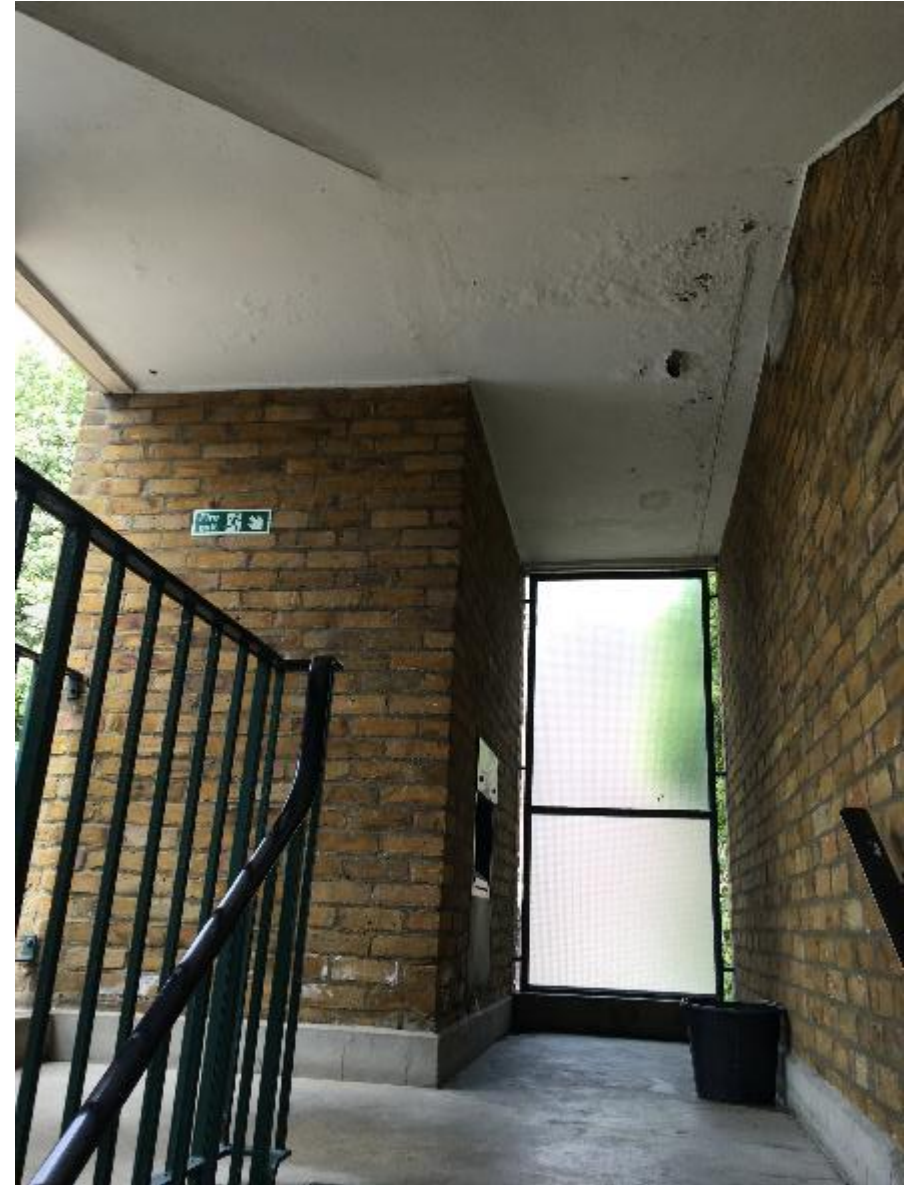
Photo 32. Evidence of penetrating damp to roof soffit of Mordern Hse stairwell. Note the bucket of water used to wash the floor or might be there to catch a roof leak.

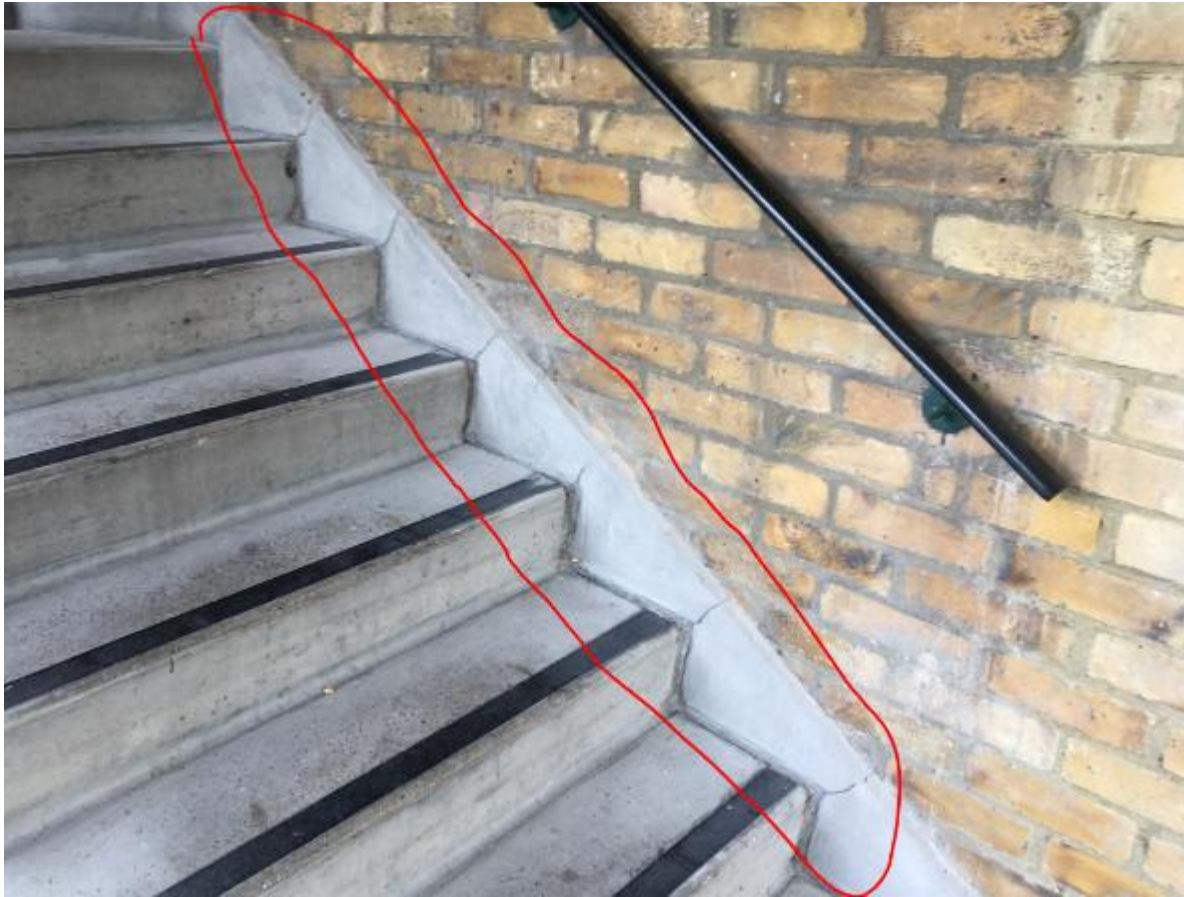
Photo 33. Showing cracking to wall stringer of stairs which may be the cause of moisture penetration below when treads are being washed down.

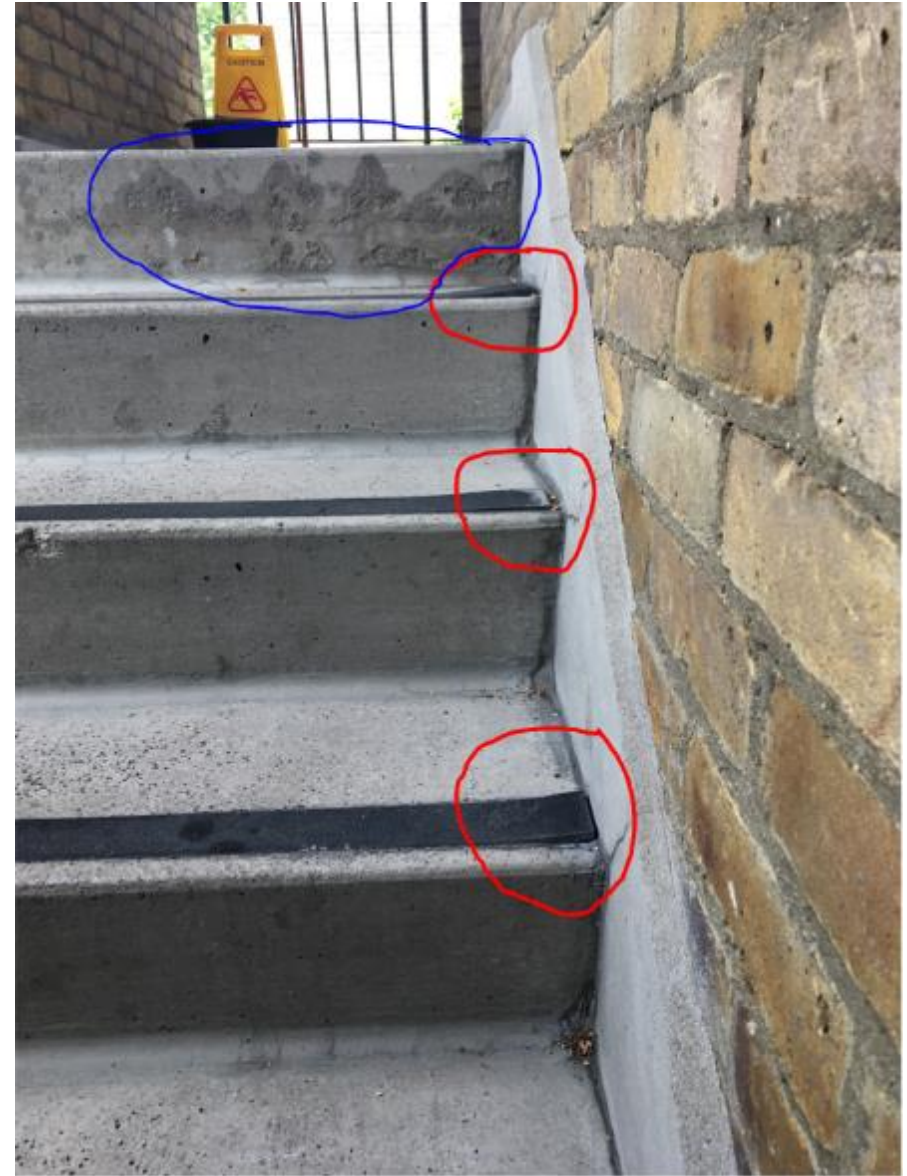
Photo 34. Rubberised strips lifting (red) also note the residual damp (blue) left after stairs have been washed down.

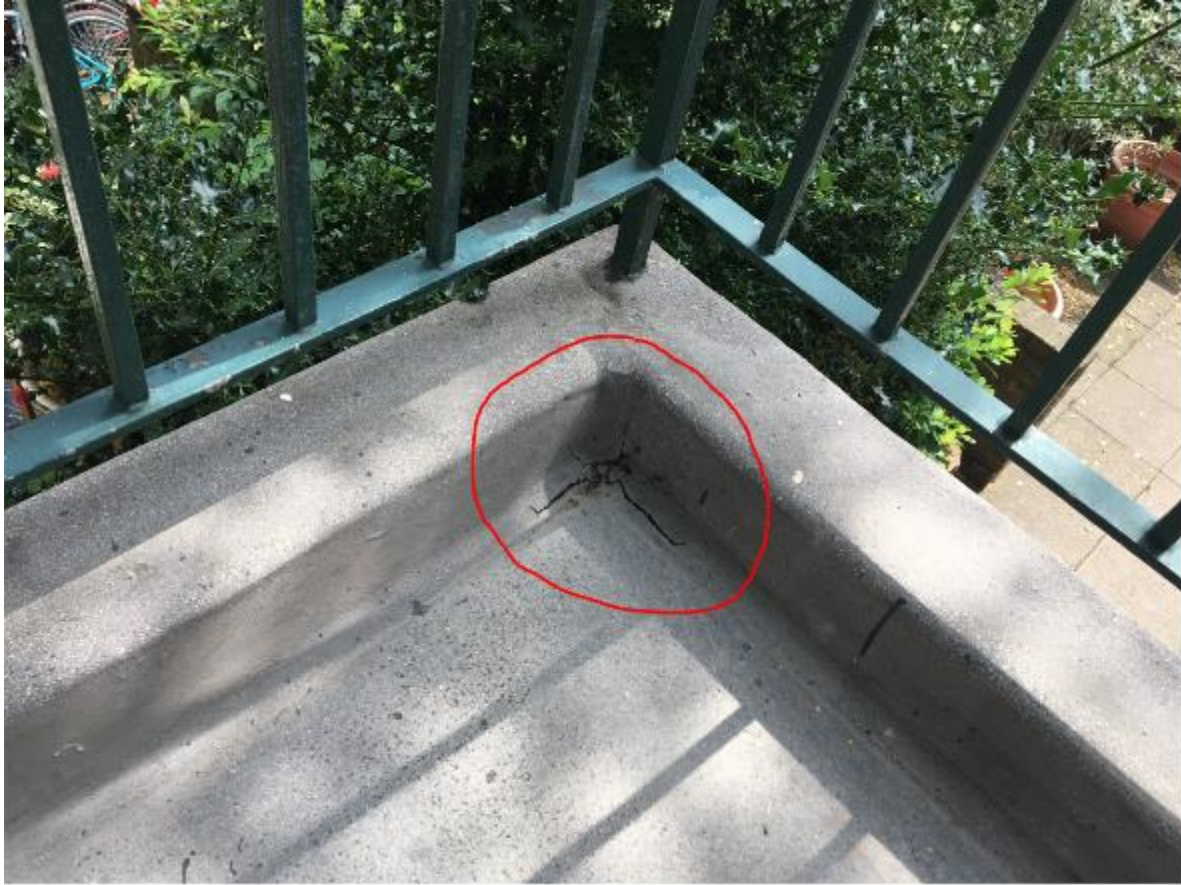
Photo 35. Mastic asphalt repair required to communal stairs landing, note failing paintwork to guarding.

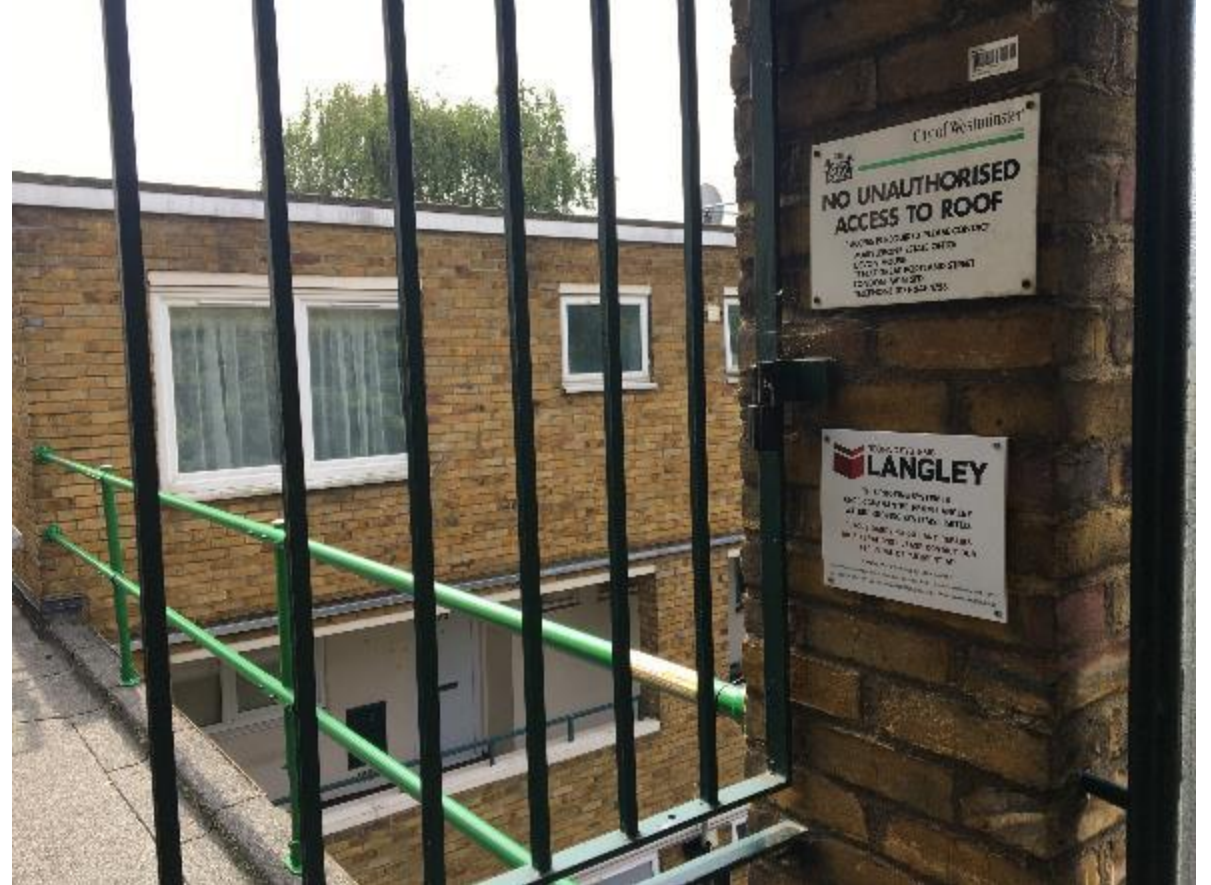
Photo 36. Evidence of roof covering replacement/overlay.

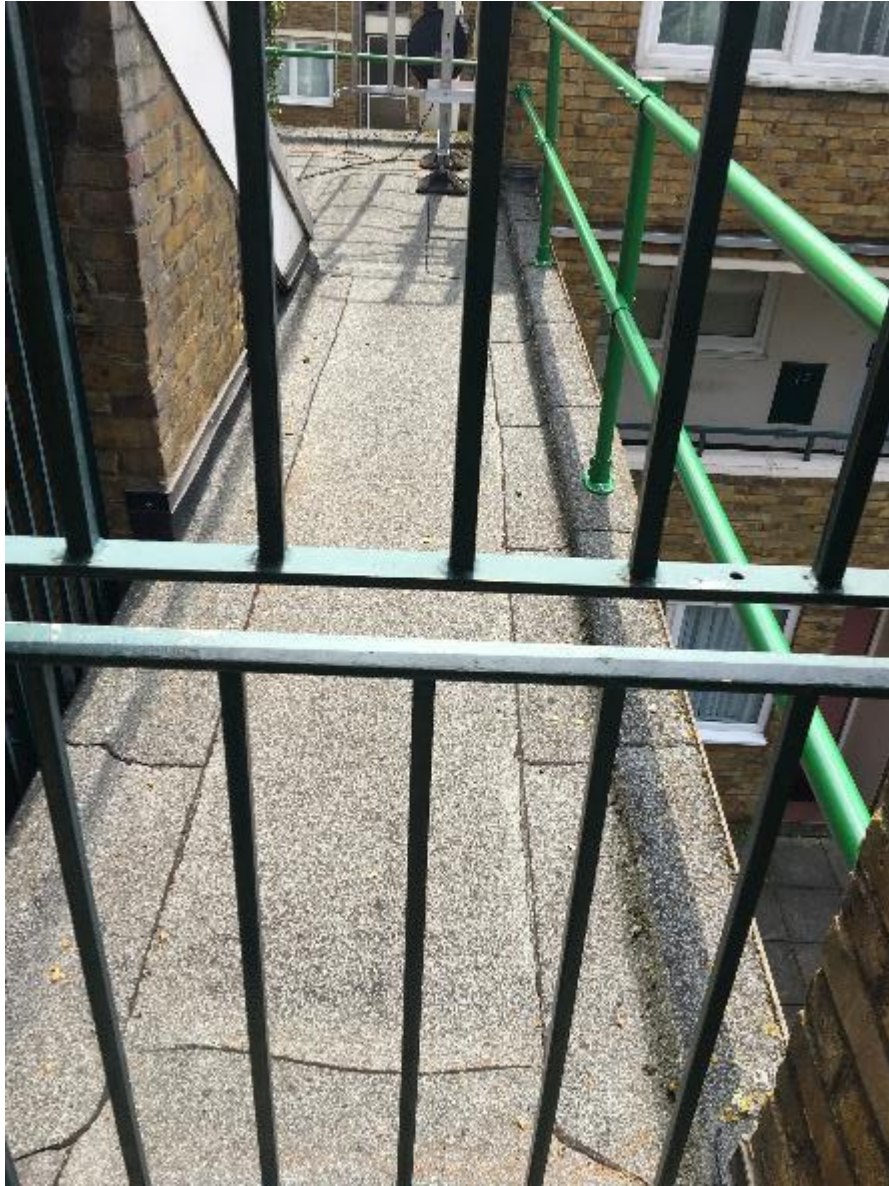
Photo 37. Showing replacement/overlayed felt system.

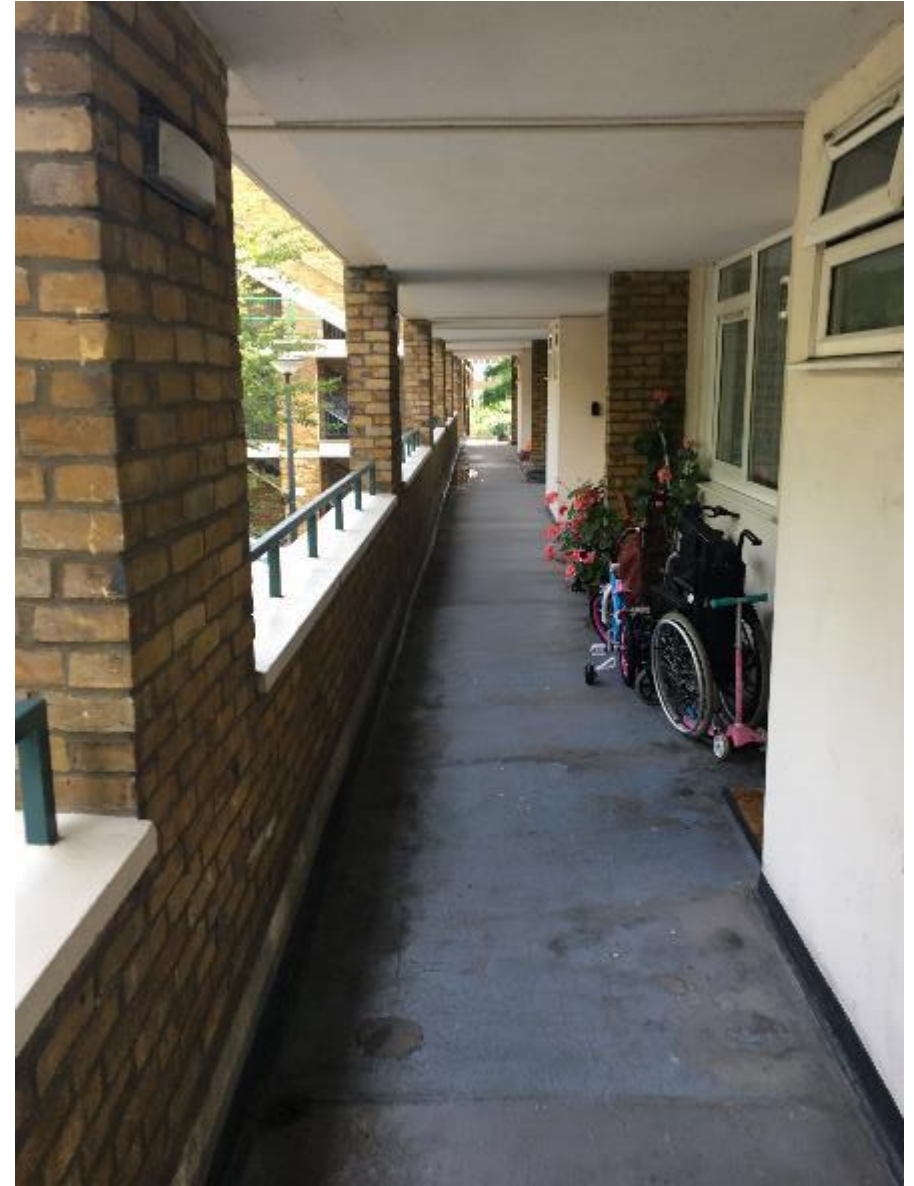
Photo 38. Example of a typical communal walkway where generically across all Blocks the decorated soffits and flat frontages are in fair condition exhibiting the usual signs of fair wear and tear. The mastic asphalt covering to the decks are in fair to good condition although surface coatings are worn.

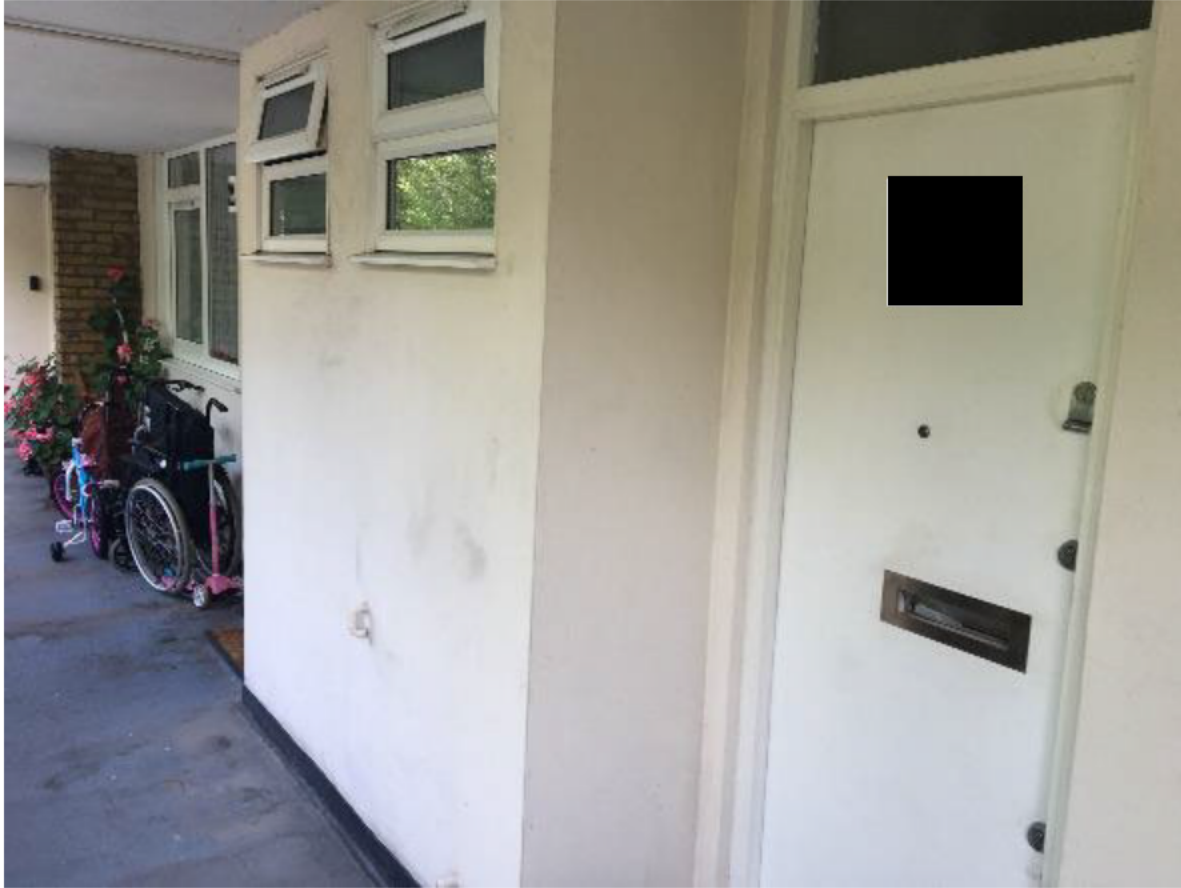
Photo 39. Close-up of decorations in fair condition exhibiting the usual signs of fair wear and tear. The windows and entrance doors are in fair condition, the PVCu components will need cleaning.

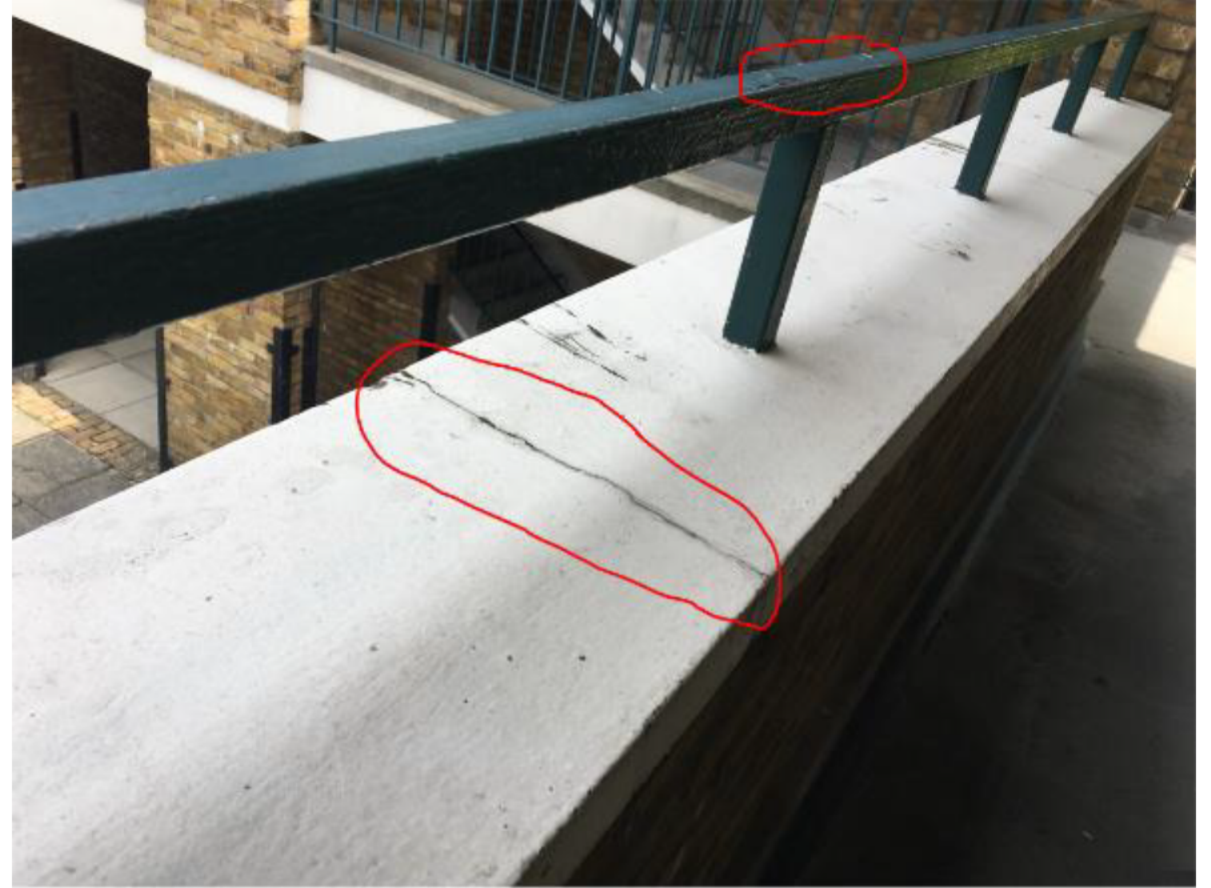
Photo 40. Generic to all Blocks is failing paintwork to wall mounted parapet guard rails as well as, paintwork to copings. The copings are once weathered, shedding rainwater onto the walkways plus, the joints are failing resulting in water ingress and subsequent concrete failure where drip grooves are sometimes choked with mortar exacerbating the defect.

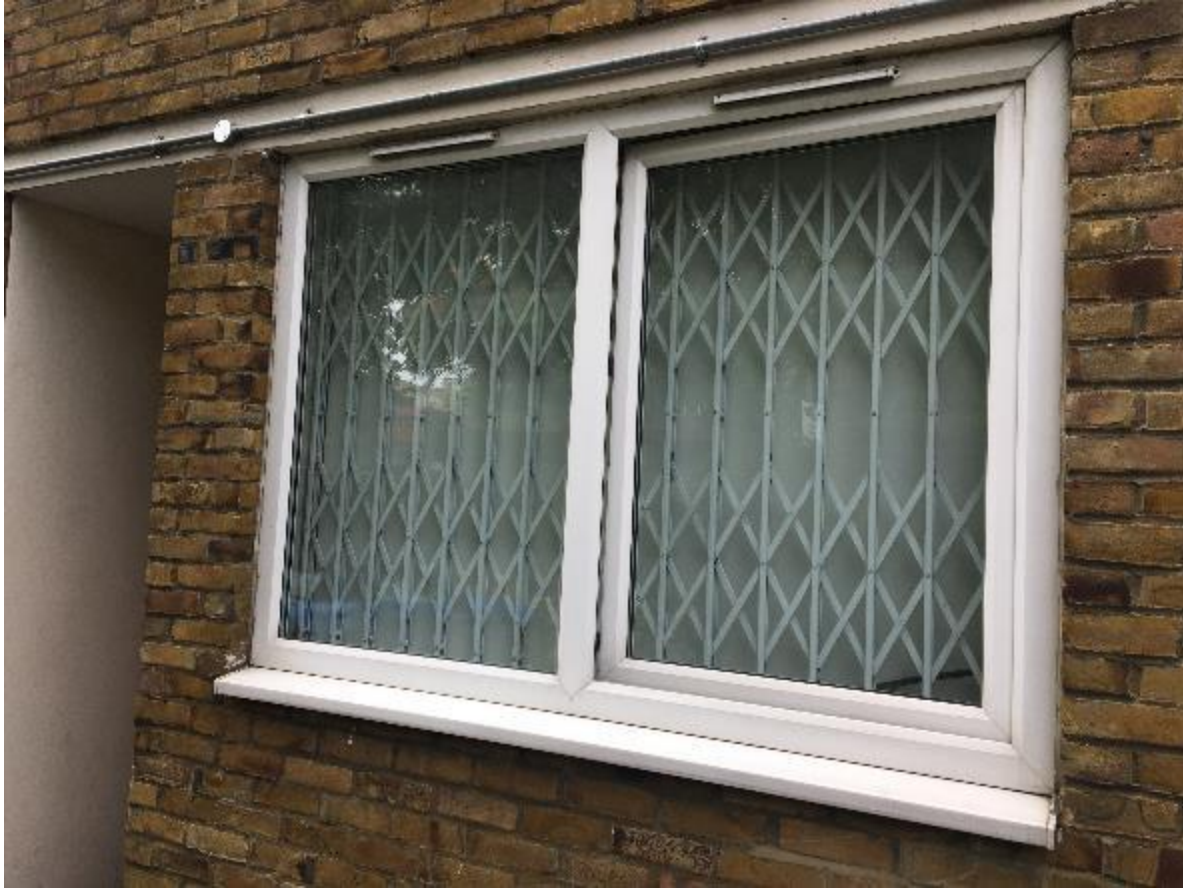
Photo 41. Back down at ground level, typical window in good condition and consideration should be given to cleaning the PVCu.

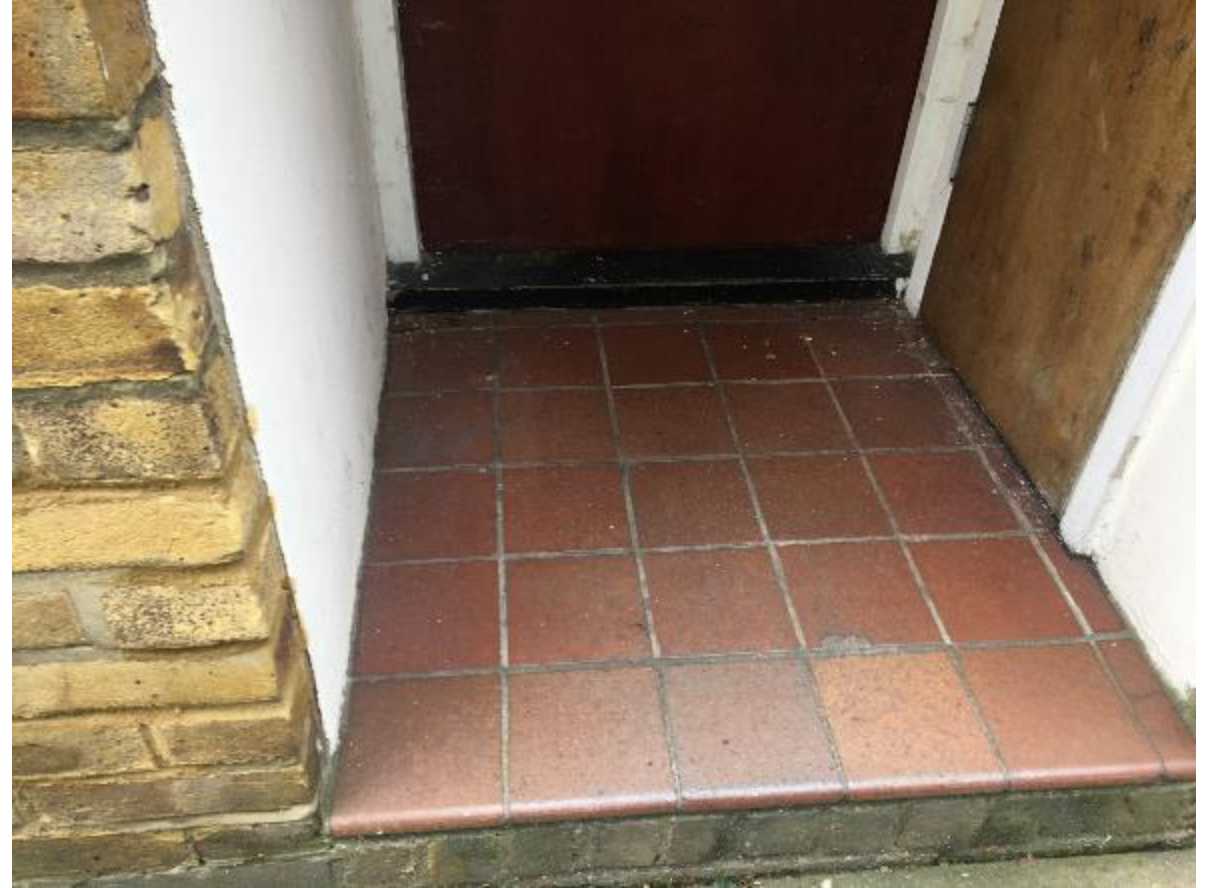
Photo 42. Ground floor front entrance steps to flats in good condition however despite being under cover, the decorations to entrance and store doors are tired.

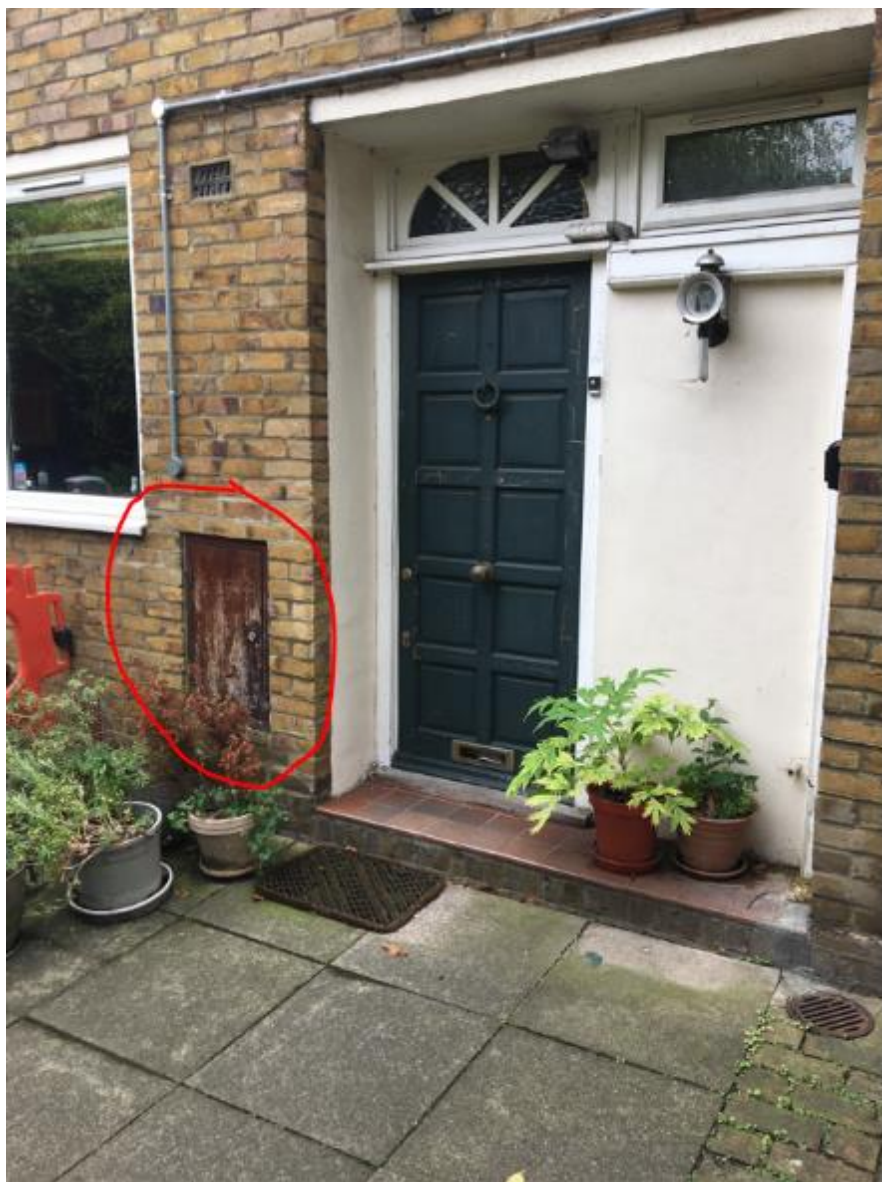
Photo 43. Generally, decorations to ground floor entrances looking tired particularly meter cupboard doors.

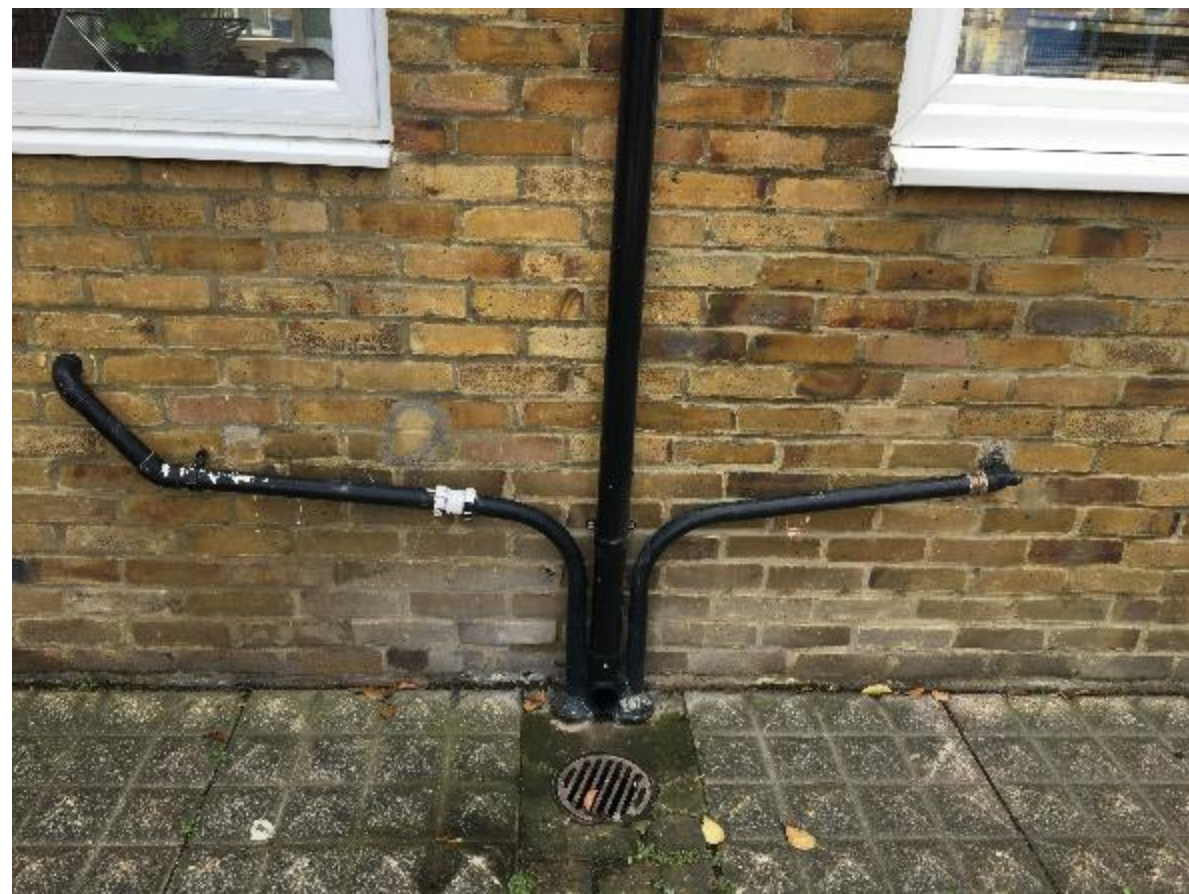
Photo 44. Generally, the paintwork to waste water pipes is failing.
