**Blandford Estate
Harewood Avenue
London
NW1**

Client Ref: Y100 – Blandford Estate

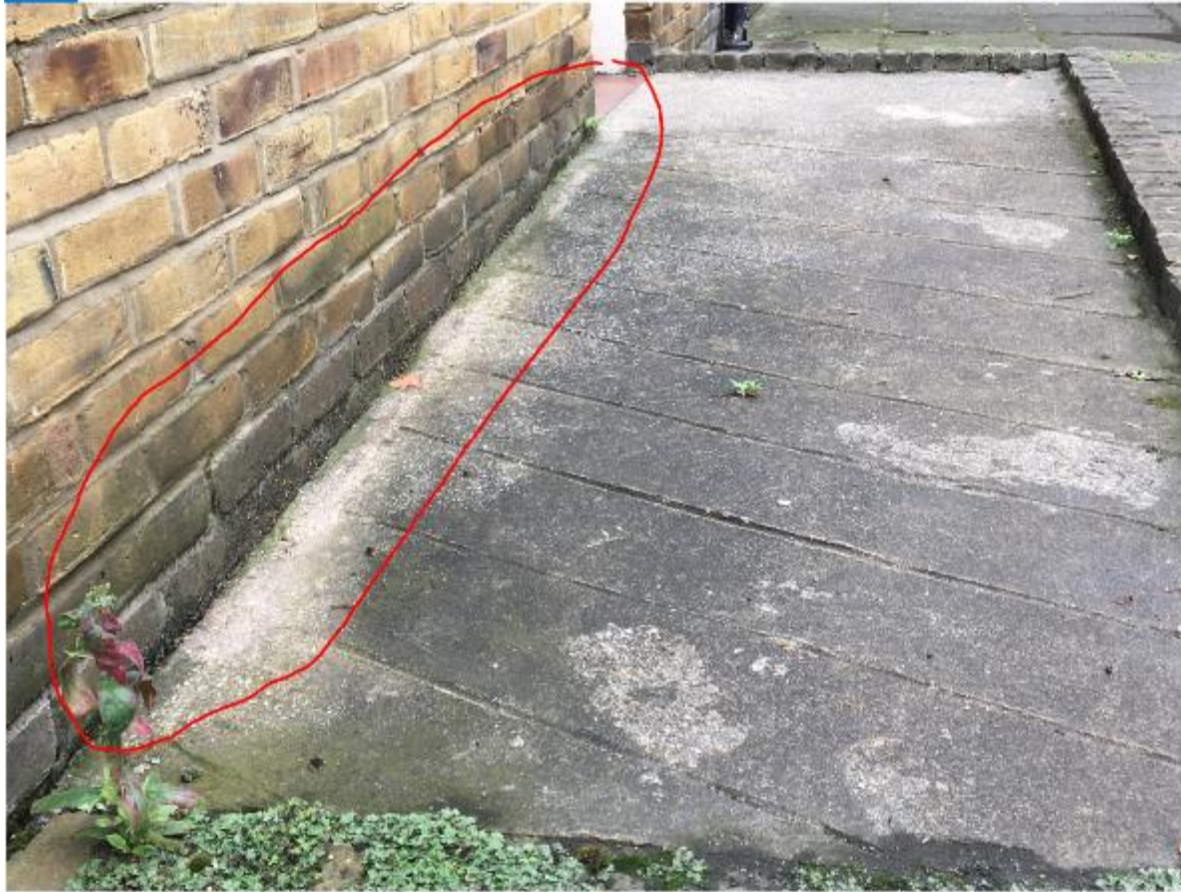
Photo 45. Ramp against wall is bridging the DPC however, it is a cavity wall and unless the cavity is breached by builder's debris or mortar snots, it is not a problem with regard to penetrating damp.

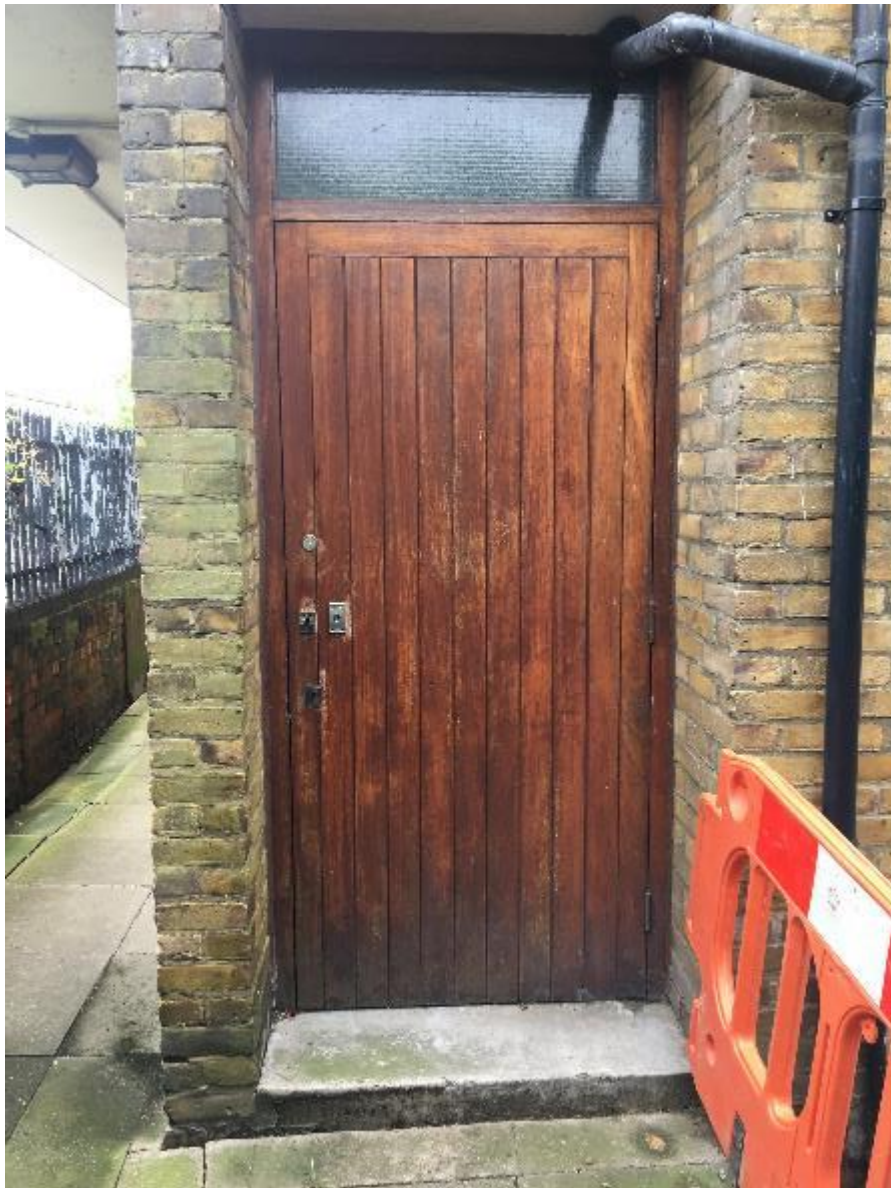
Photo 47. Generically across all four Blocks, decorations to store doors are in poor condition.

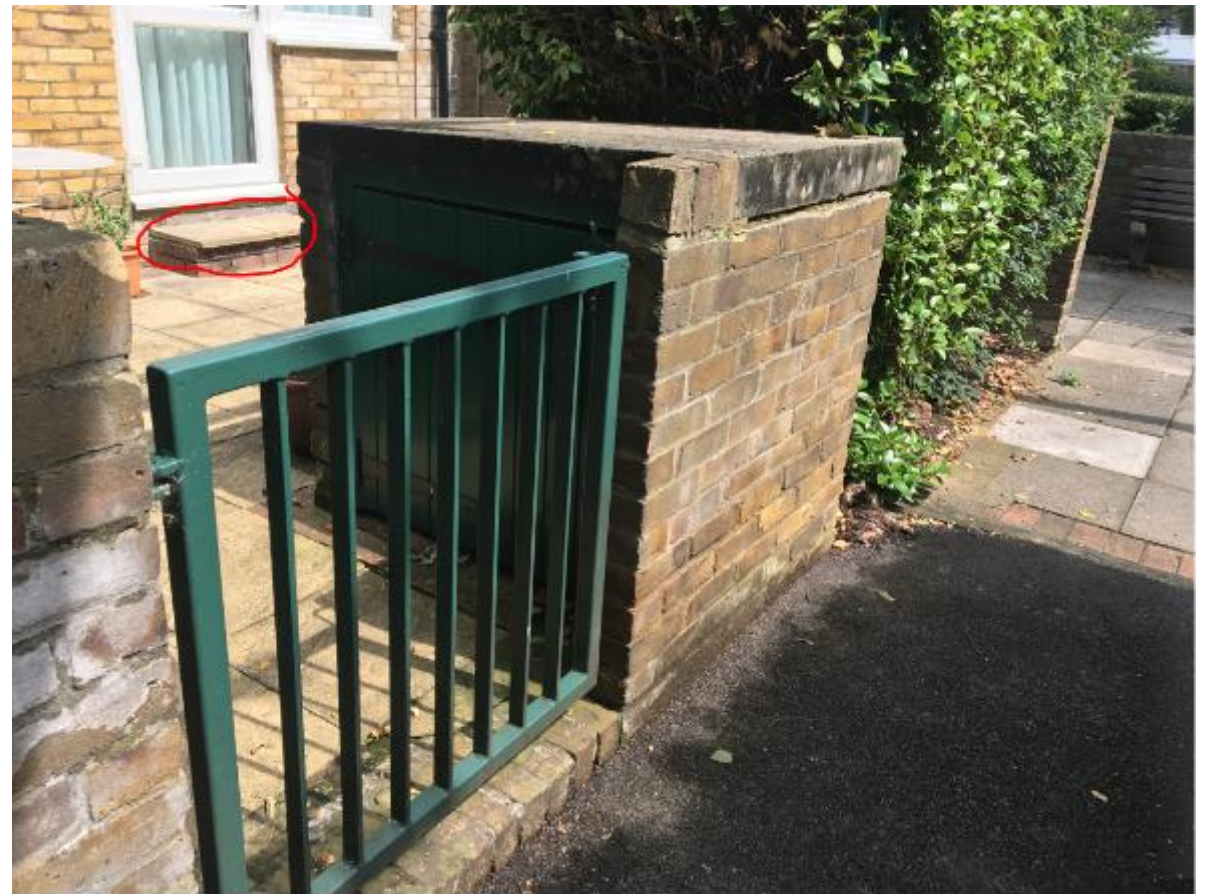
Photo 48. Generally across all four Blocks the decorations to private bin stores and gates is in fair to poor condition. However, the rear entrance door paving slab steps appear unstable.

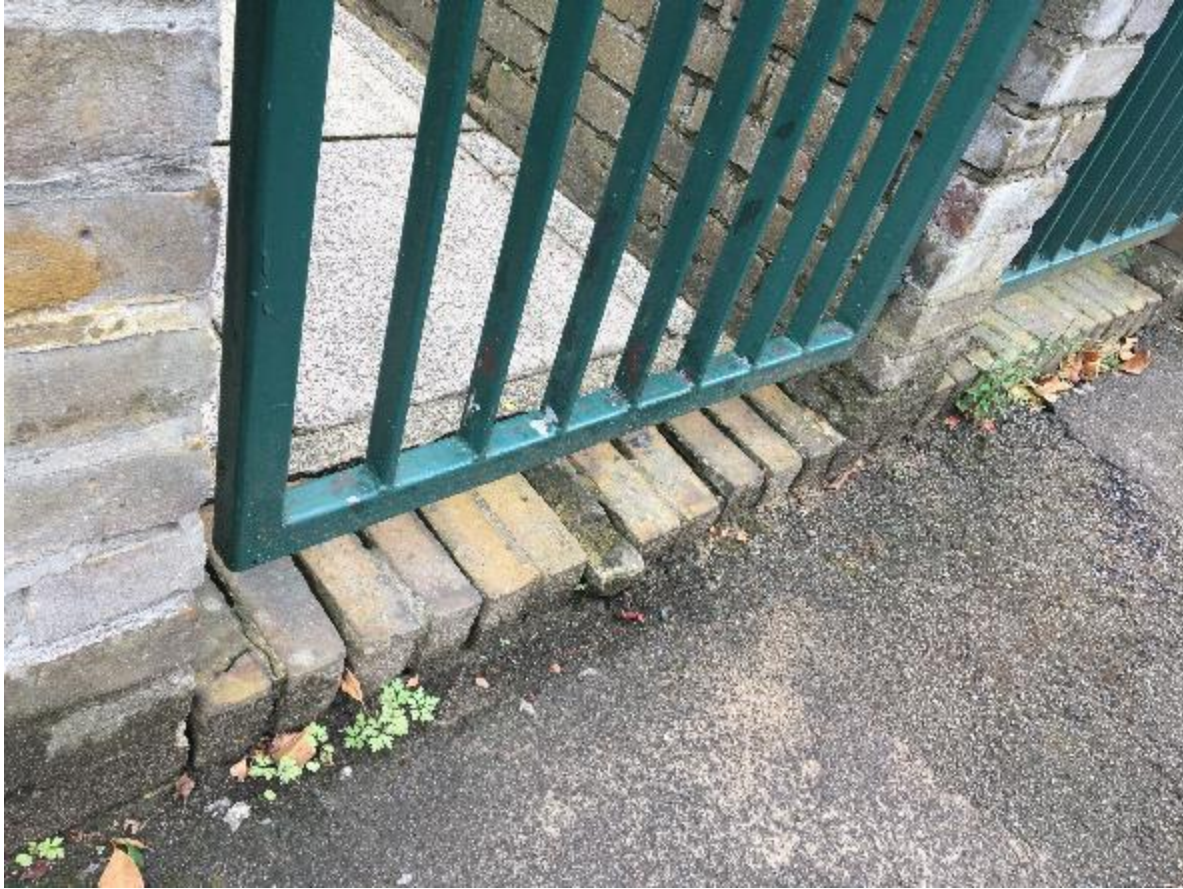
Photo 49. In some cases, the brick steps to rear garden gates are defective.

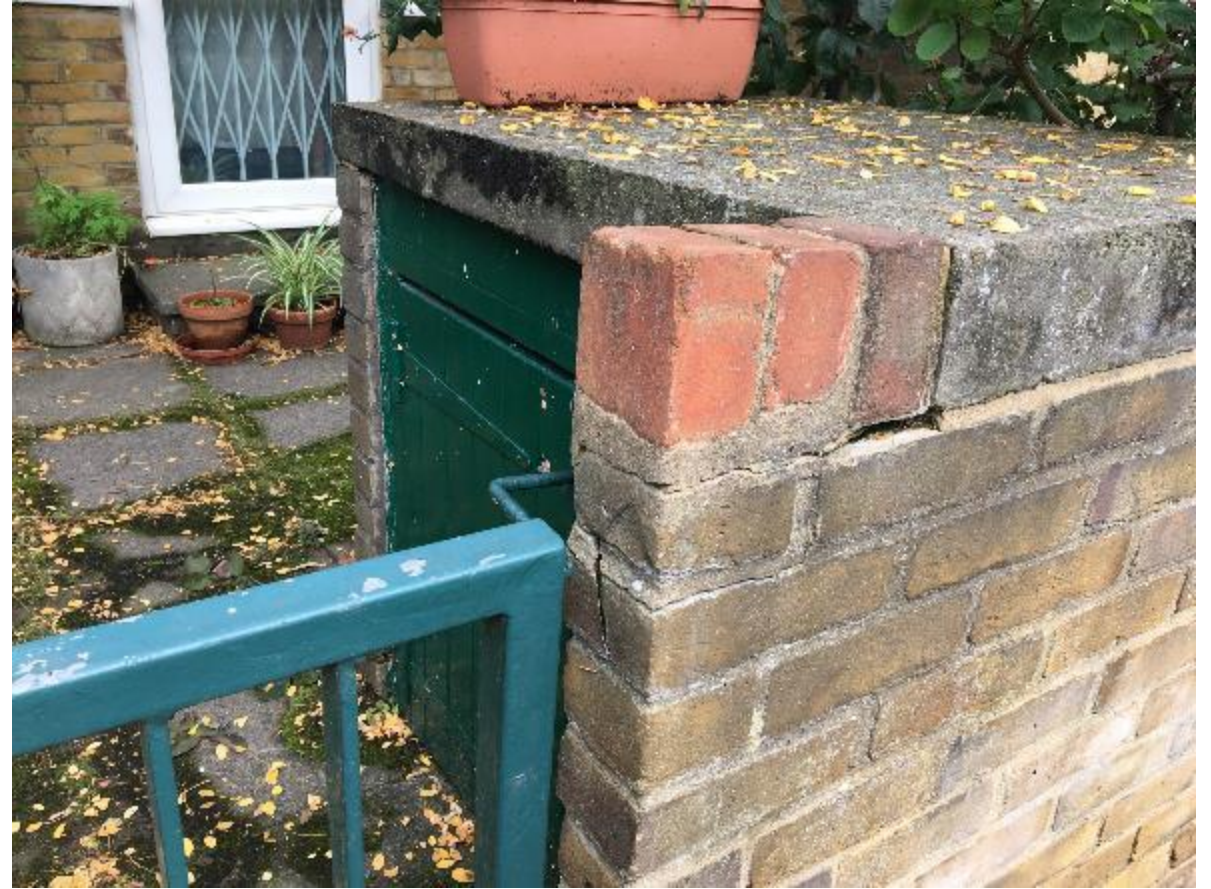
Photo 50. In many cases the rear garden boundary wall brickwork is suffering from impact damage.

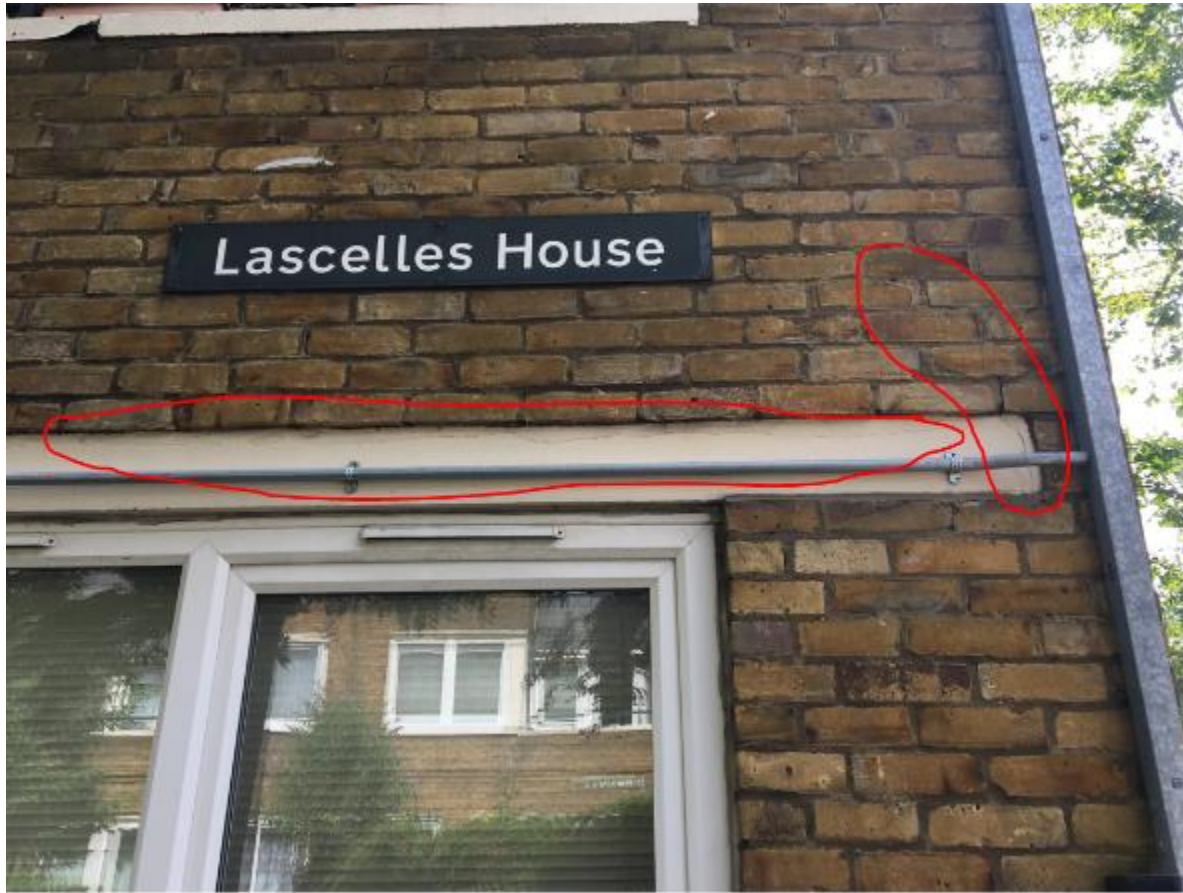
Photo 51. Lascelles House, where as at Mordern Hse, the cracking to the front elevation corner adjacent Harewood Avenue is considered to be of minor significance.

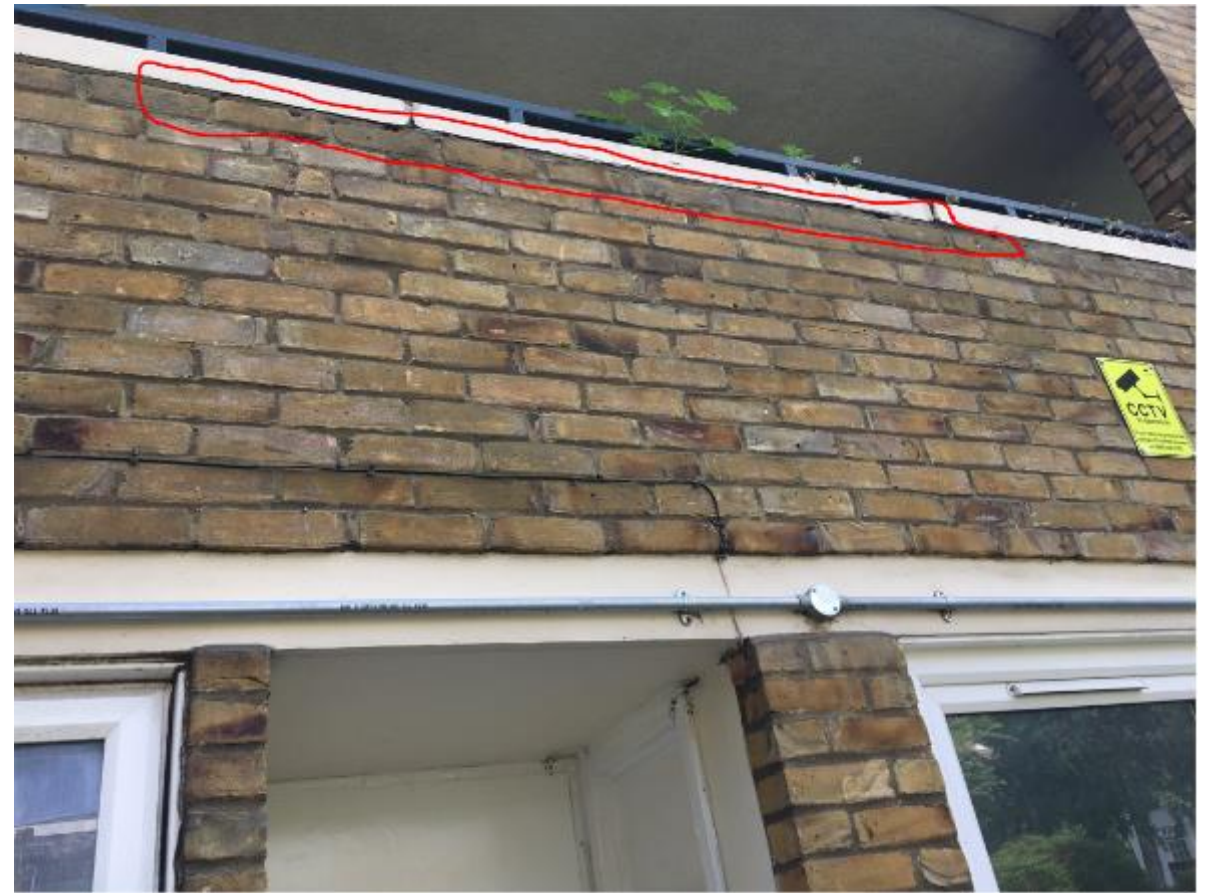
Photo 52. Here, as is generally the case across the Blocks, the communal walkway parapet copings are failing due to moisture penetration and freeze thaw action.

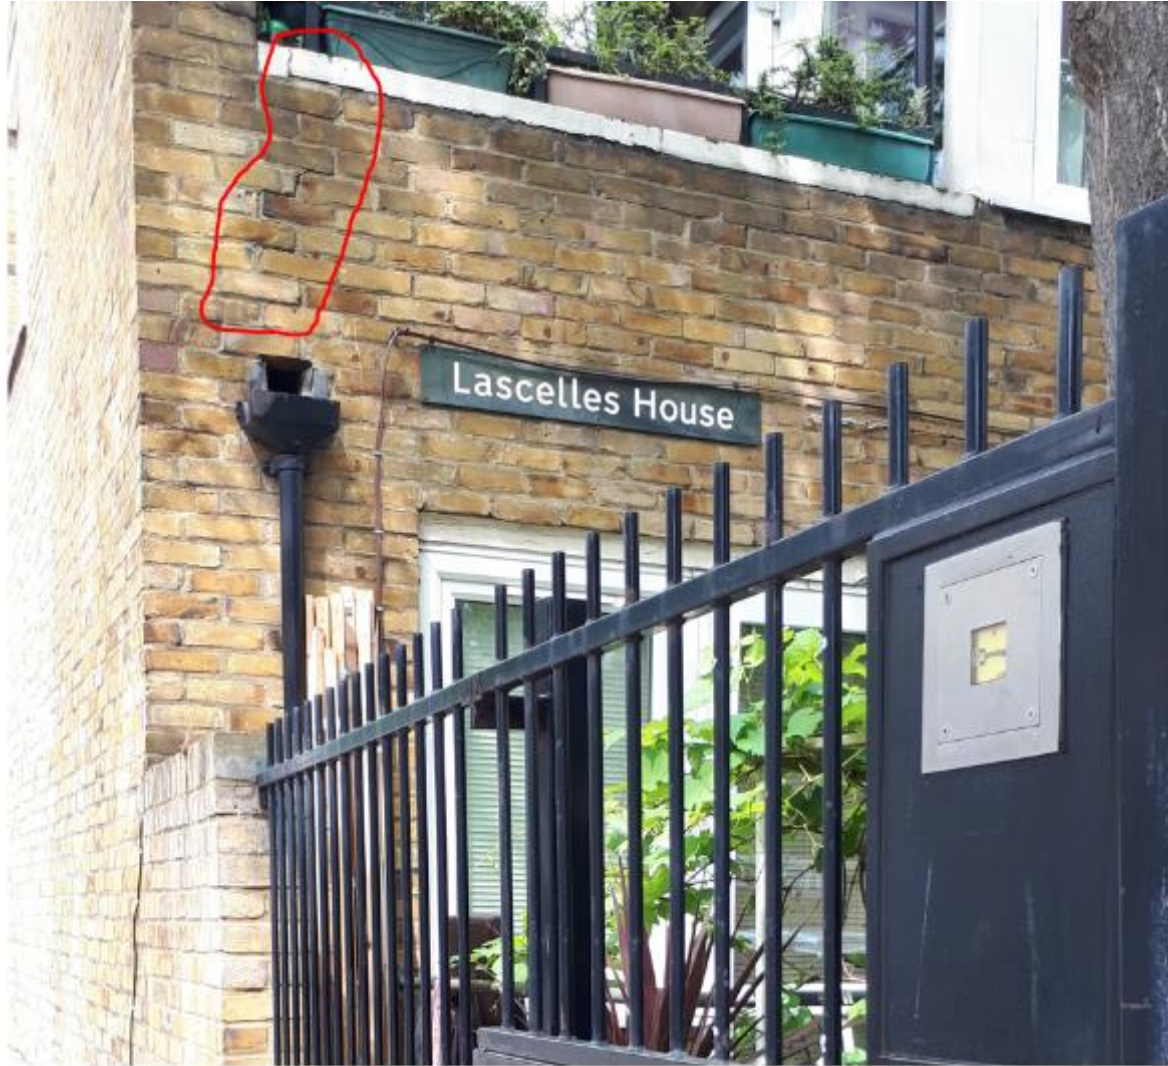
Photo 53. Similar cracking as found to the rear of Mordern Hse here, one could simply repoint the brickwork.

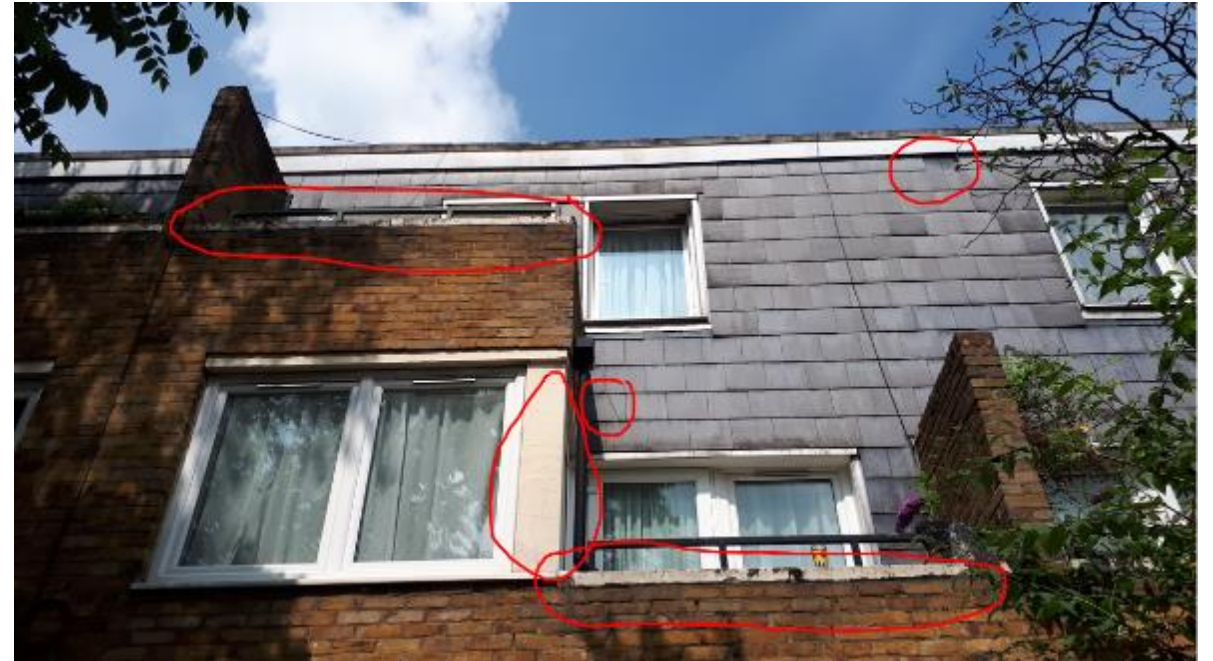
Photo 54. As on the rear elevations of other Blocks there is defective pointing, failing paintwork and the odd missing or broken vertical tile.

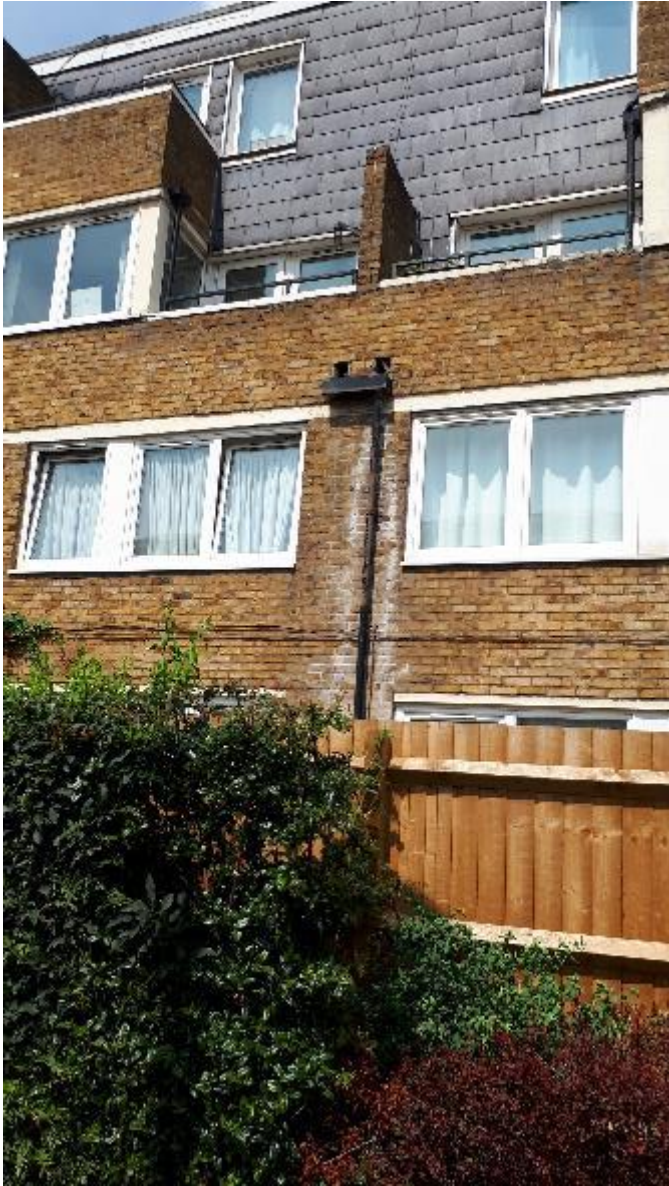
Photo 55. As on other Blocks, there is failing paintwork to rear elevation RWGs and subsequent corrosion of hoppers.

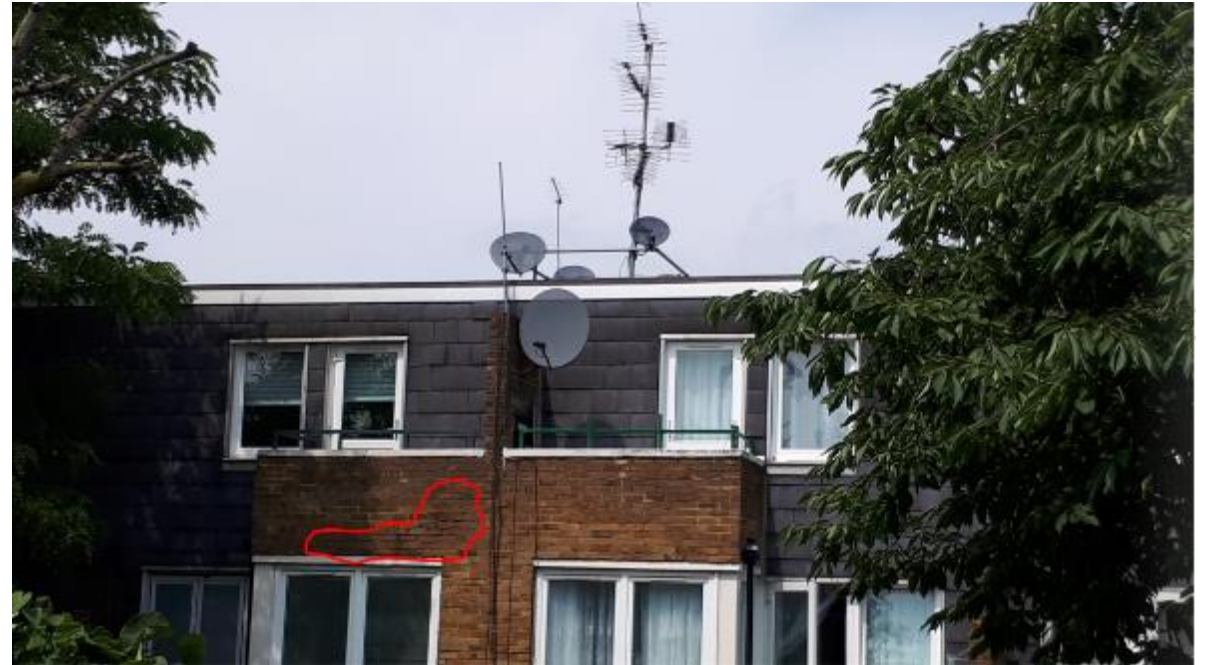
Photo 56. Again as on other Blocks, there is defective brickwork pointing at height.

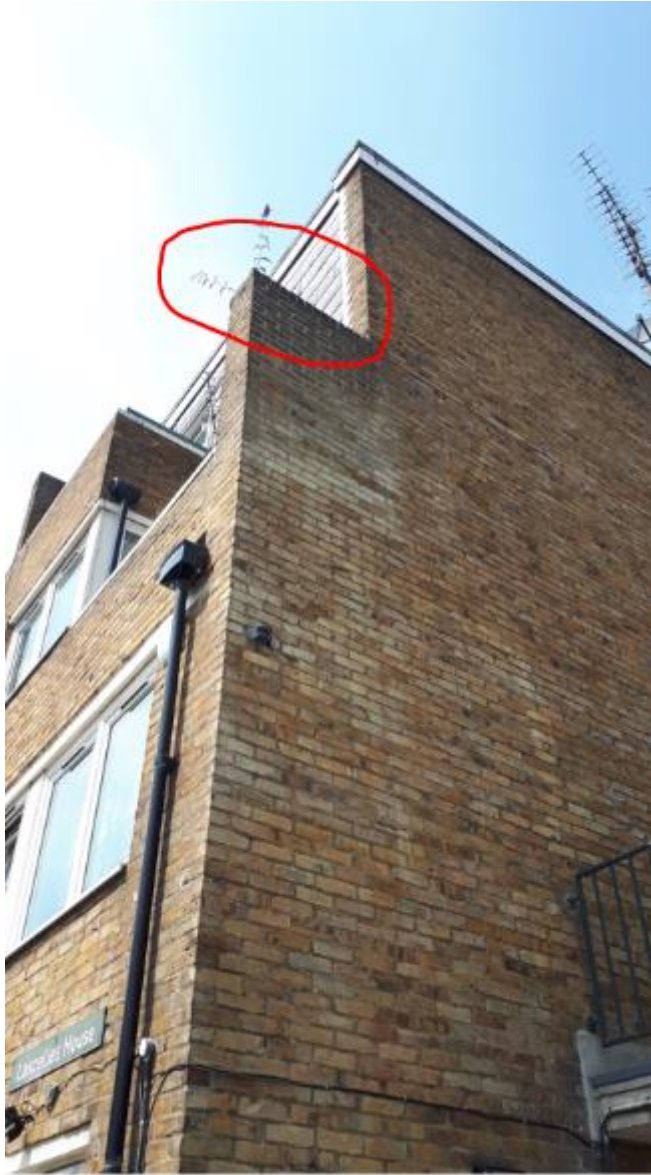
Photo 57. Showing self-seeded buddleia growing out of brickwork.

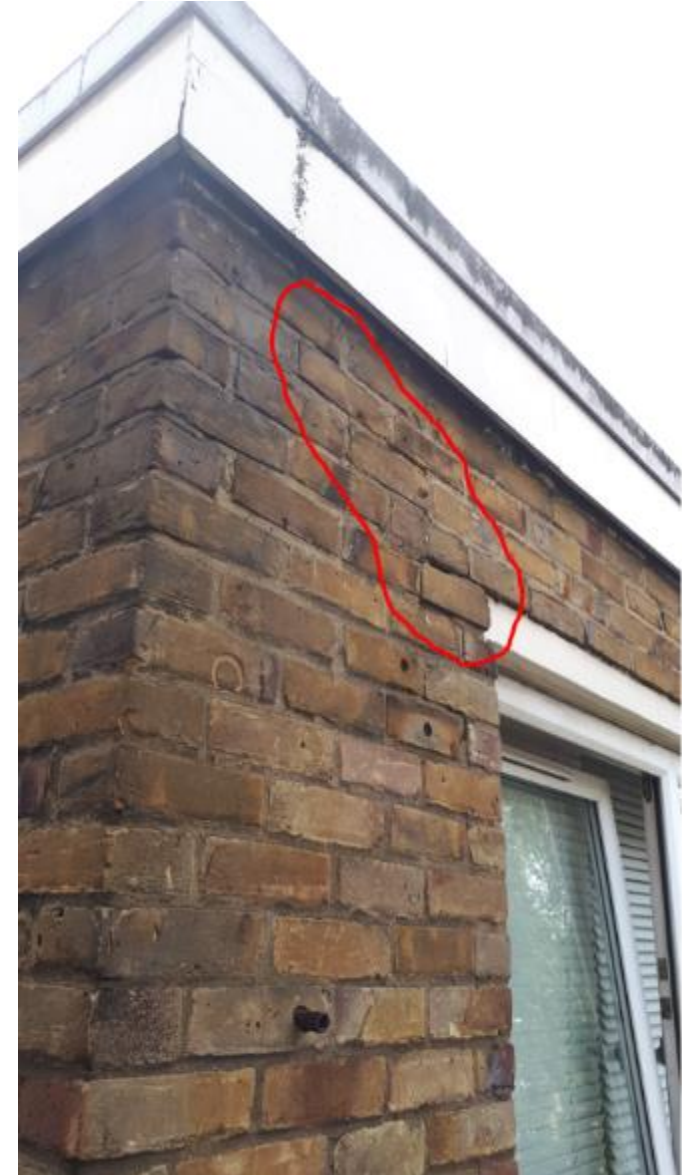
Photo 58. Front elevation as seen from communal stairwell landing showing defective pointing as well as failing paintwork to timber fascia.

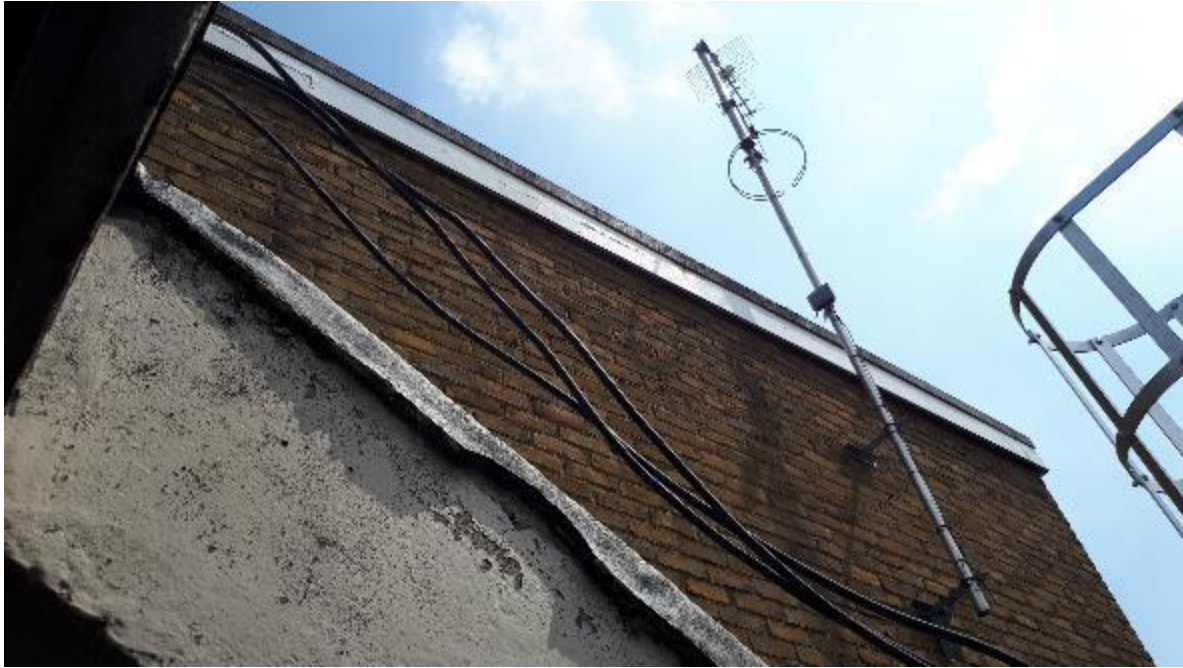
Photo 59. Again showing failed paintwork at height.

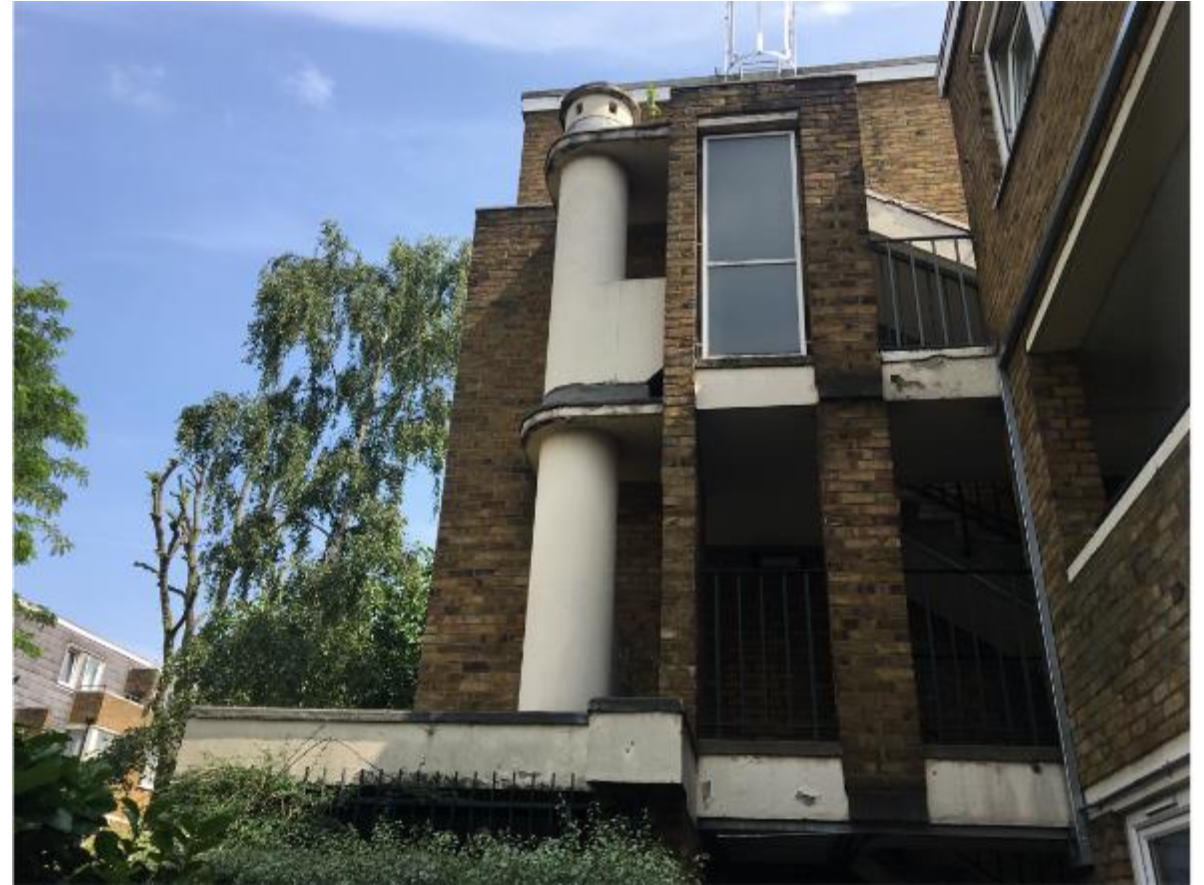
Photo 60. Again, failing decorations and self-seeded vegetation which if not removed will disturb brickwork.

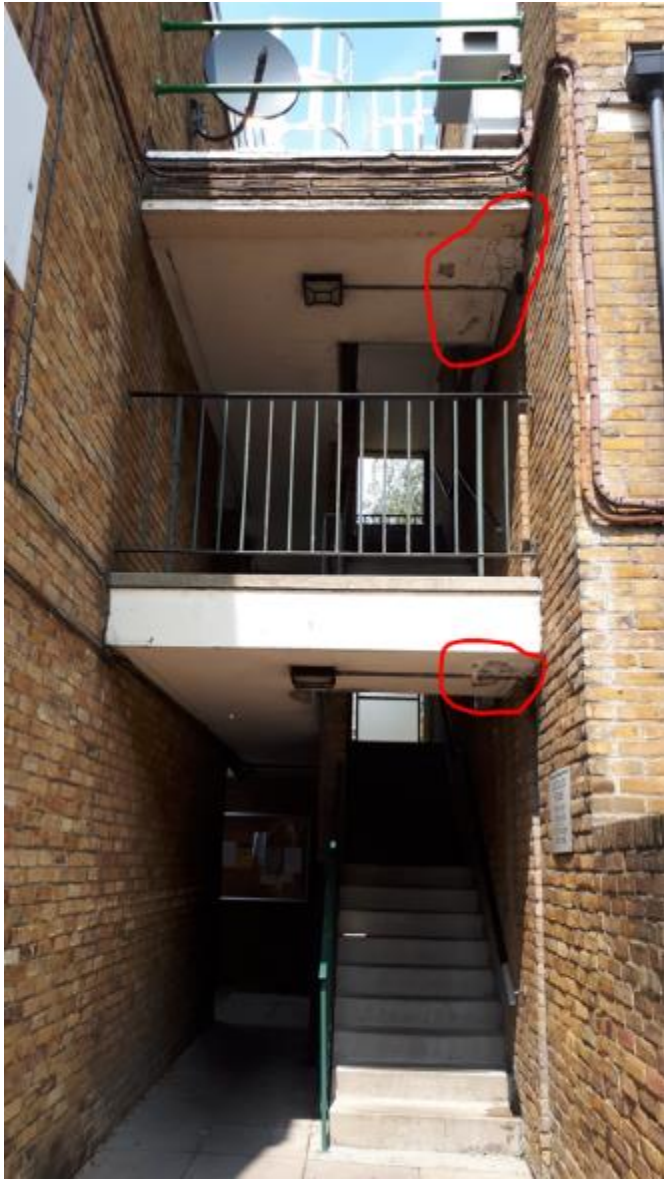
Photo 61. Roof leak to Lascelles' stairwell, downpipe also probably defective as such, leak manifesting below landing.

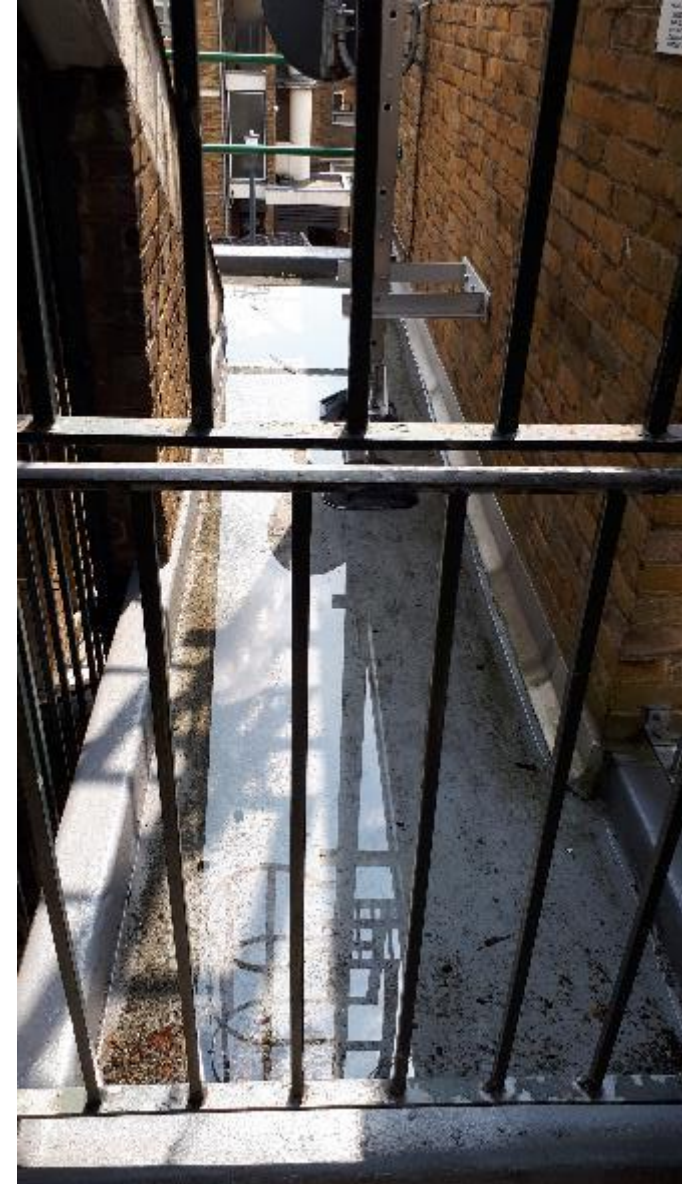
Photo 62. Flat section of stairwell roof.

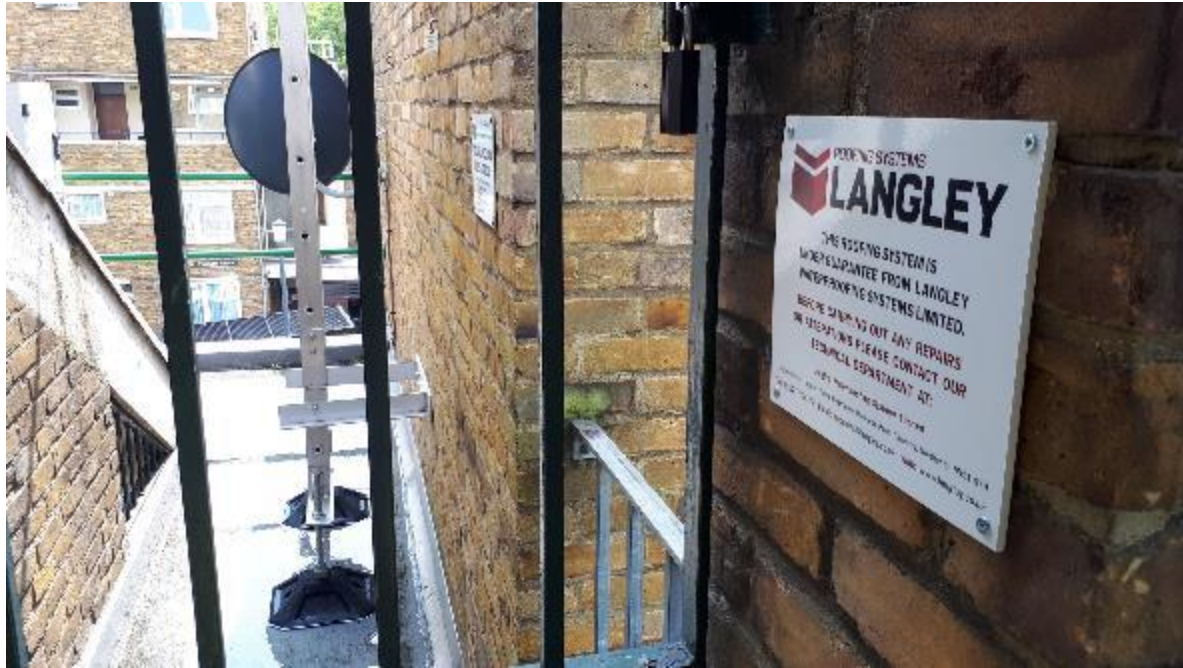
Photo 63. Same roof section and evidence of replacement/overlay covering.

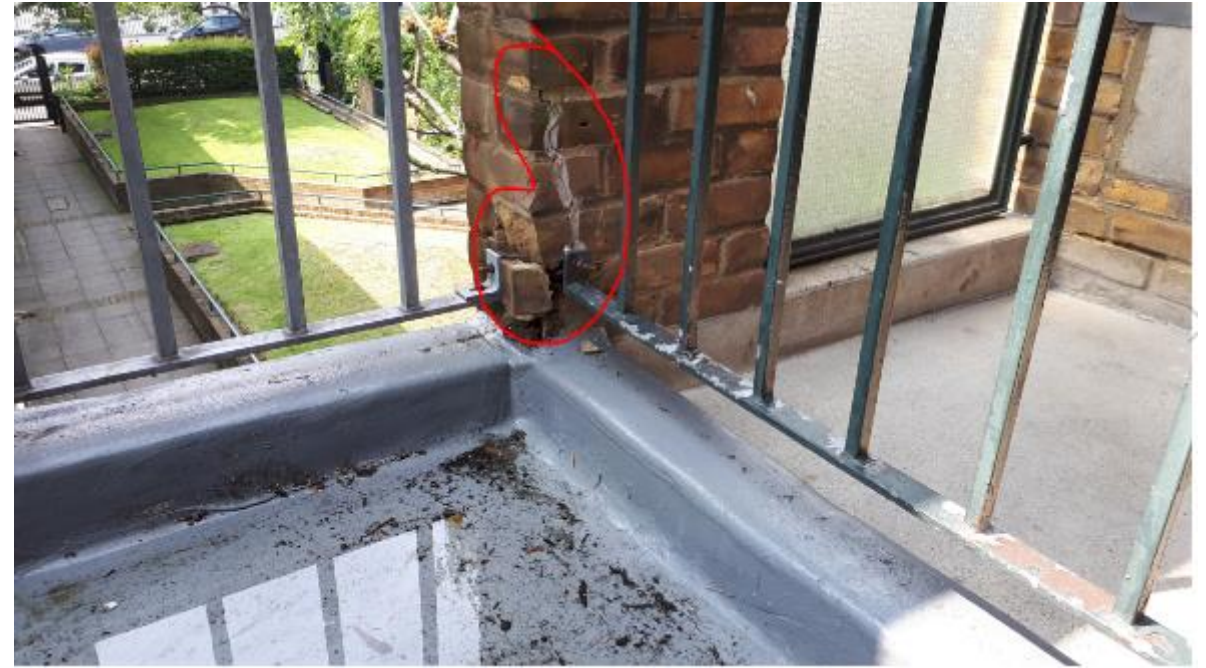
Photo 64. Same roof section, note impact damage to brickwork and evidence of historic repair.

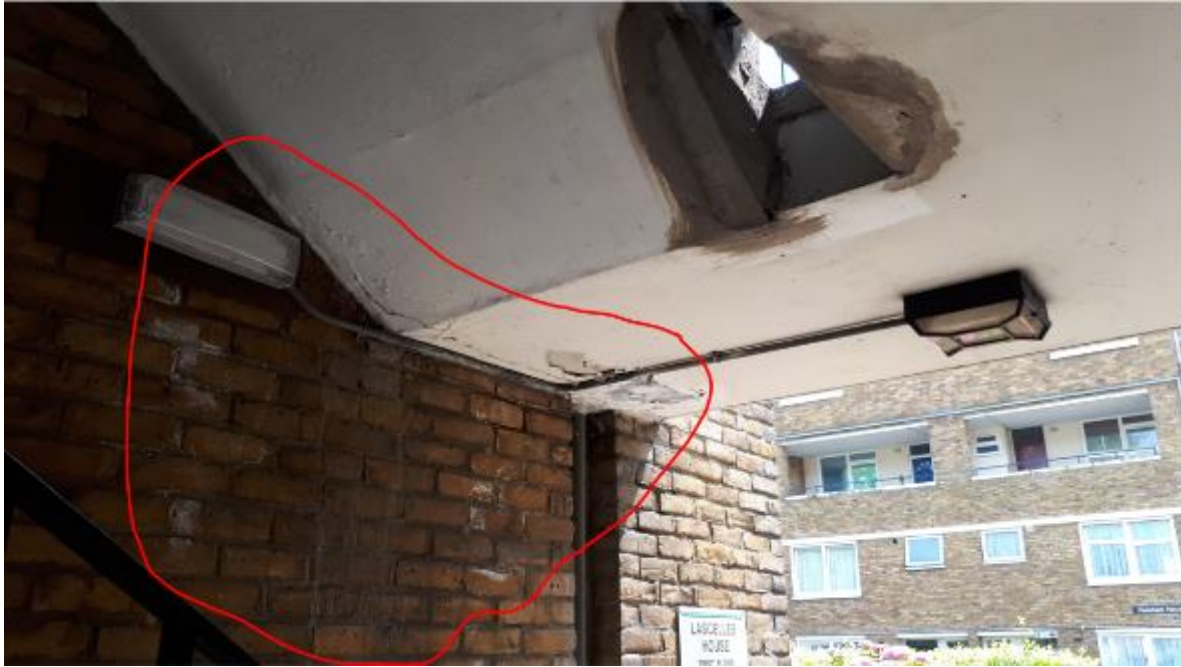
Photo 65. As shown in photo 61, water damage to decorations of stairwell soffit, note past repair to core.

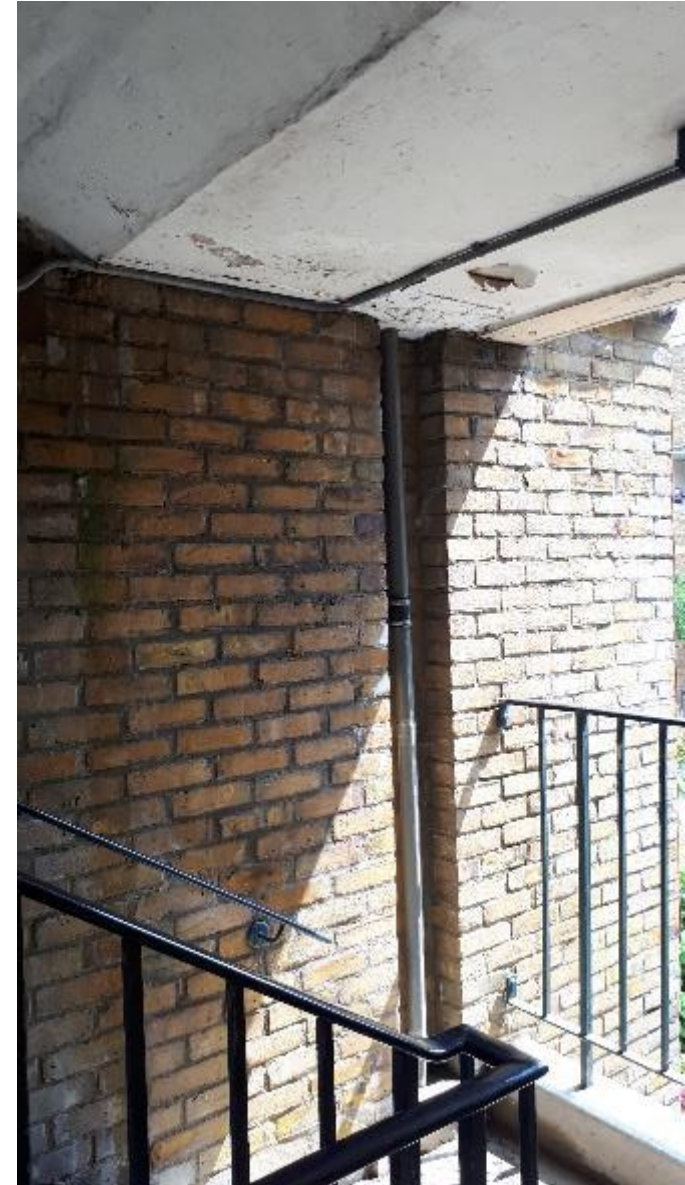
Photo 66. Again as shown in photo 61, water damage to decorations of stairwell soffit.

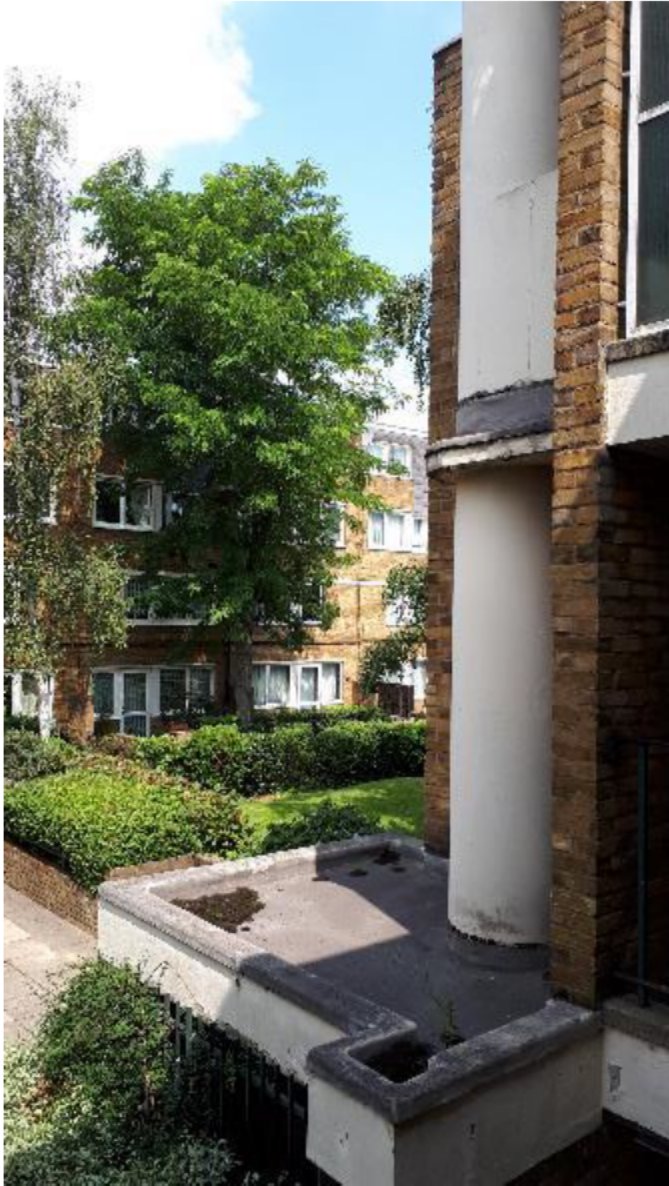
Photo 67. Mastic asphalt covering to bin store roof and bin chute collar roof requires attention.

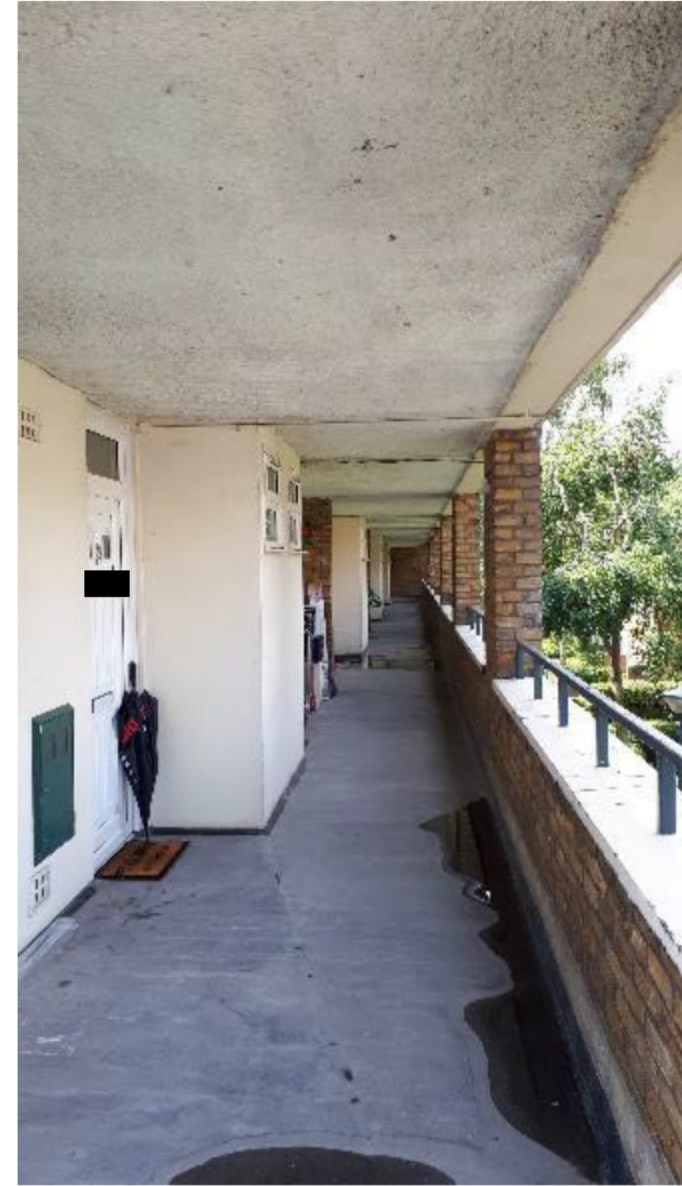
Photo 68. As on other Blocks, the mastic asphalt covering to deck of walkway is in good condition.

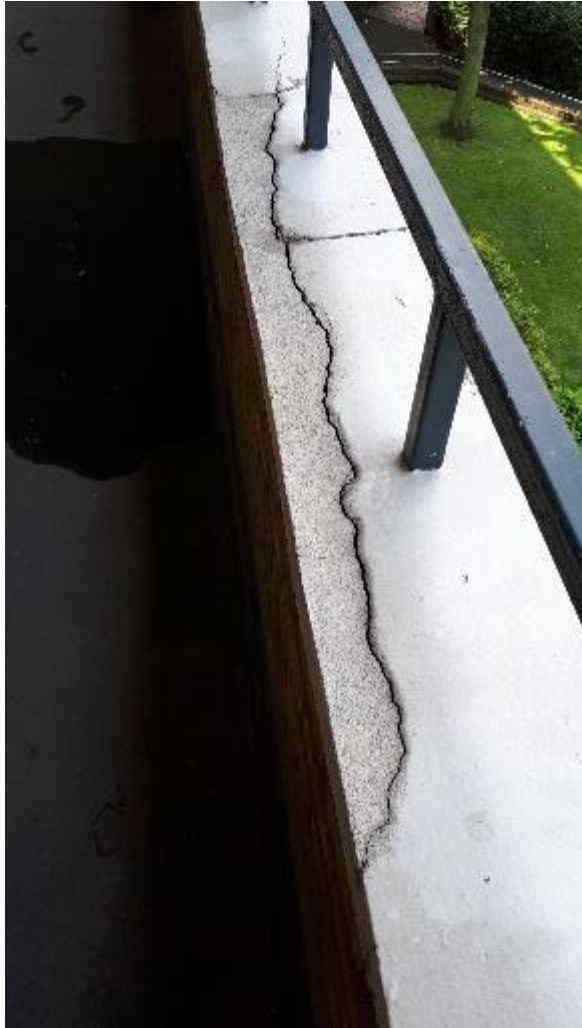
Photo 69. As on other Blocks, the coping is once weathered, shredding rainwater onto the walkway deck. Here the coping drip groove is choked with historic repair mortar (see next photo). The surveyor is of the opinion that the as-built 12inch (305mm) wide coping is not wide enough to effectively shed water away from the face of the brickwork. The inside edge of the drip groove should be a minimum of 20mm away from the brickwork face which was not always found to be the case as the thickness of the walls varied.

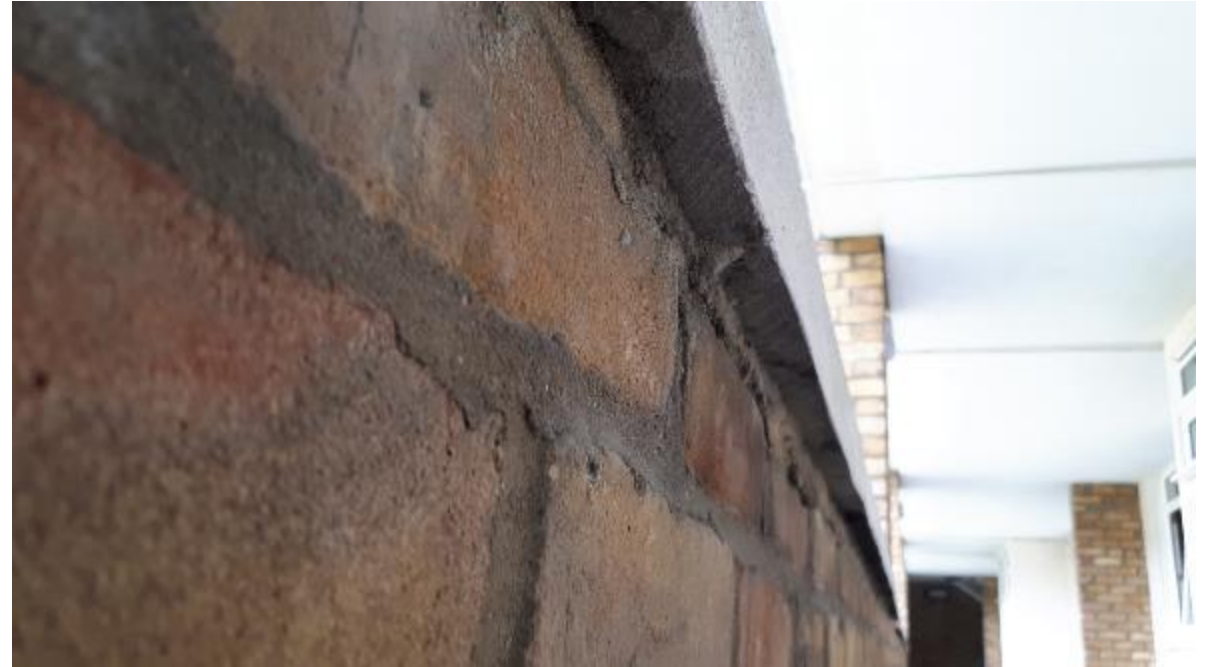
Photo 70. Showing historic repair mortar choking drip groove.
