**Blandford Estate
Harewood Avenue
London
NW1**

Client Ref: Y100 – Blandford Estate

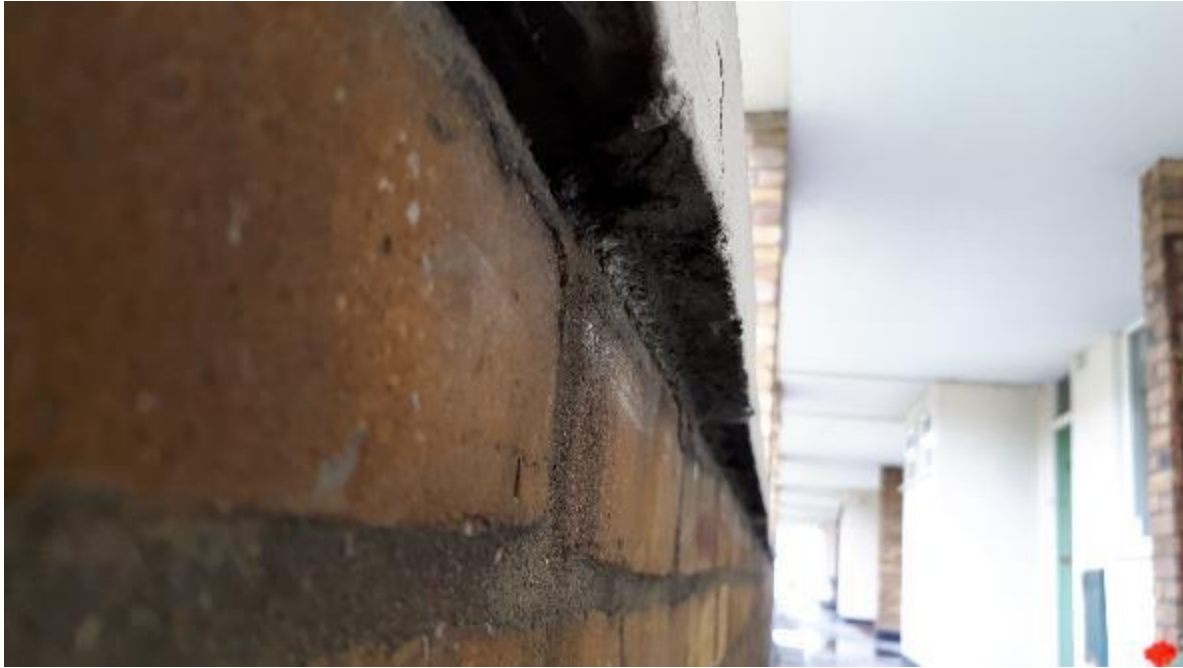
Photo 71. As-built coping simply too narrow as inside edge of drip groove should be a minimum 20mm clear of the brickwork face. Moisture has travelled back under the copings and with freeze thaw action on these north facing elevations as well as rebar corrosion has caused them to fail.

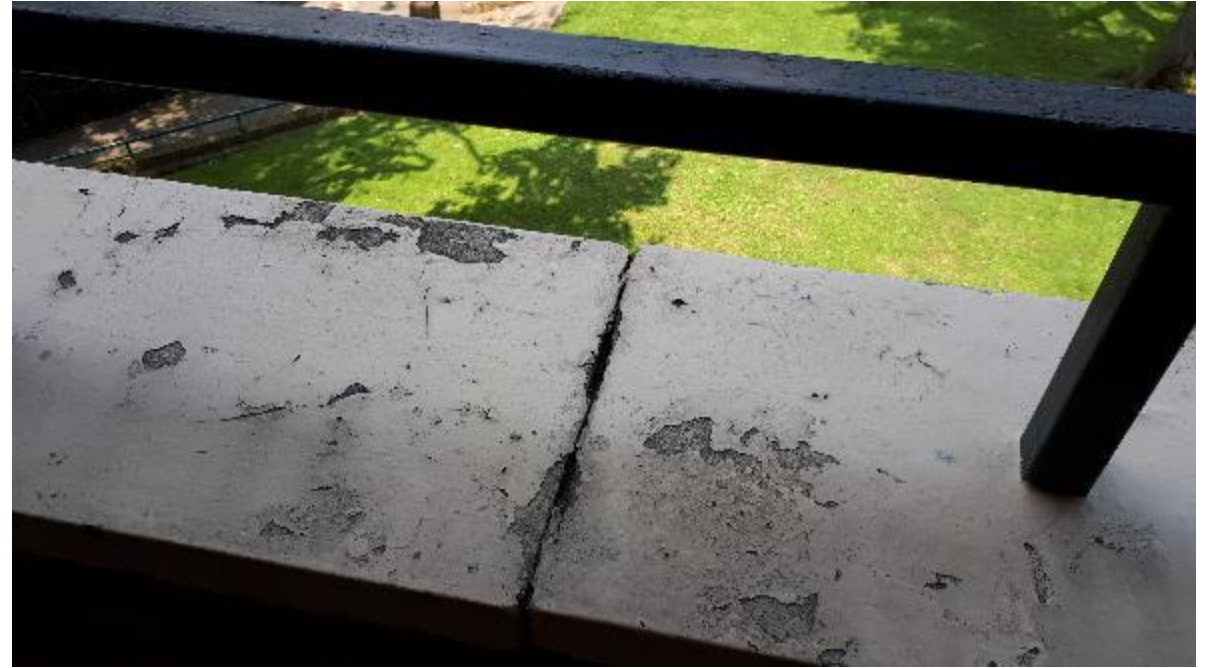
Photo 72. Defective coping joints let rainwater in and corrode rebars, exacerbating the defect.

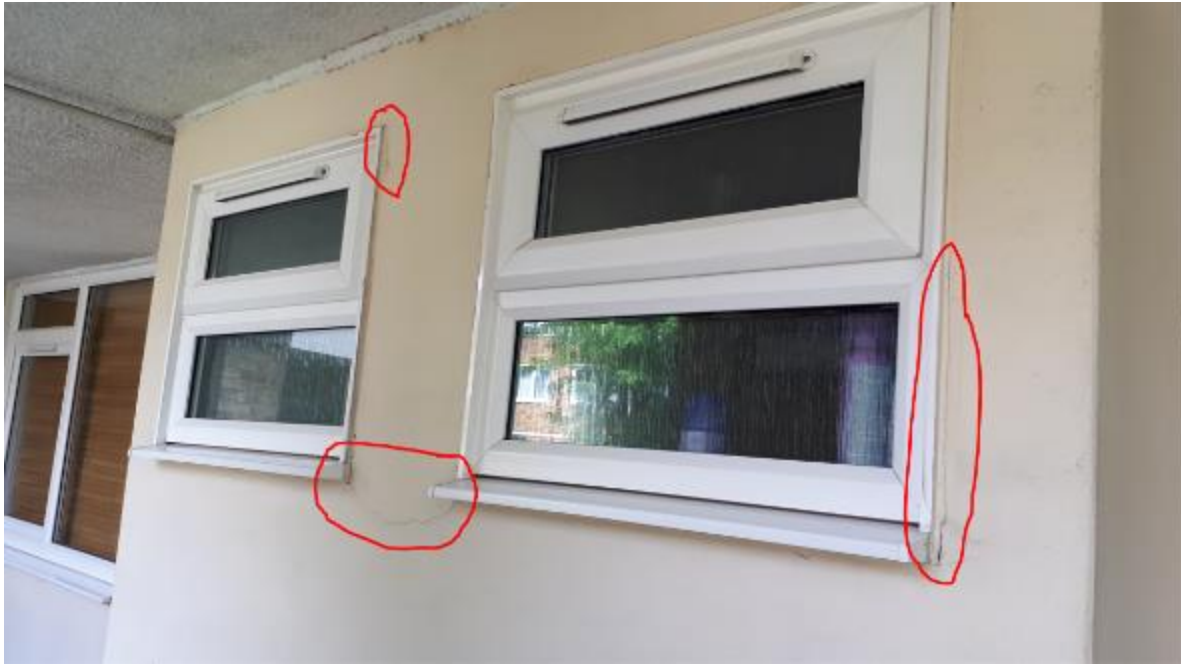
Photo 73. Not of particular concern are the hairline cracks to the rendered finishes, probably caused by the vibration of closing the windows.

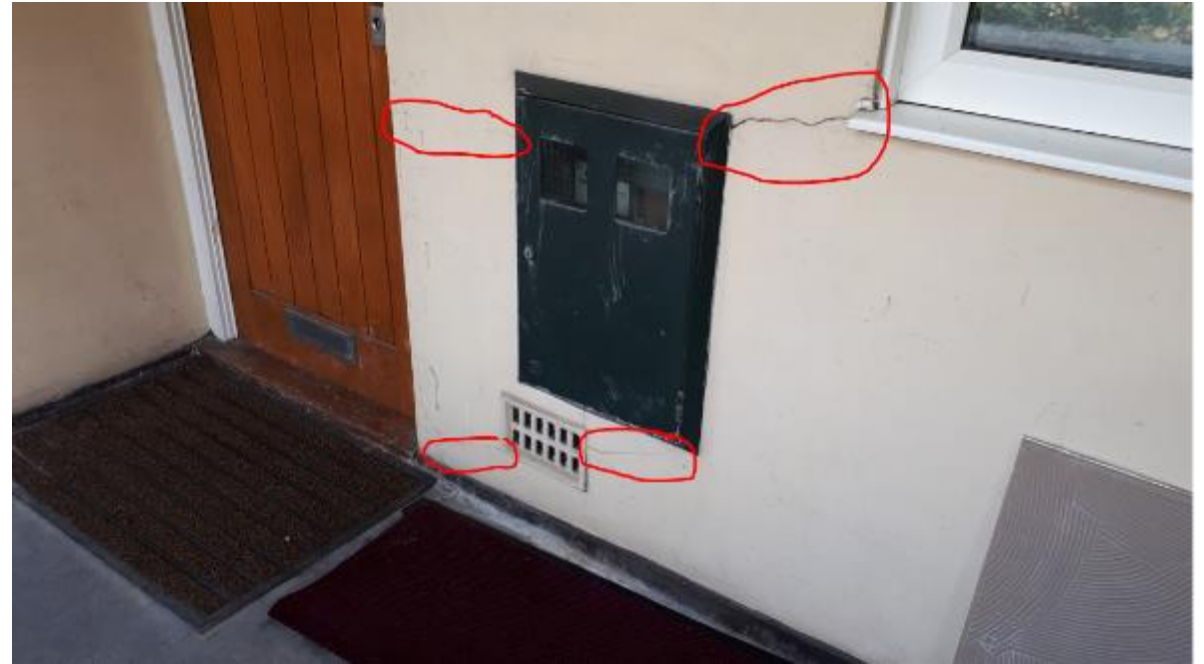
Photo 74. Again, most likely to be vibration, movement cracking.

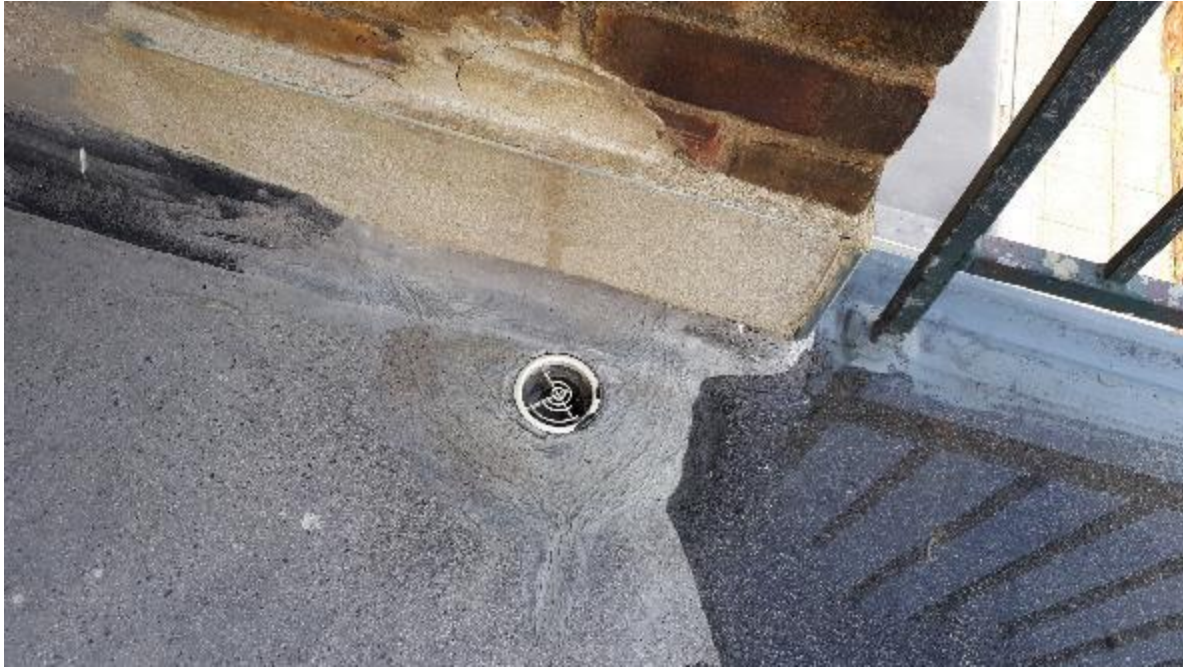
Photo 75. Grilles to walkway outlets broken across all Blocks.

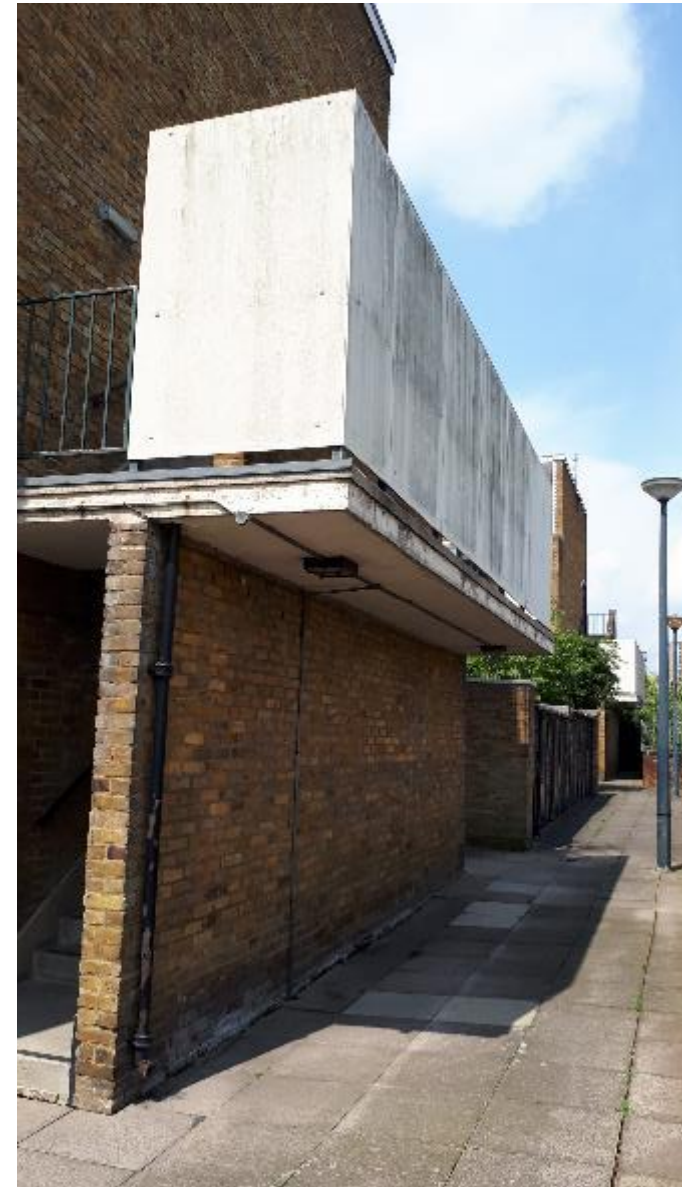
Photo 76. As on other Blocks at the railway end, the landing guarding needs redecorating.

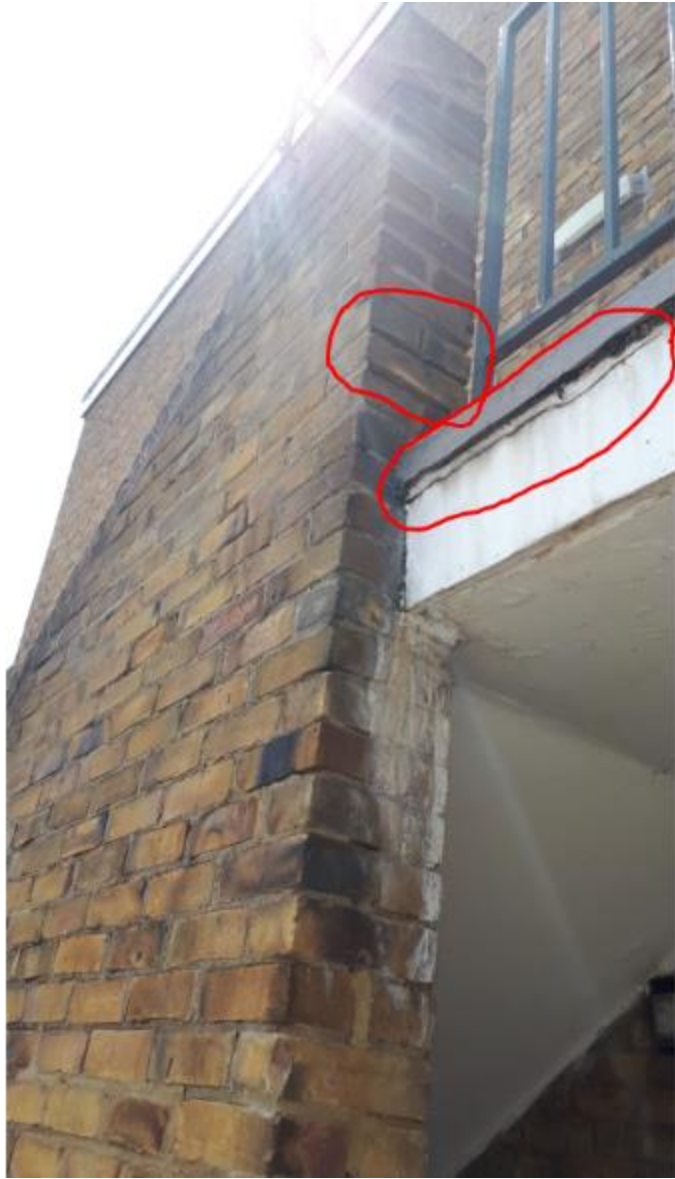
Photo 79. Same stairs, defective pointing and cracking are probable points of water ingress, seeping out below the soffit indicated by heavy limescale build-up.

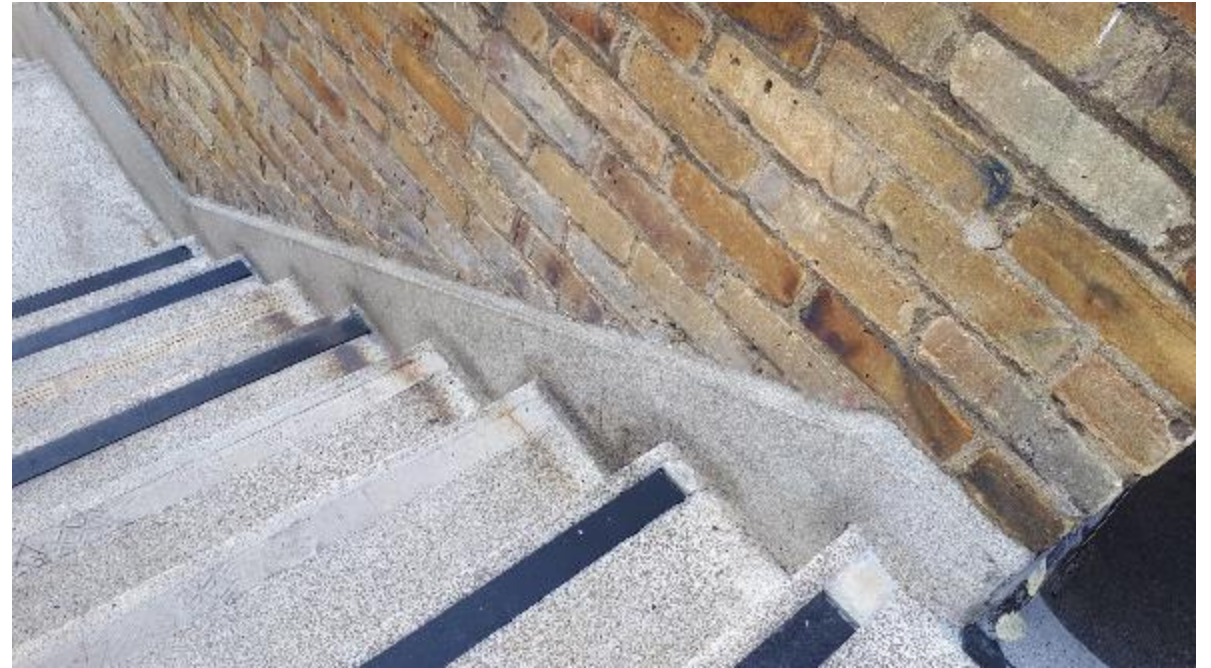
Photo 80. Same stairs, showing cracking to re-rendered wall stringer plus, missing and shrunken nosing strips.

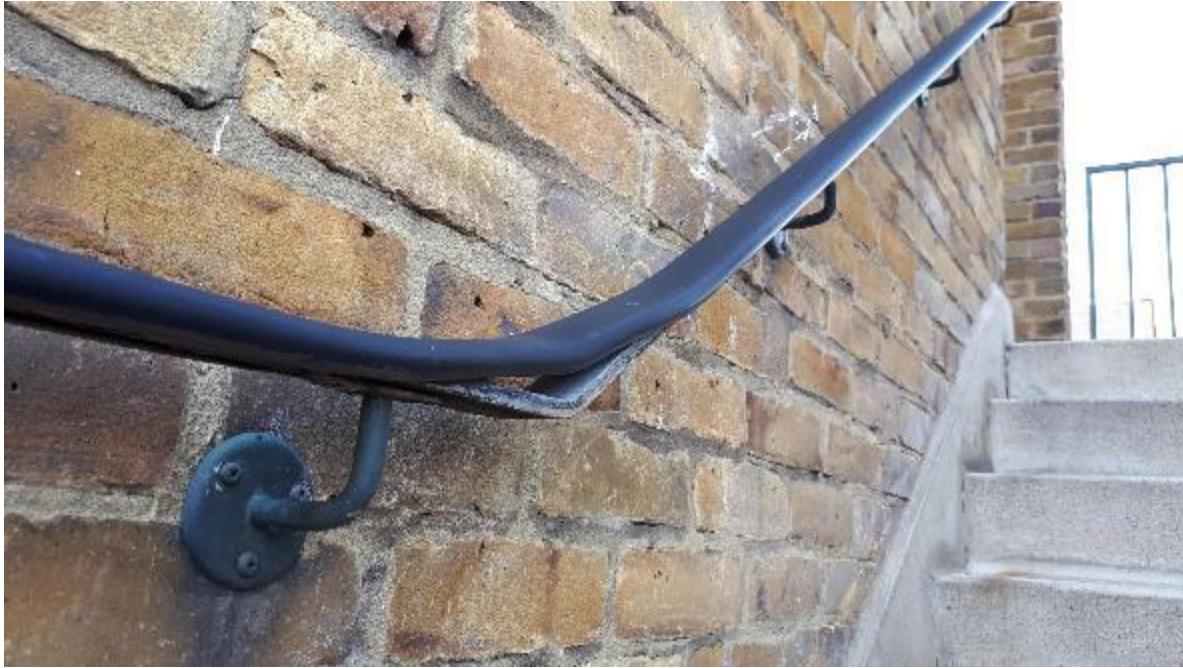
Photo 81. Same set of stairs, handrail grip debonding.

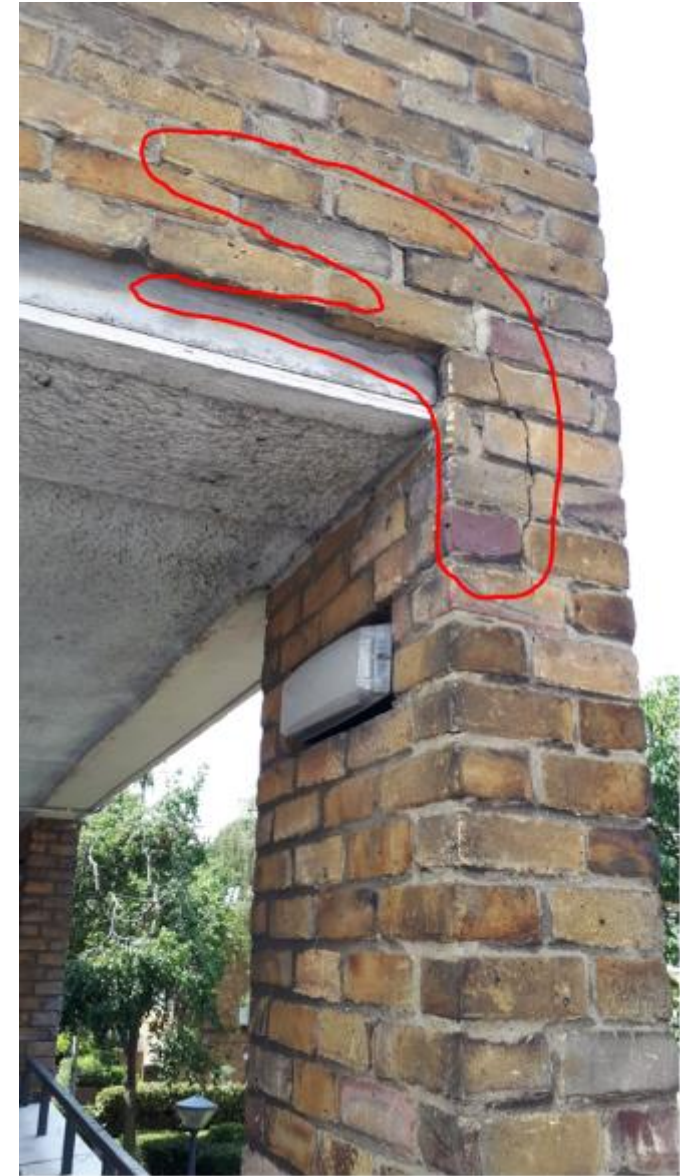
Photo 82. Same set of stairs, Lascelles Hse, movement and/or thermal cracking, concrete abutting brickwork, possibly exacerbated by nearby trains.

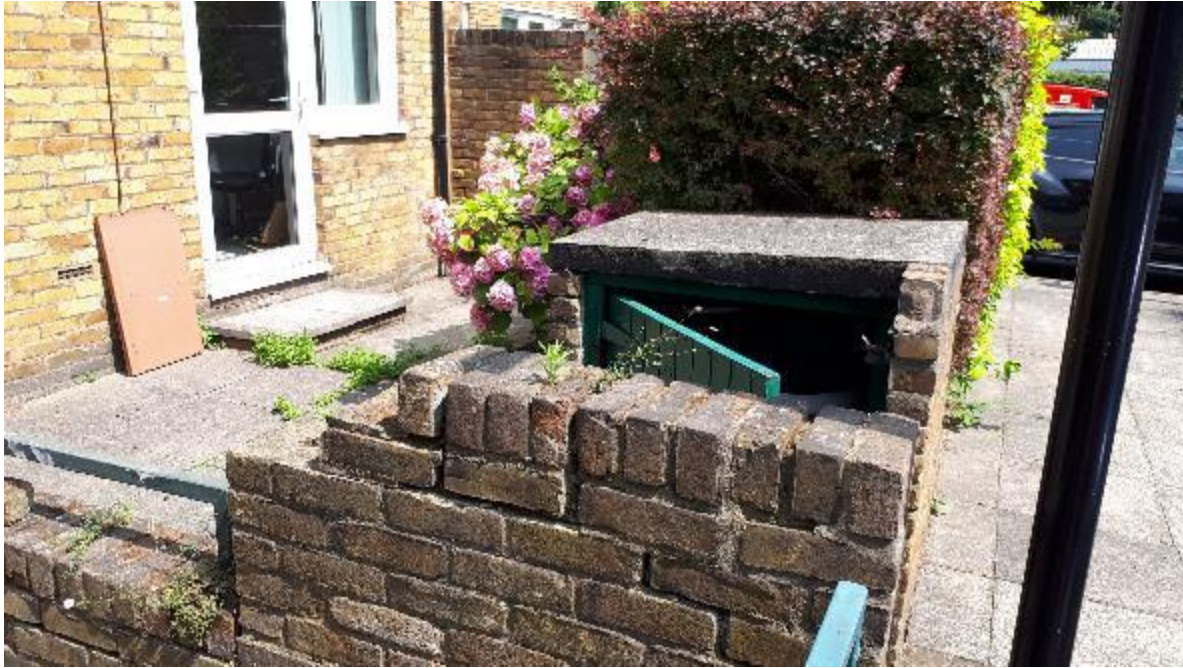
Photo 83. Defective brickwork to rear boundaries of flats, found to a lesser degree elsewhere.

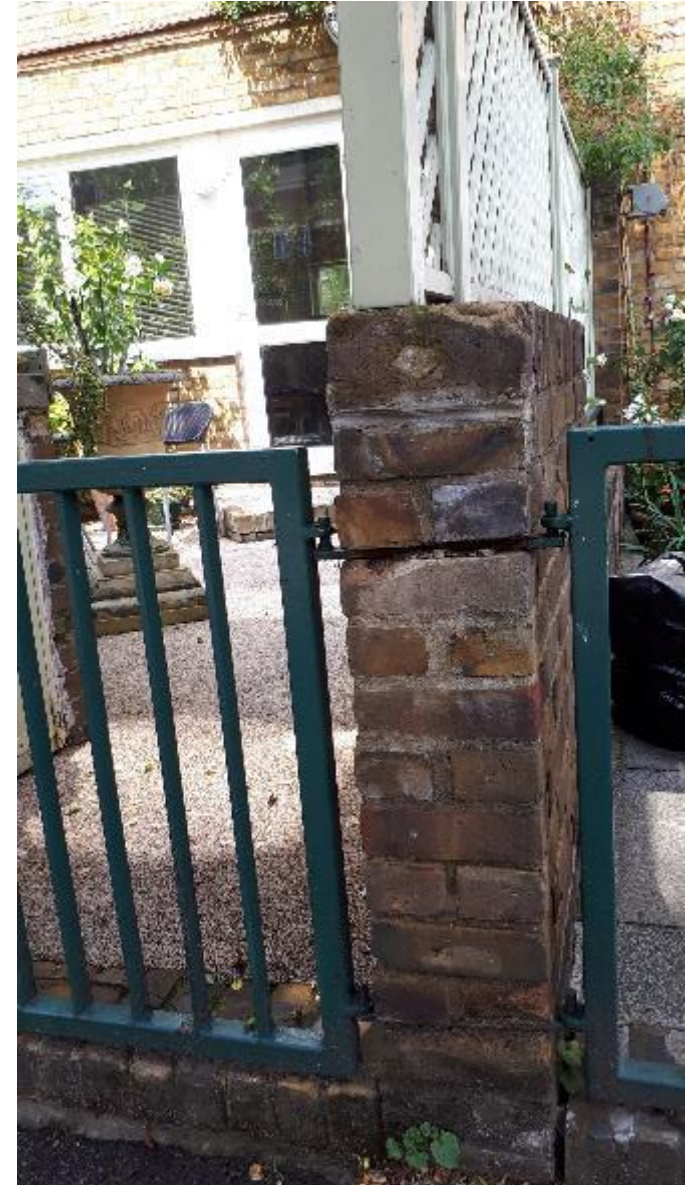
Photo 84. Defective pointing.

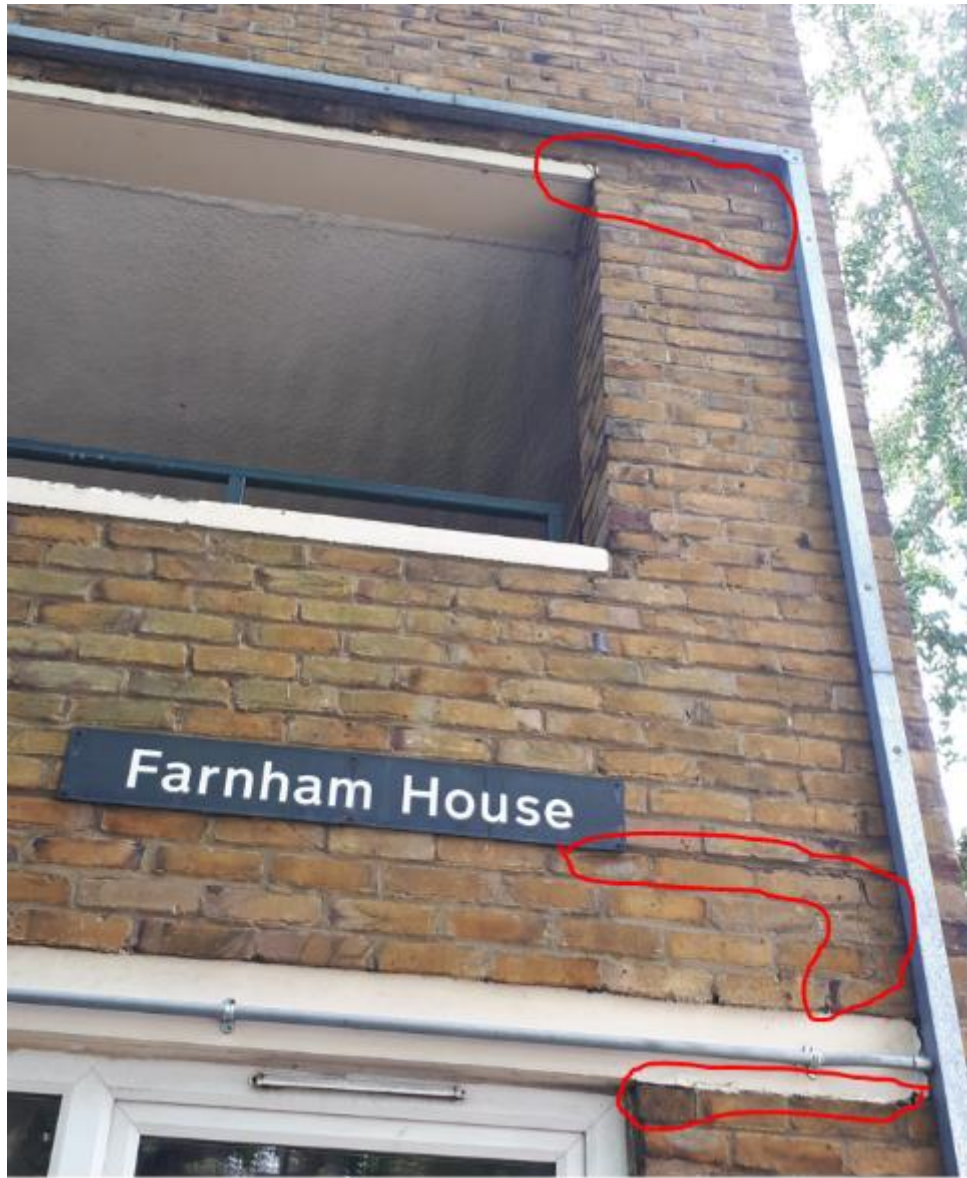
Photo 85. Similar cracking as seen on the other Blocks.

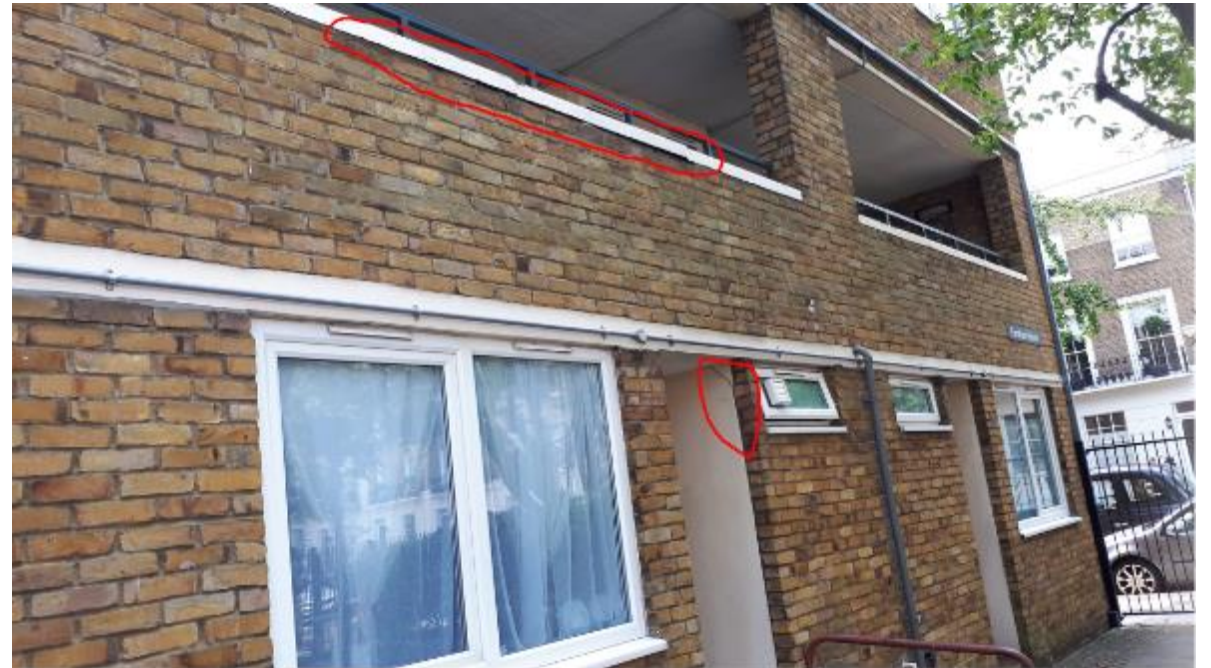
Photo 86. Generic pointing failure beneath copings to walkways as found on other Blocks. There is minor settlement cracking lower down.

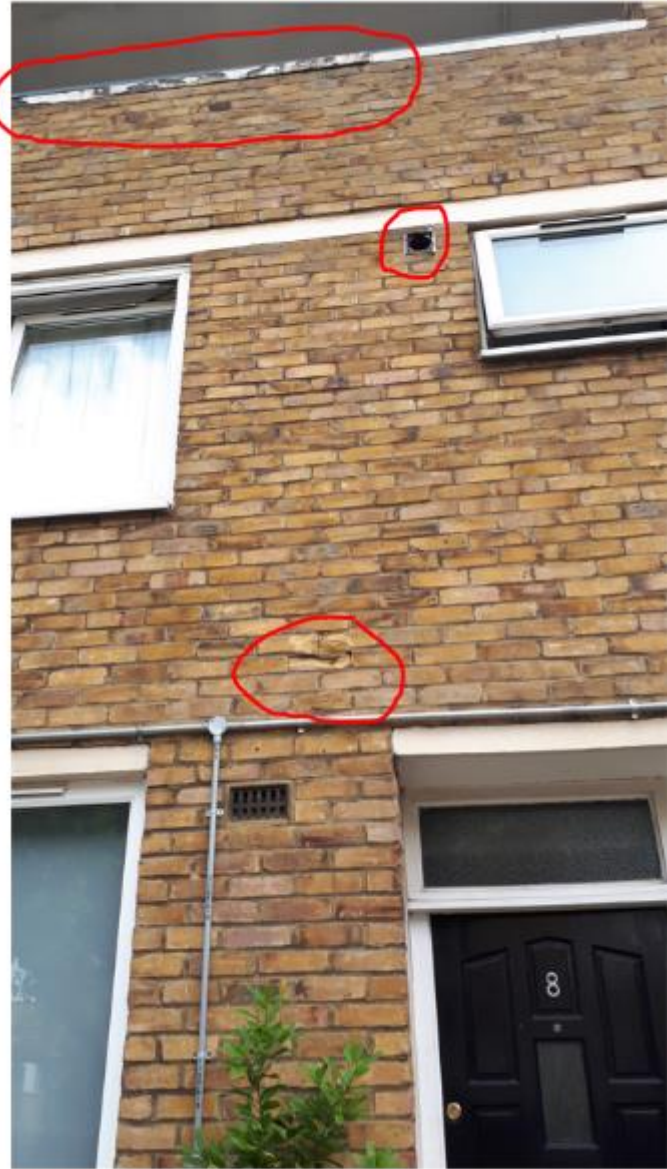
Photo 87. Again, generic defective coping and pointing plus, missing extract fan duct grille and impact damage to brickwork.

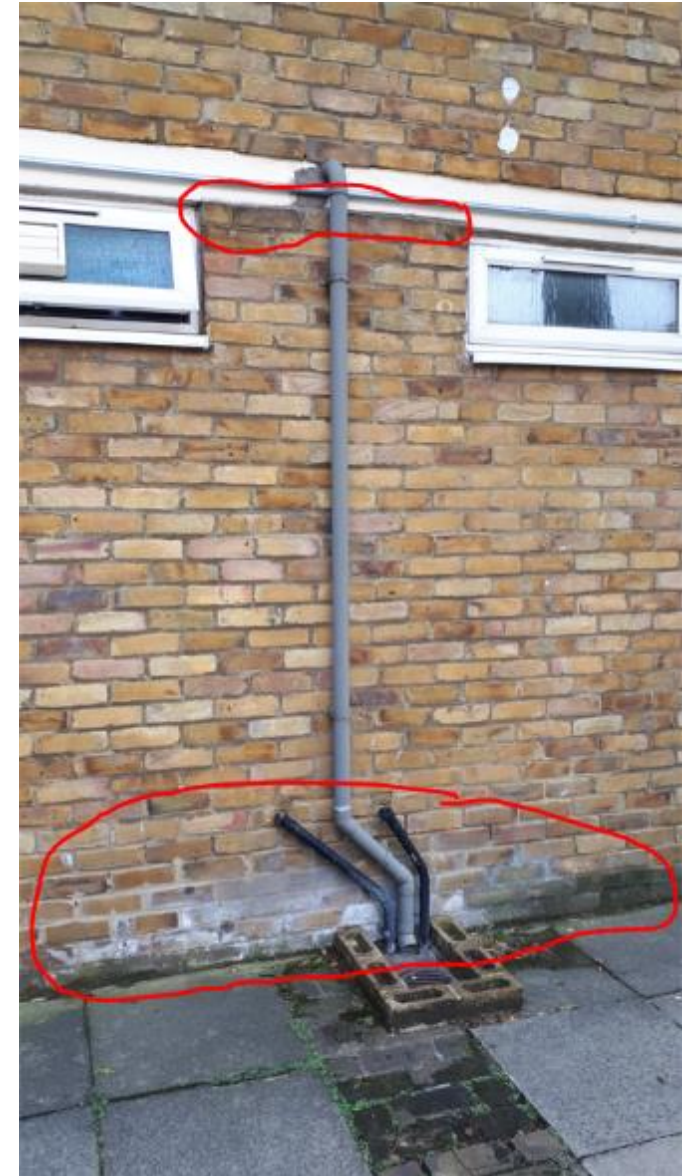
Photo 88. Arguably looks worse than what it is unless wall cavity and DPC have been breached. Repointing required between windows, a defect found on other Blocks.

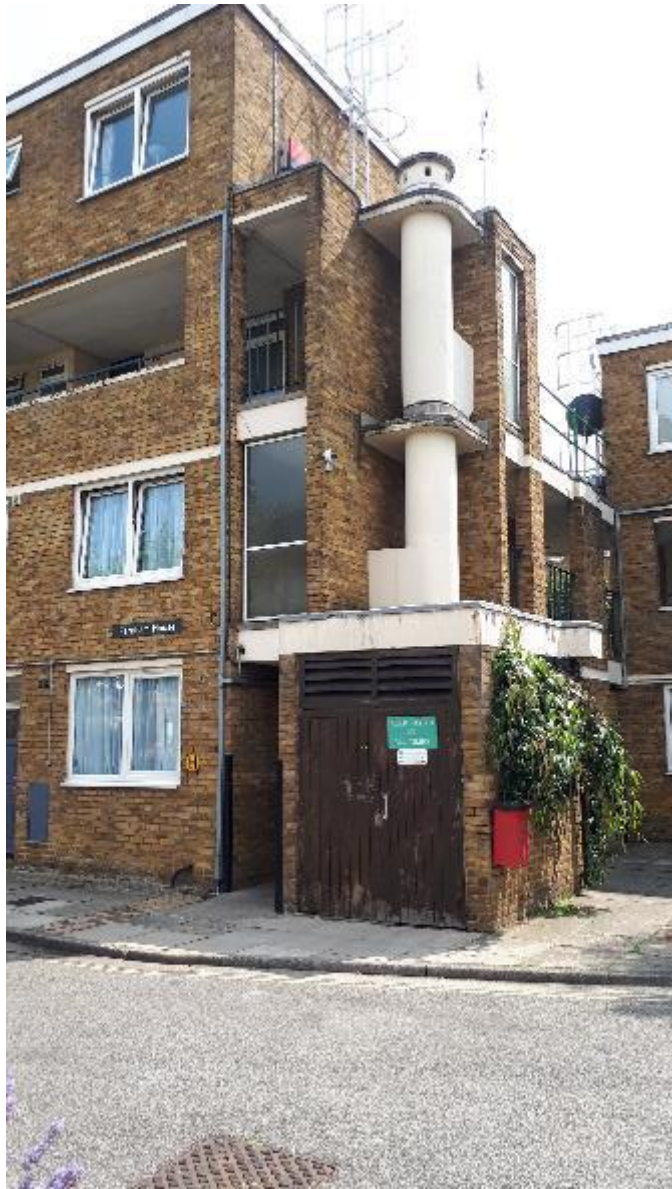
Photo 89. Farnham Hse communal stairs and bin store.

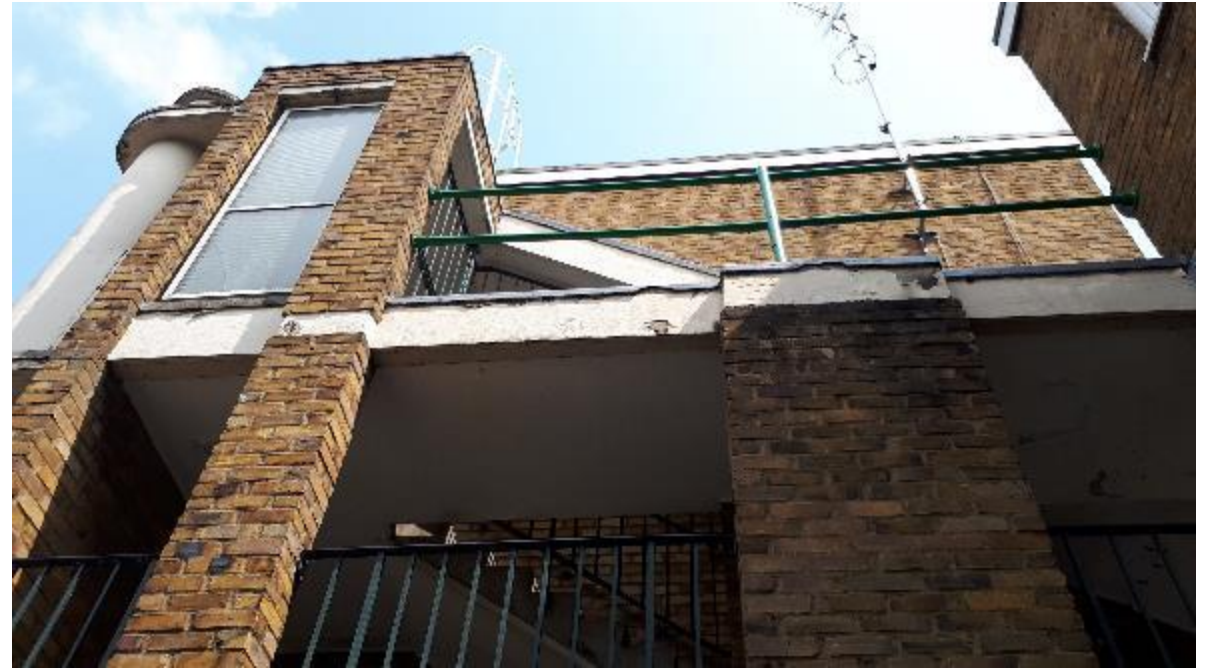
Photo 90. Failing decorations and defective mastic asphalt coverings.

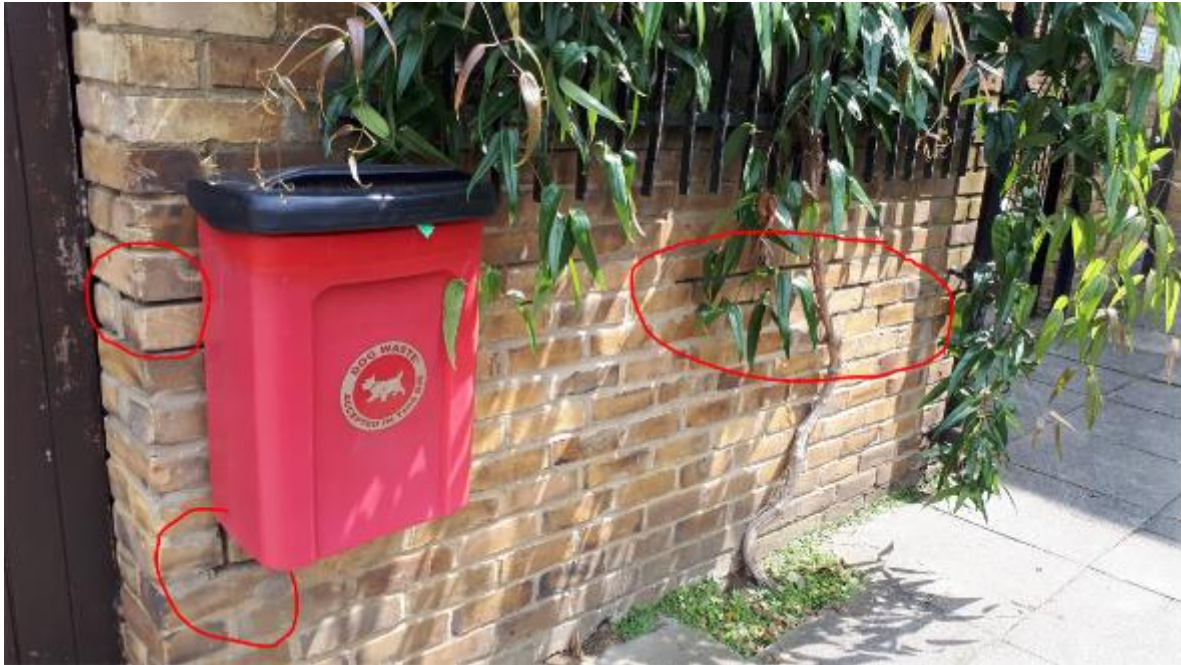
Photo 91. Eroded pointing to bin store.

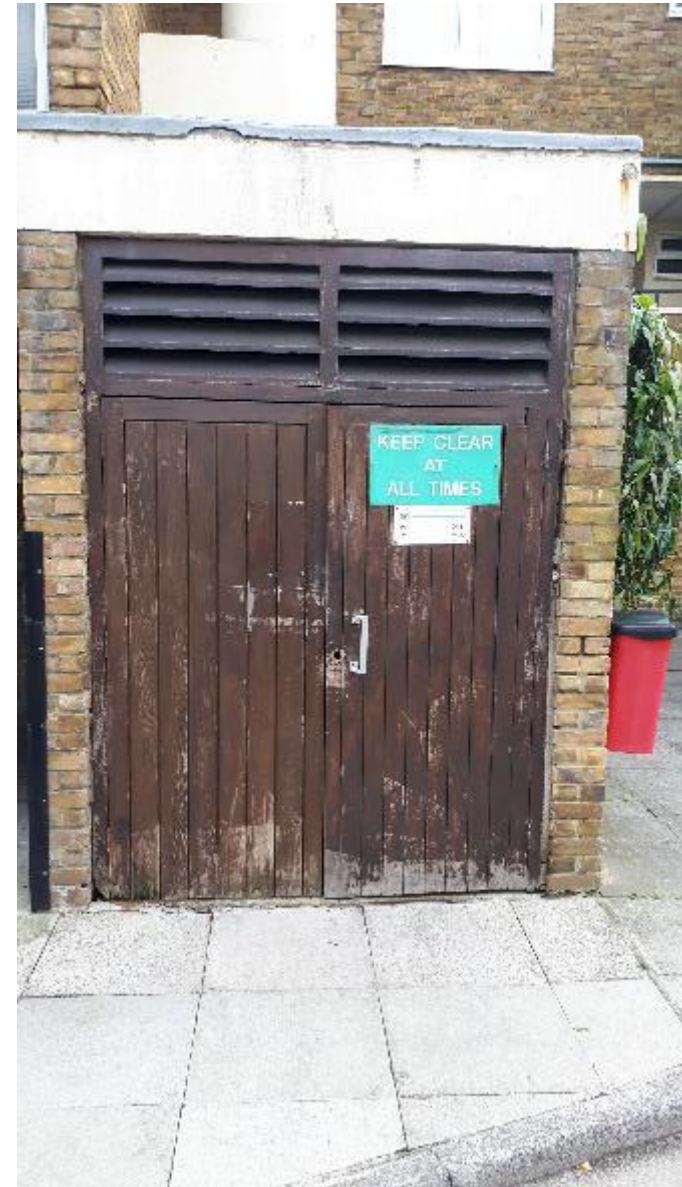
Photo 92. Repair and redecoration of bin store doors required at Farnham Hse.

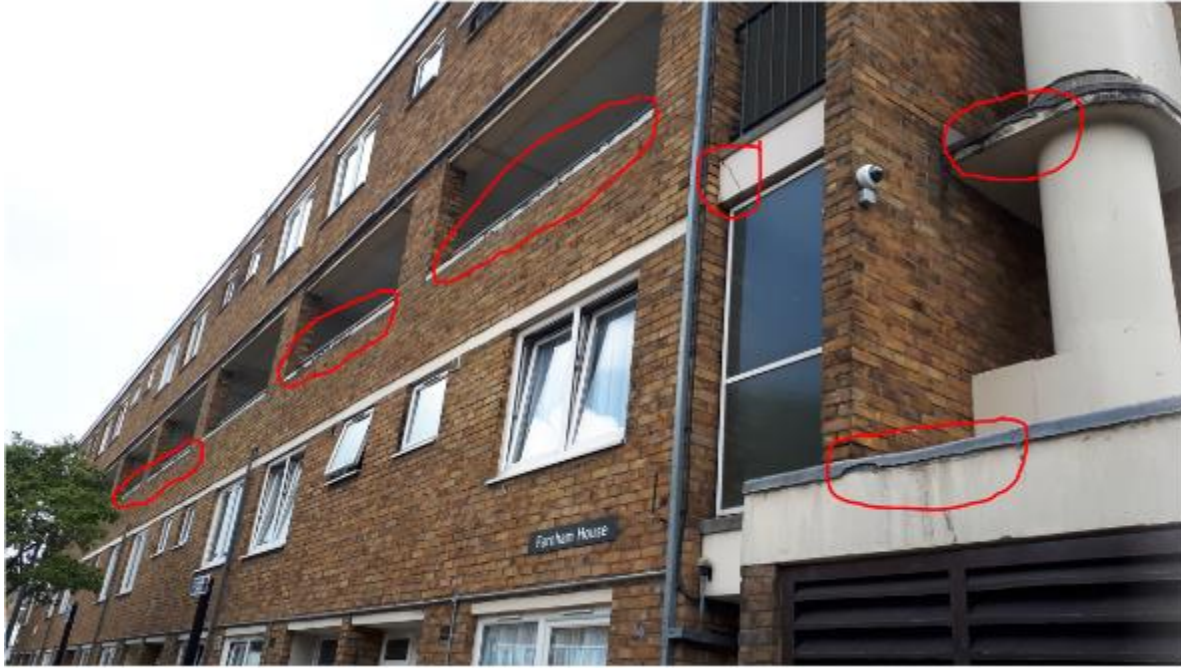
Photo 93. Generic defects to façade of Farnham Hse as found elsewhere across Blocks.

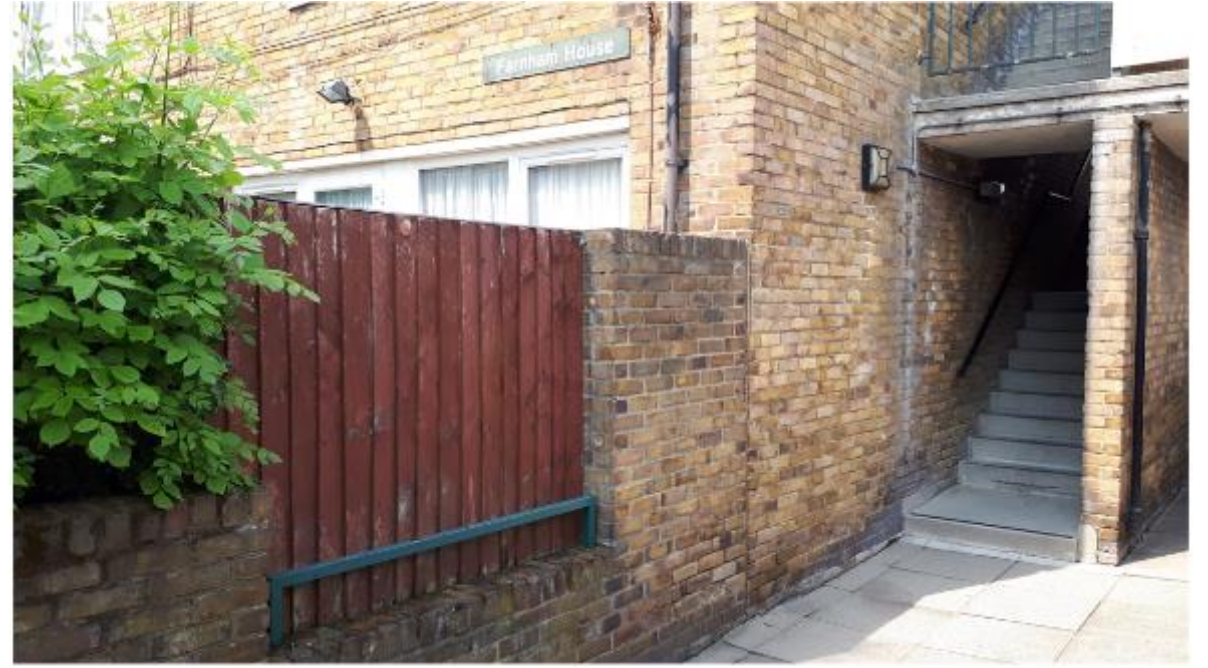
Photo 94. Generic limescale build-up, defective brickwork pointing and failed decorations.

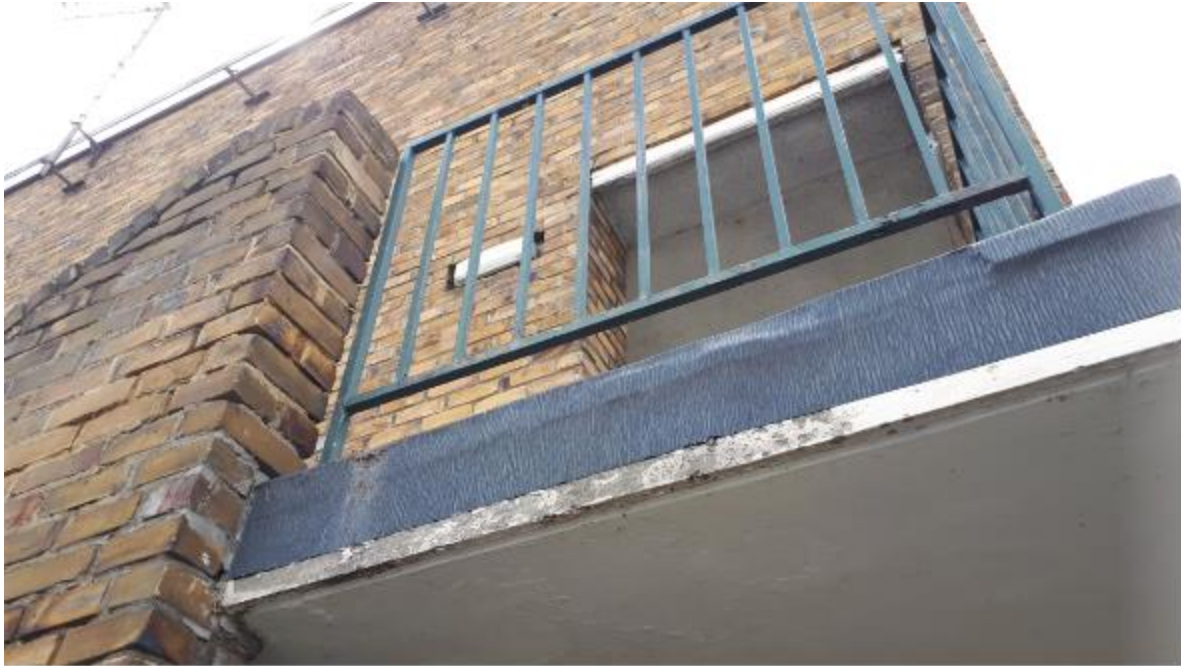
Photo 95. Farnham Hse stairs adjacent railway, note defective pointing to brickwork and historic covering repair carried out to mitigate moisture penetration.

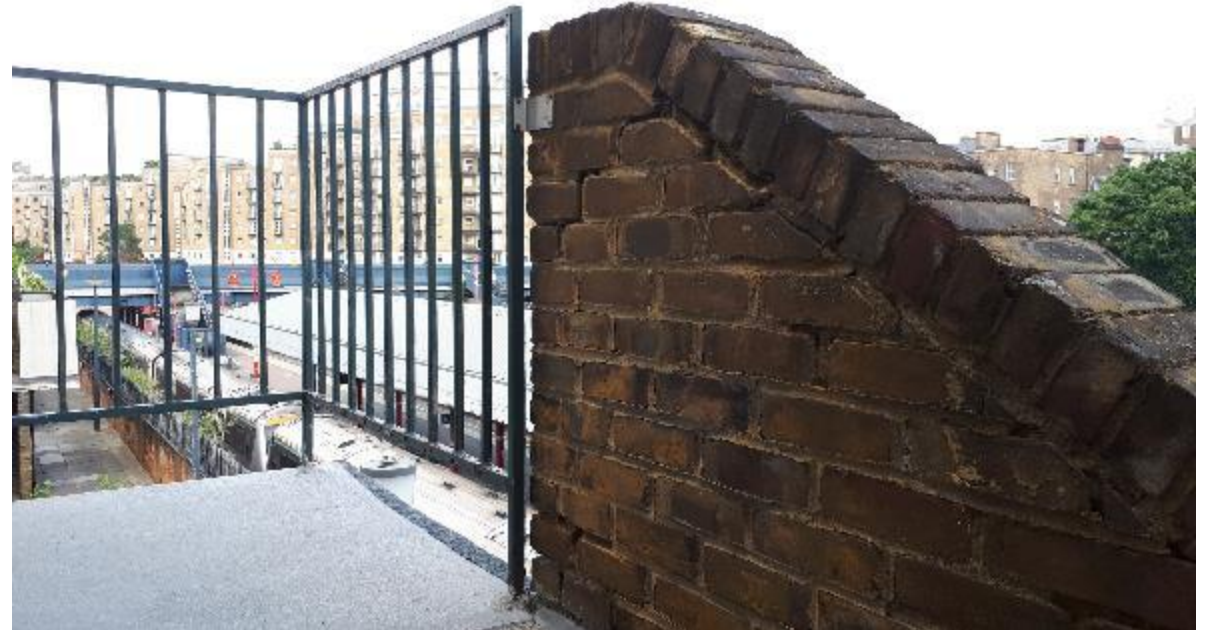
Photo 96. As viewed from above.

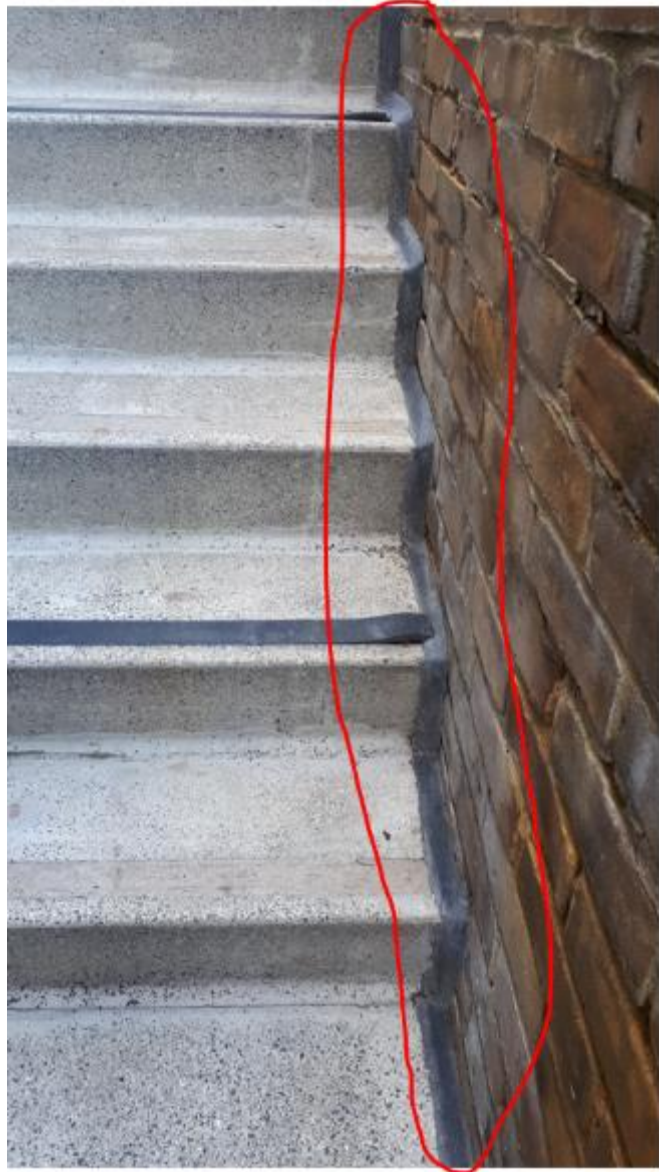
Photo 97. Same flank stairs, note re-jointing between tread/riser ends and brickwork. Some nosing strips missing and lifting.

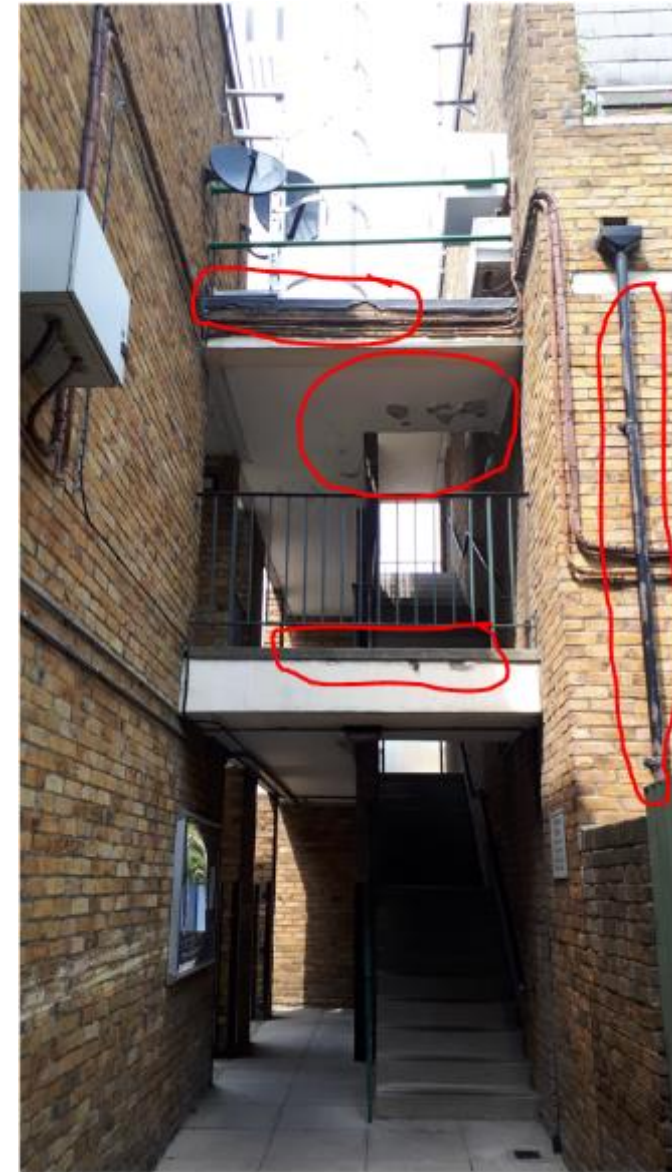
Photo 98. Rear view of Farnham Hse stairwell showing generic defects as found on the other Blocks i.e., failing decorations and mastic asphalt.

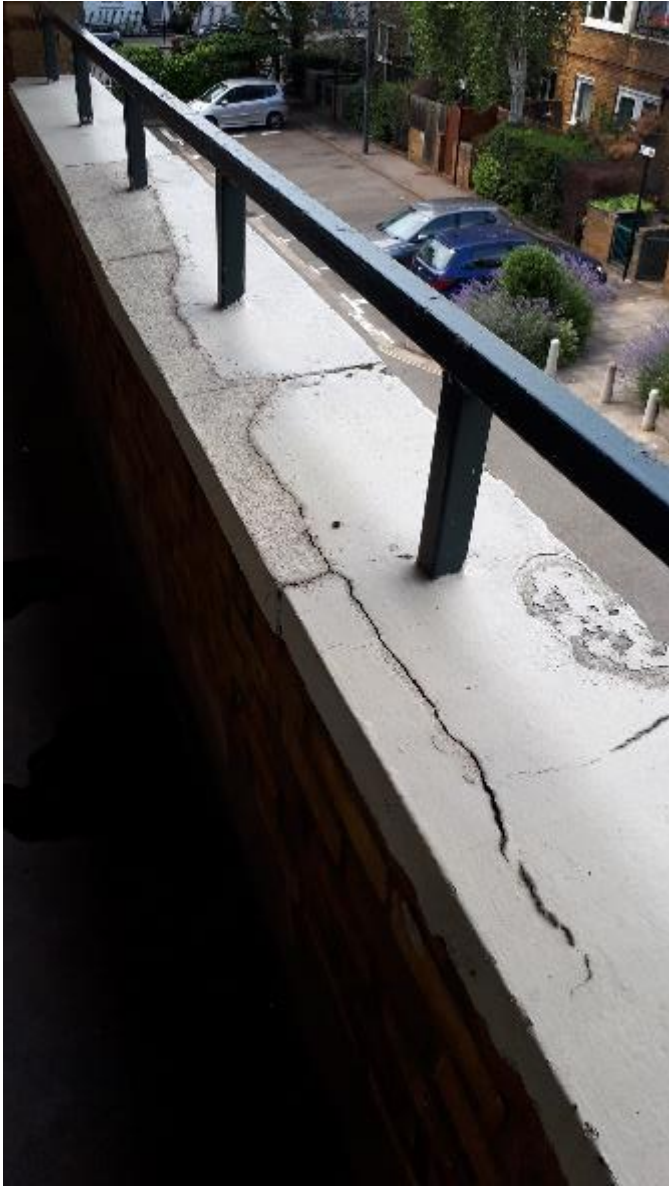
Photo 99. Generic walkway coping failure.
