**Blandford Estate
Harewood Avenue
London
NW1**

Client Ref: Y100 – Blandford Estate

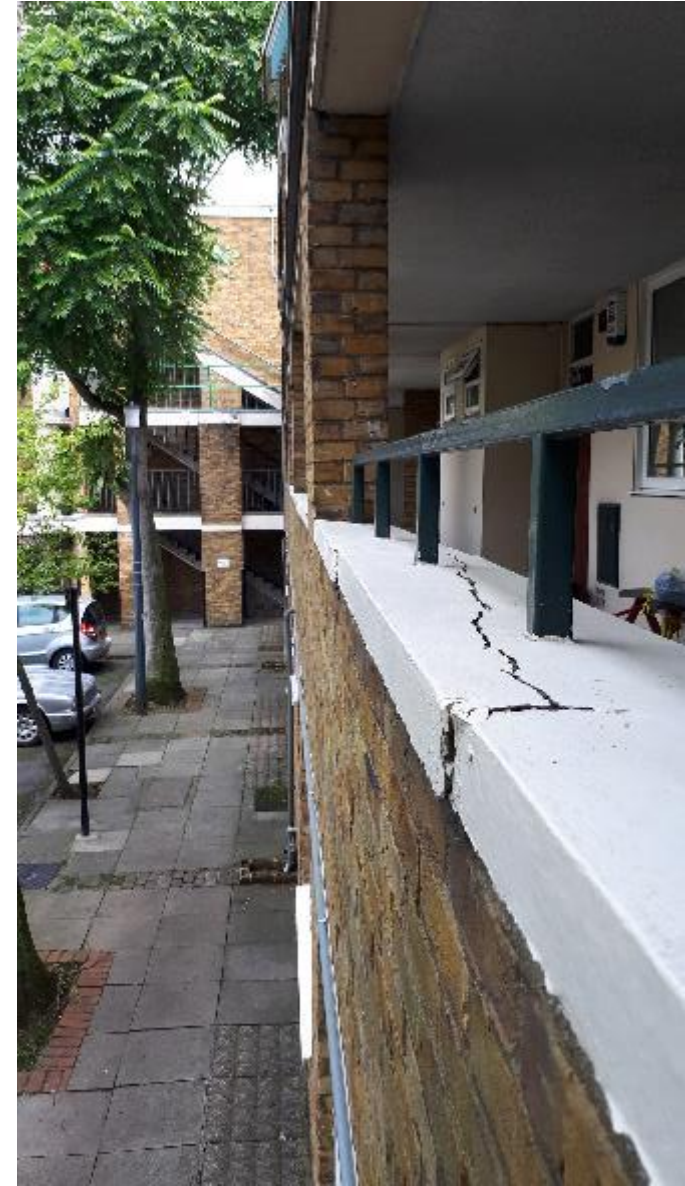
Photo 100. As previous photo.

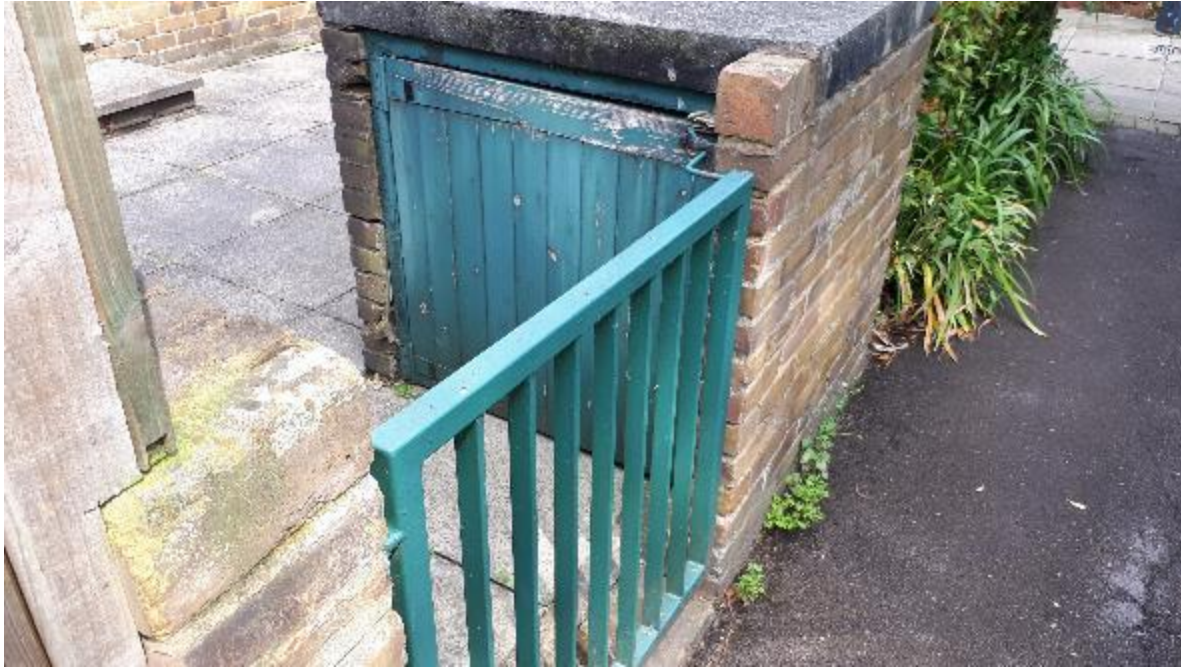
Photo 101. As on other Blocks, failing paintwork to bin stores and gates.

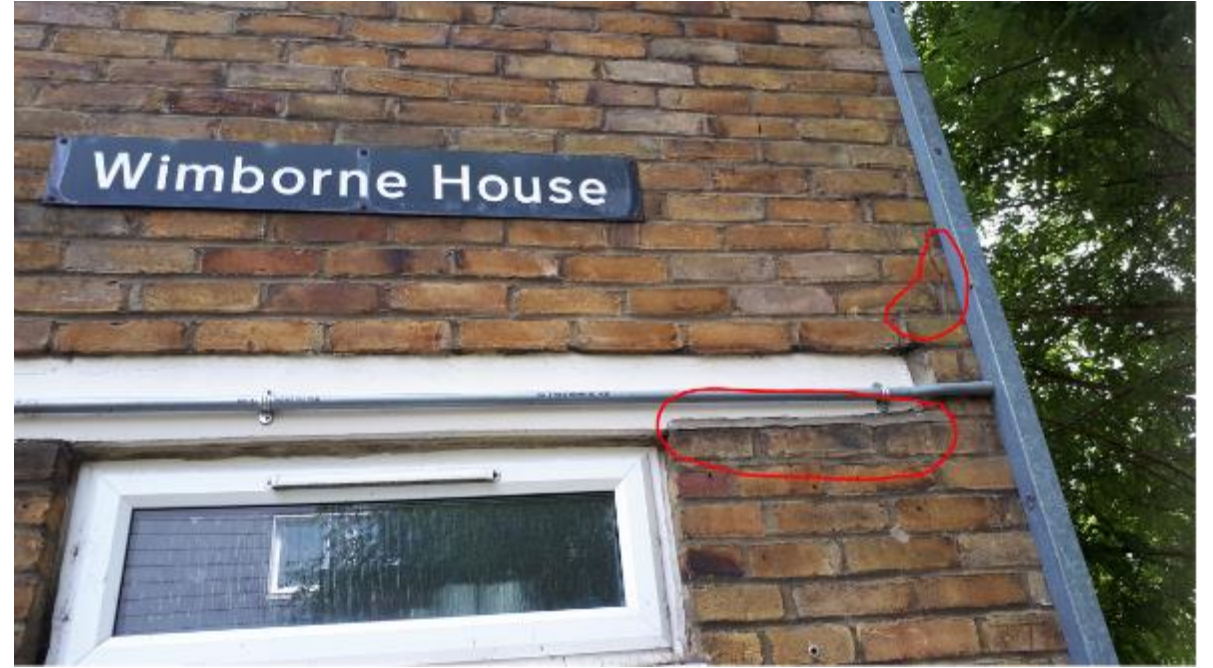
Photo 102. Wimborne House, same location as on other Blocks (front elevation, RHS end adjacent Harewood Avenue) showing evidence of minor movement cracking considered not to be an immediate cause for concern despite close proximity of mature acacia trees, see next couple of photos.

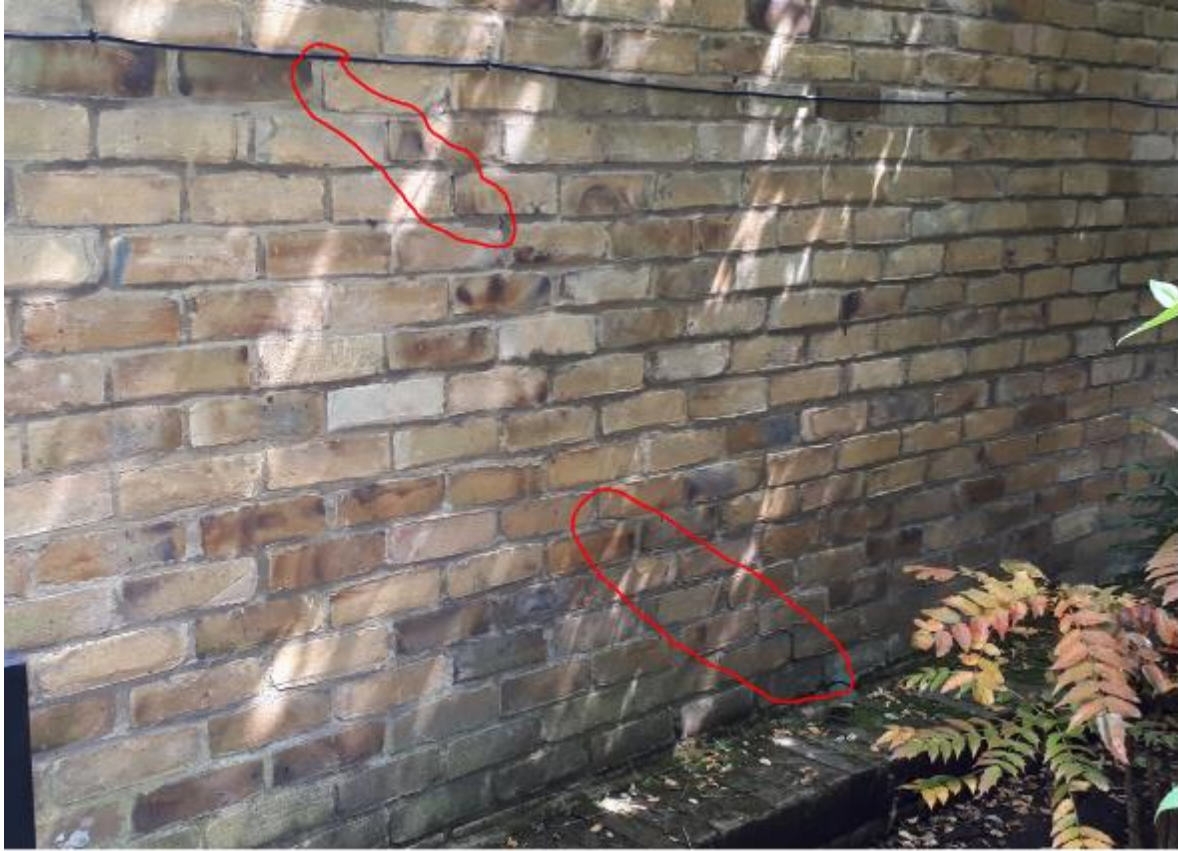
Photo 103. Close-up of stepped movement cracking to flank elevation considered to be of minor significance given width of cracks and fact that the bricks are not fractured.

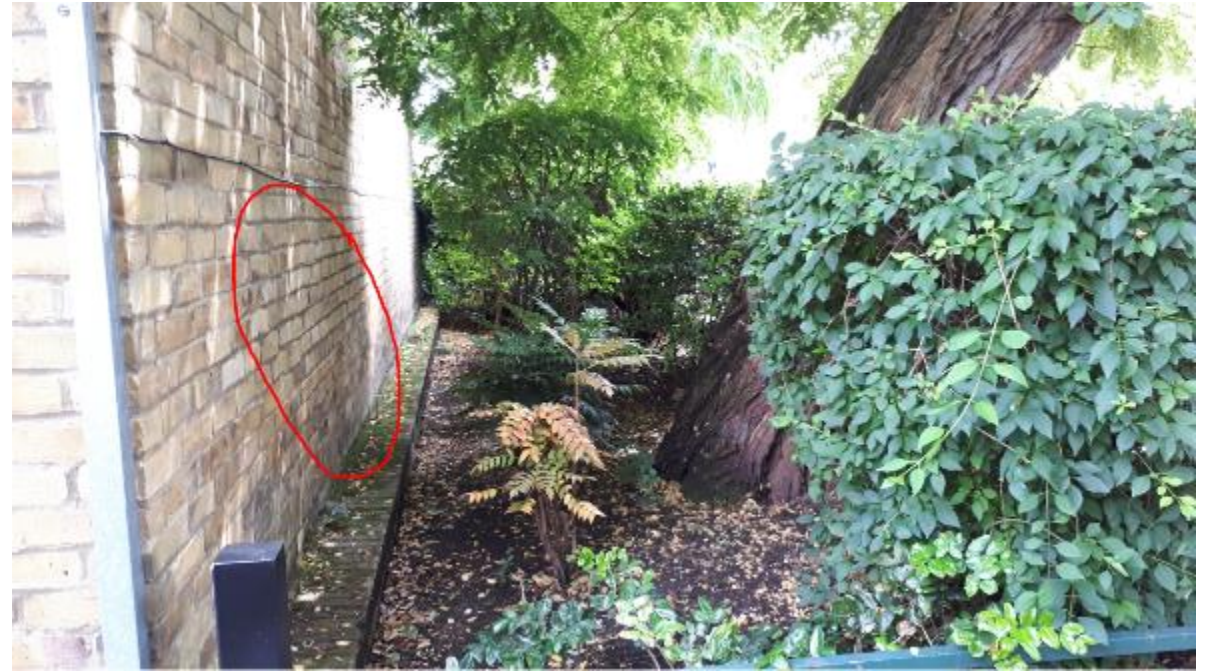
Photo 104. Showing location of same stepped cracking in relation to acacia tree.

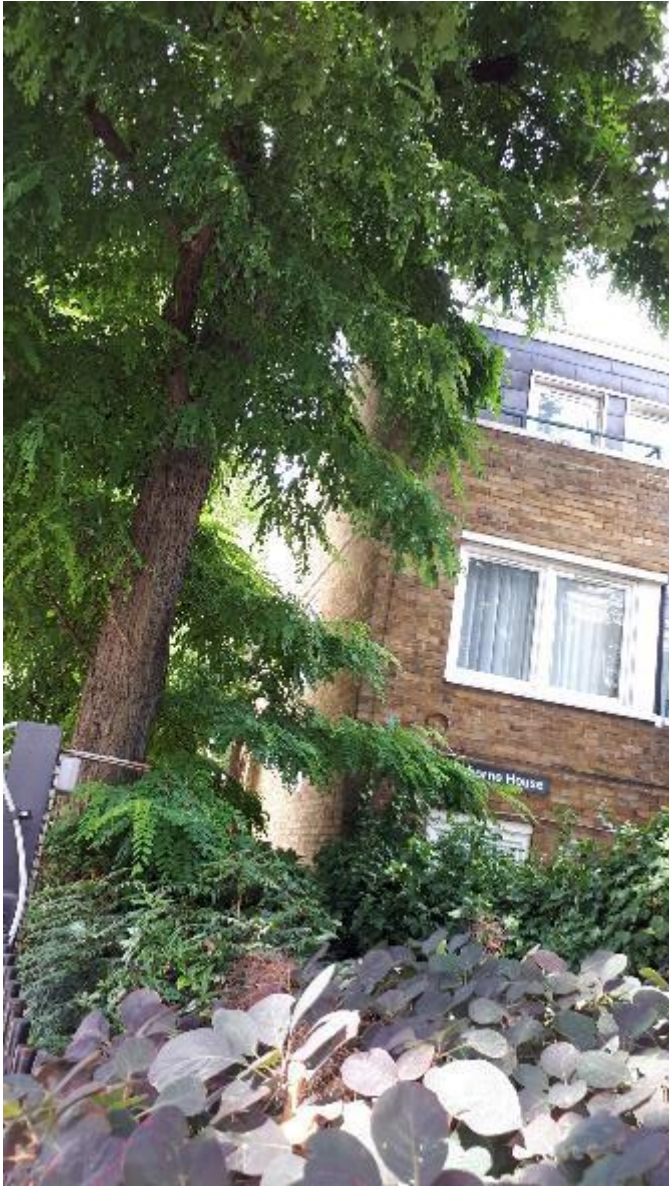
Photo 105. Rear corner of Wimborne Hse showing mature acacia tree.

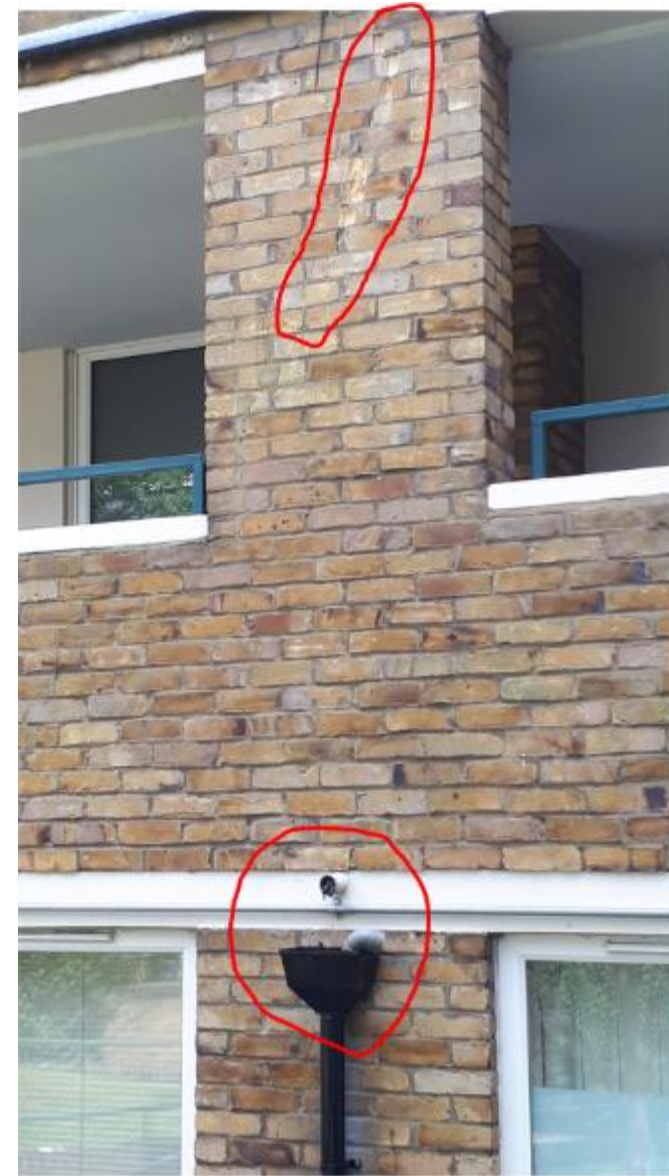
Photo 106. Showing evidence of historic crack repair preparation work at height to façade of four storey Block of Wimborne Hse. Plus, disconnected walkway drain pipe.

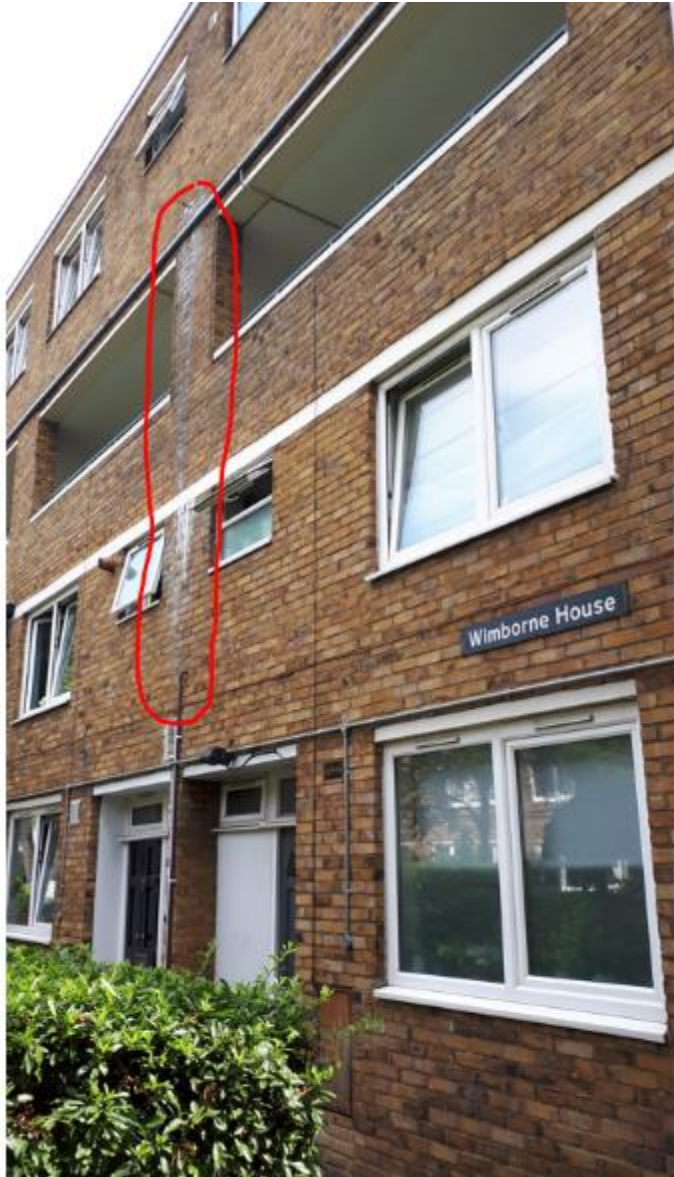
Photo 107. Significant limescale build-up to façade of four storey Wimborne Hse Block.

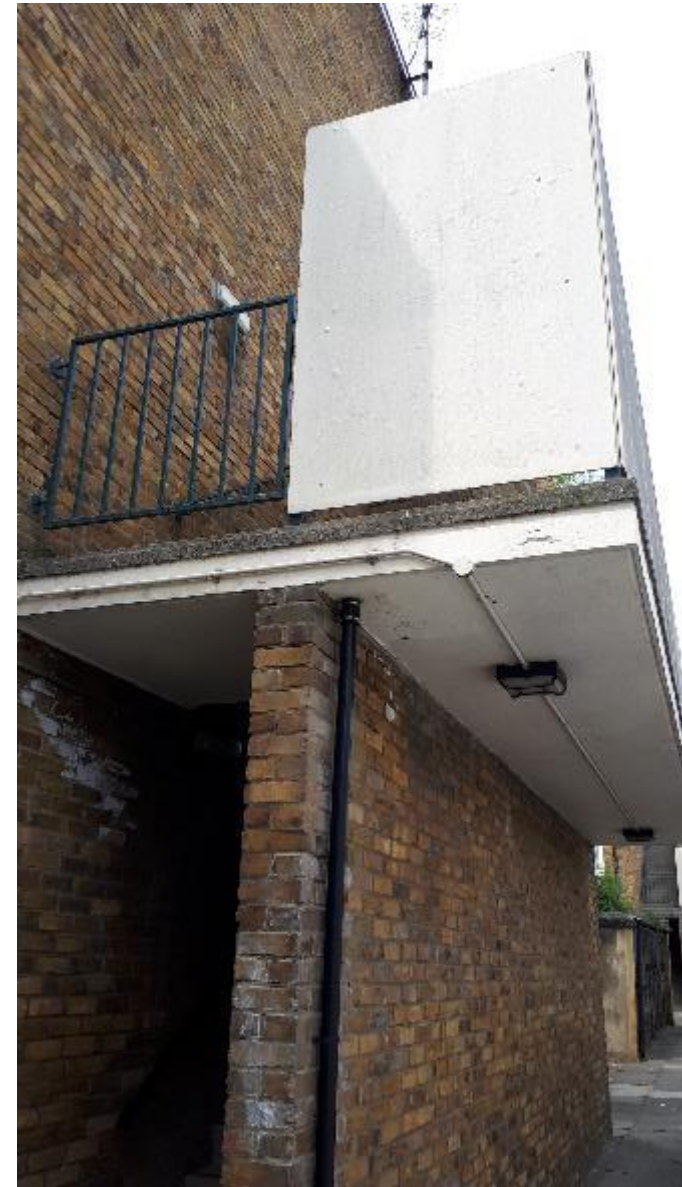
Photo 108. As on other Blocks, failing decorations to stairs nearest railway.

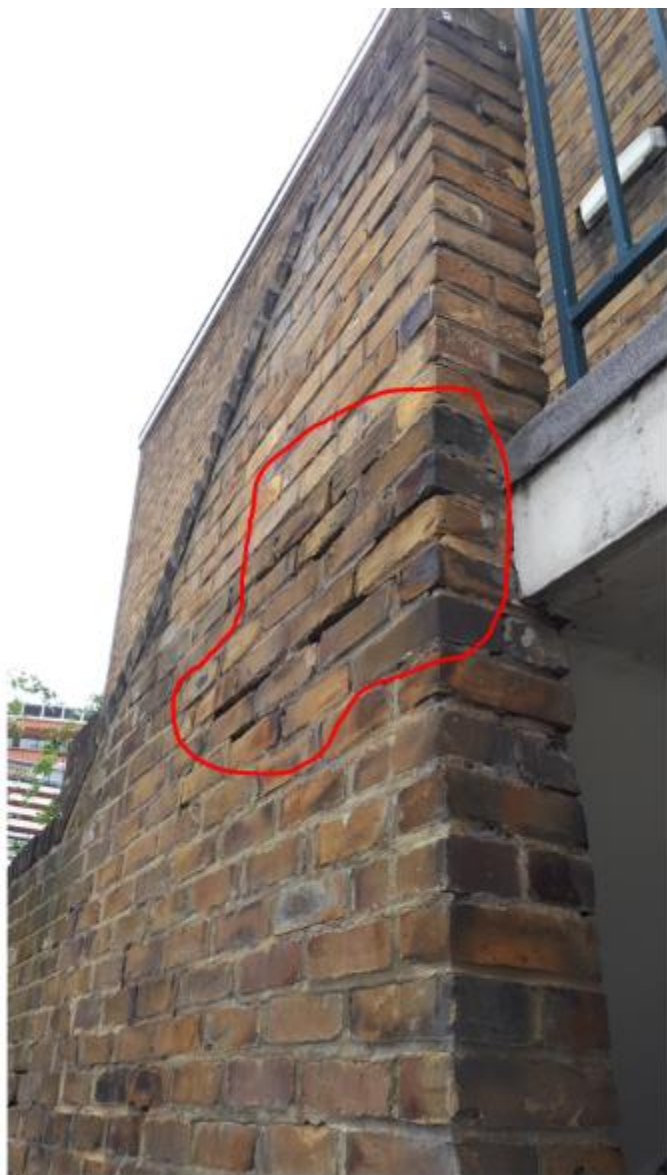
Photo 109. Same stairs and as on other Blocks the pointing is defective.

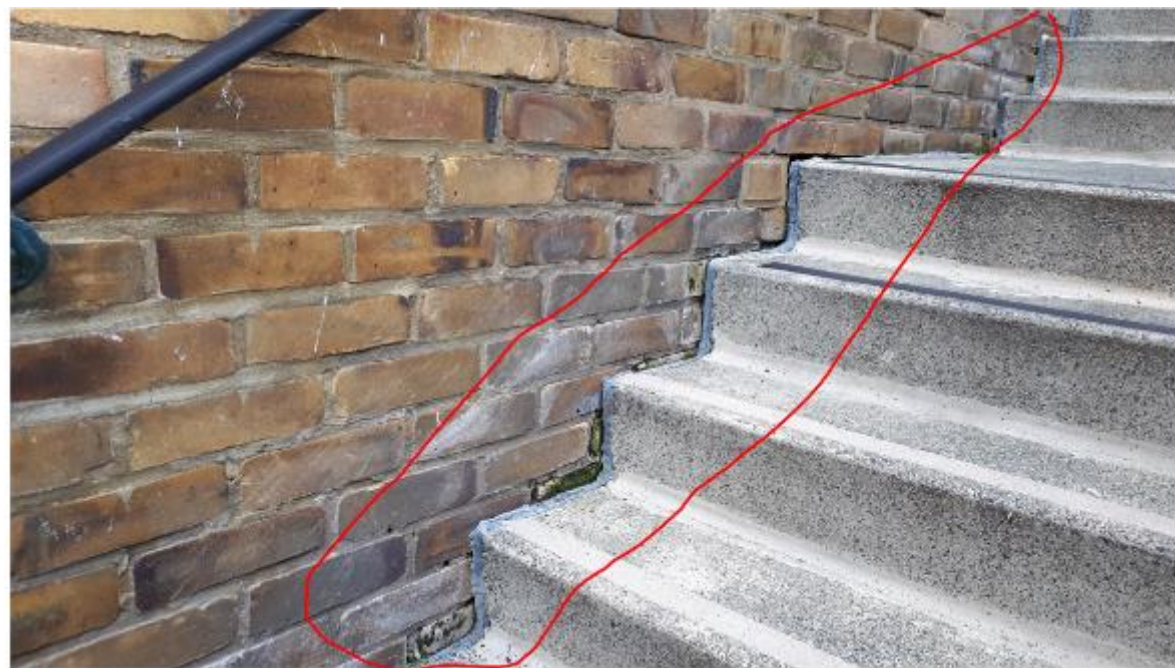
Photo 110. Same stairs, see previous attempt at making good joint between steps and brickwork.

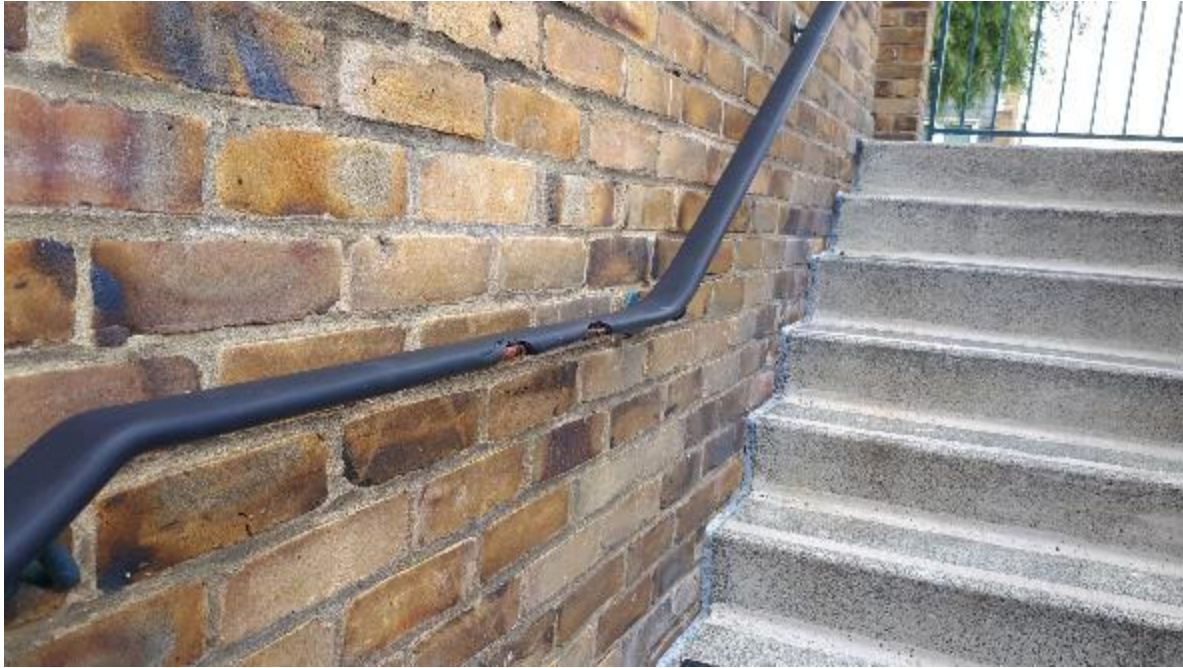
Photo 111. As on another Block, the handrail grip is defective.

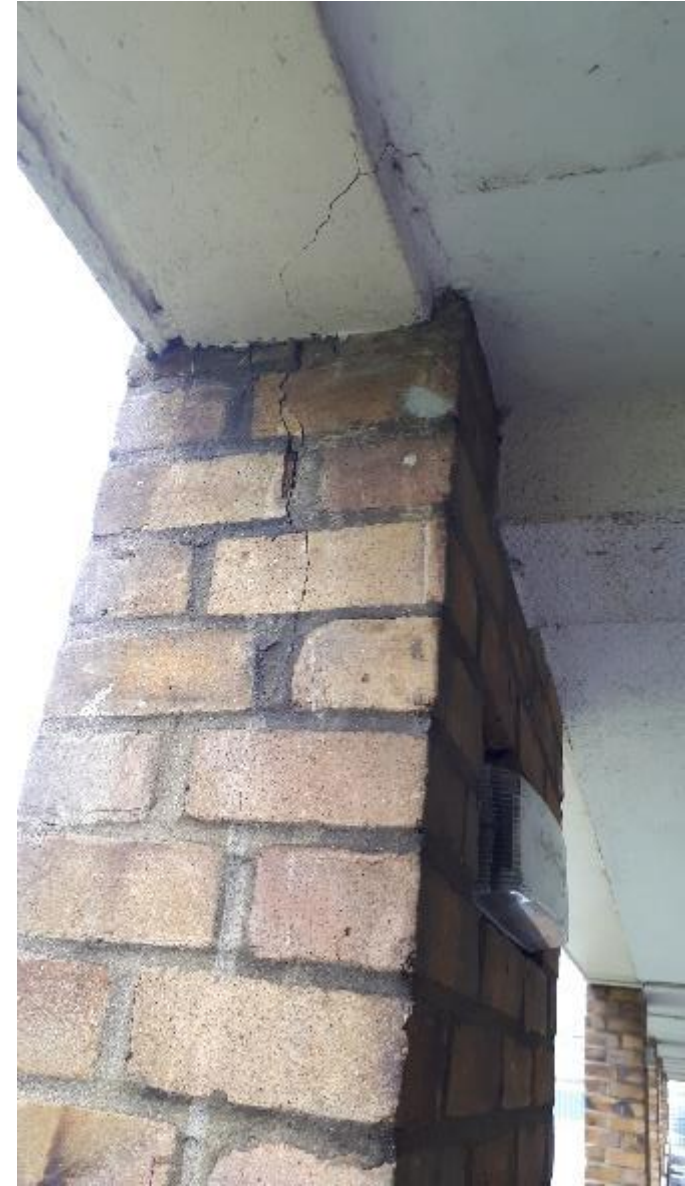
Photo 112. As on other Blocks, here on Wimborne the brickwork walkway pillar is cracked.

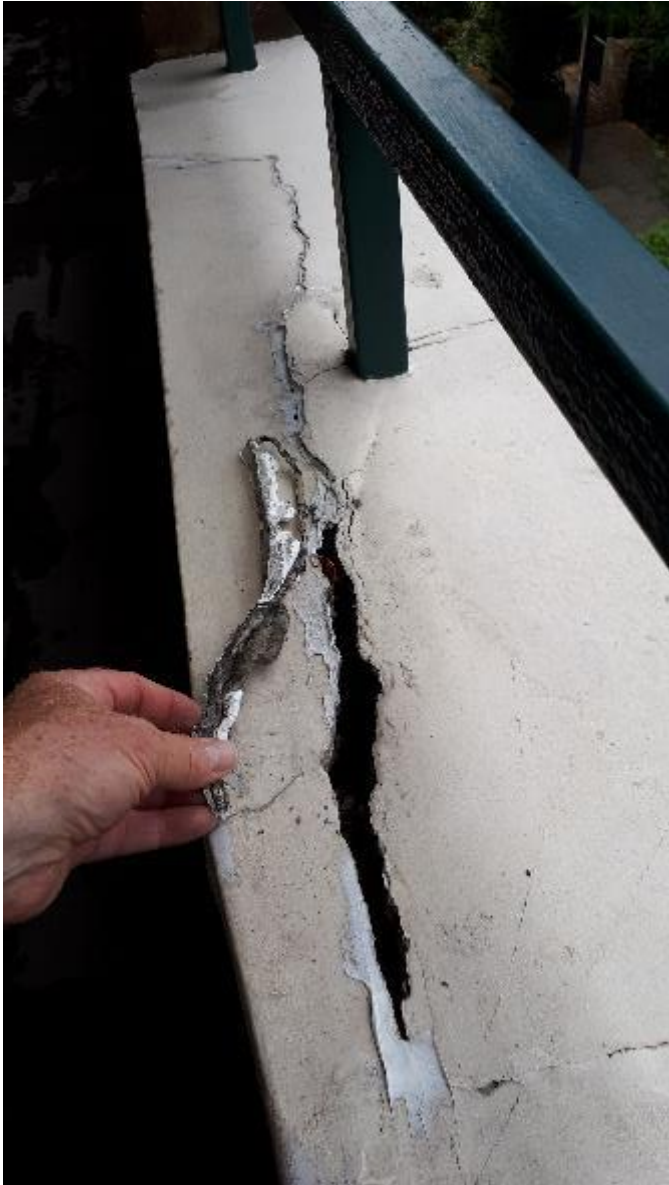
Photo 113. As on other Blocks the walkway copings are defective, here the cracking has been filled with mastic.

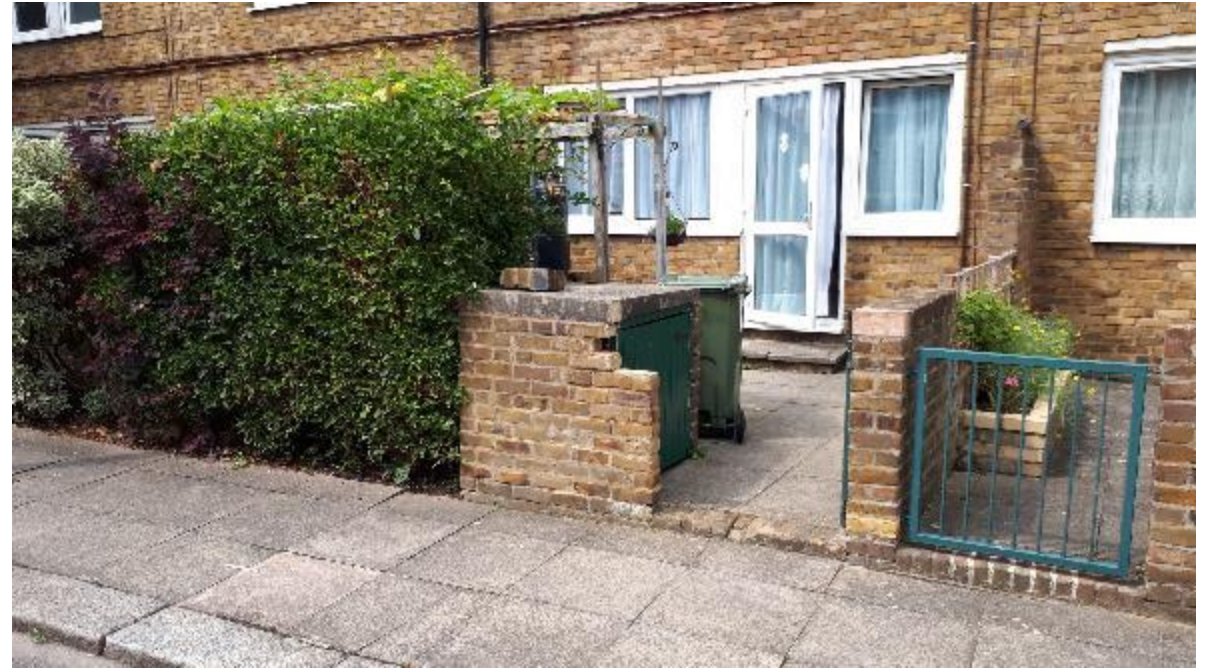
Photo 114. As elsewhere, the private garden boundary walls at Wimborne Hse are defective.

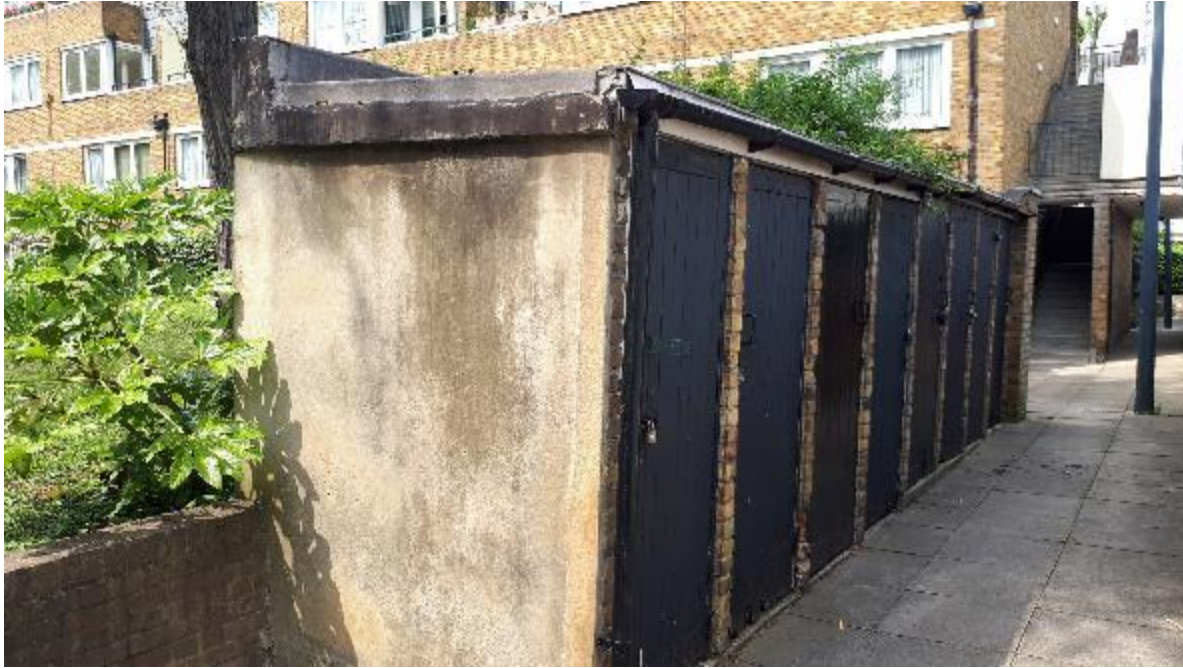
Photo 115. One of two pram sheds requiring attention.

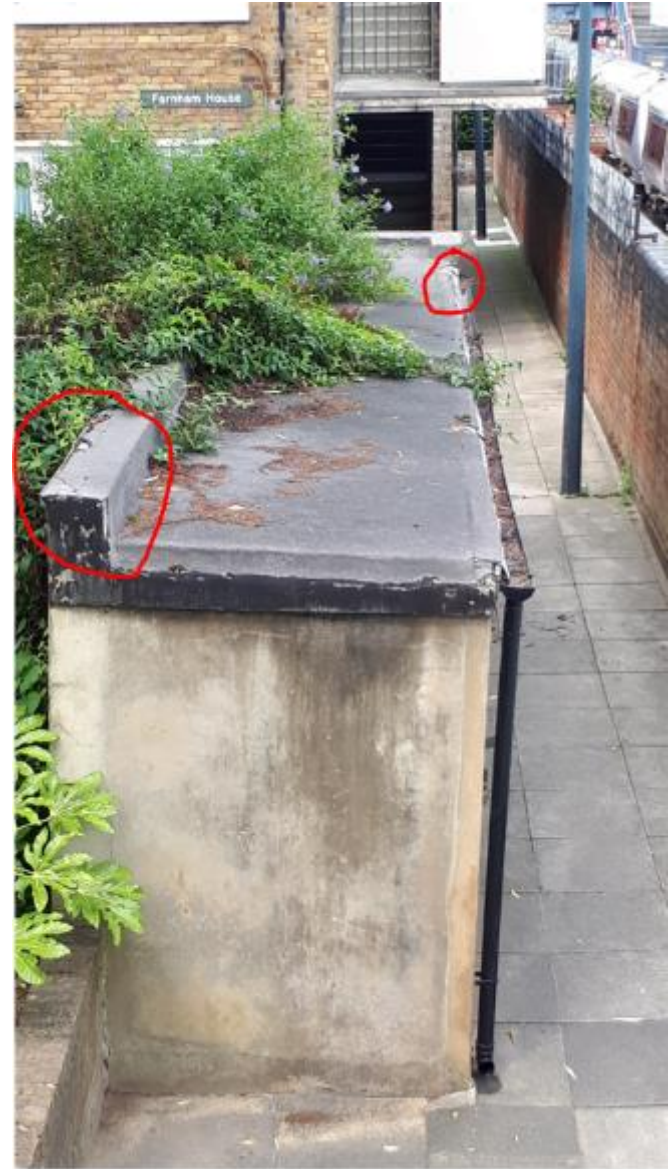
Photo 116. Same pram shed with defective mastic asphalt roof covering.

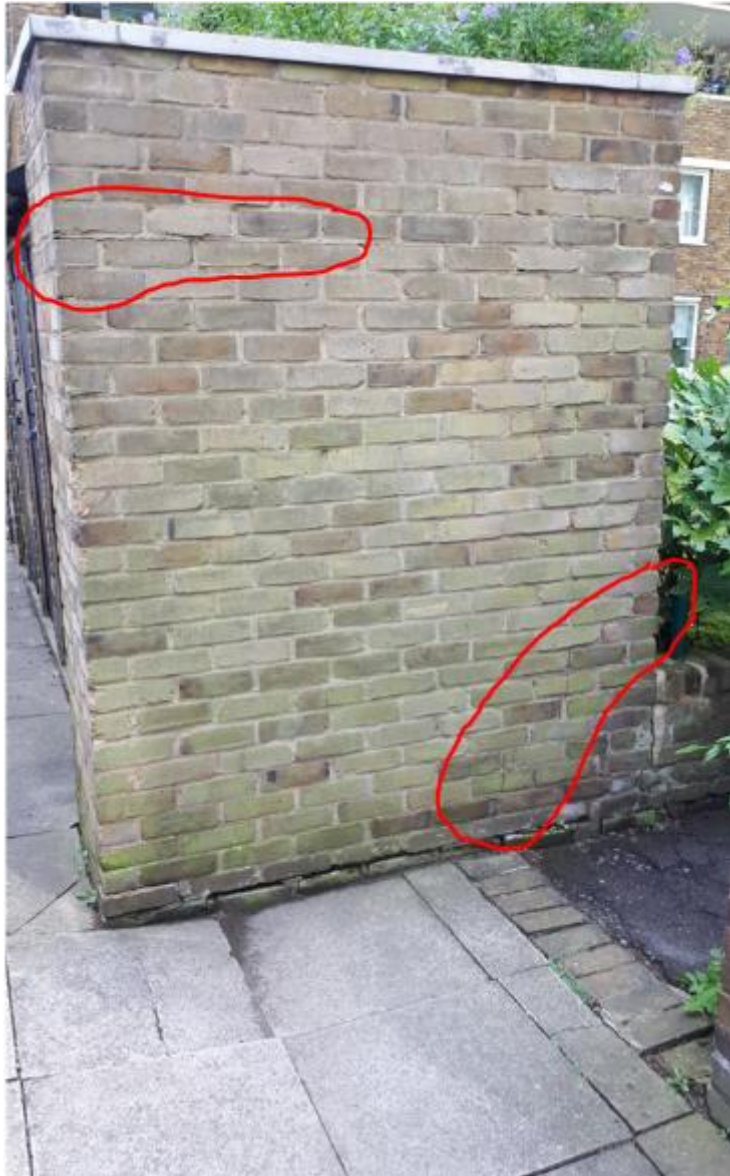
Photo 117. Same pram shed showing need for localised repointing of brickwork, any hairline stepped cracking considered to be of minor significance.

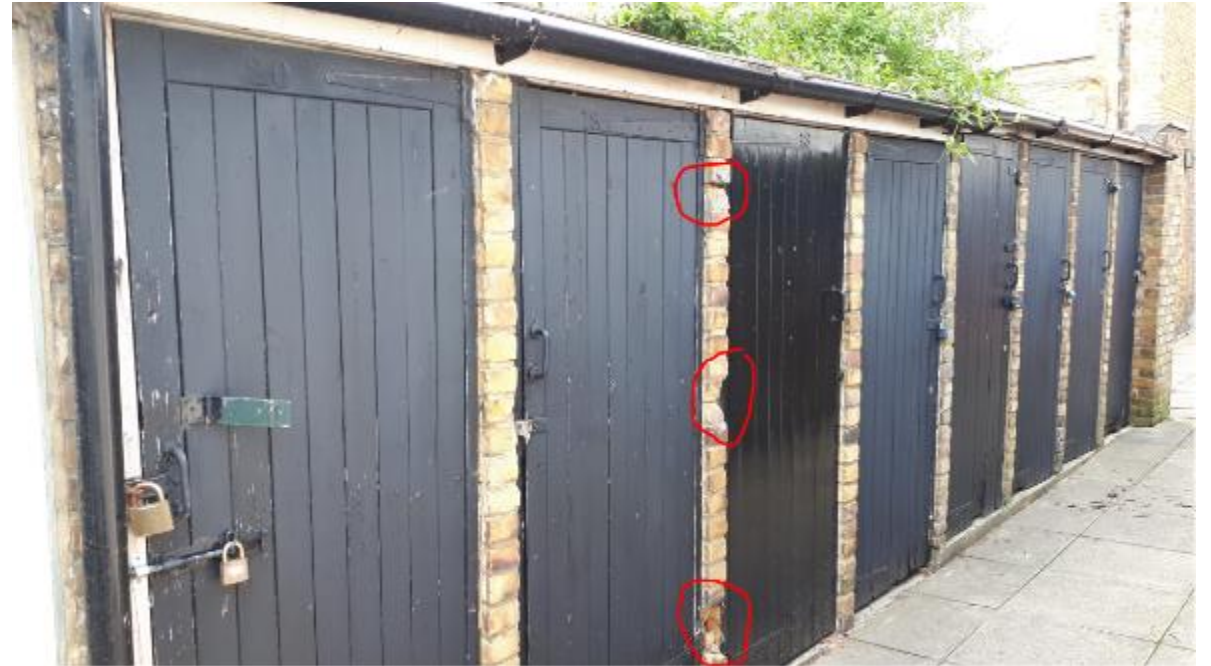
Photo 118. Pram shed brickwork and joinery repairs required as well as redecoration.

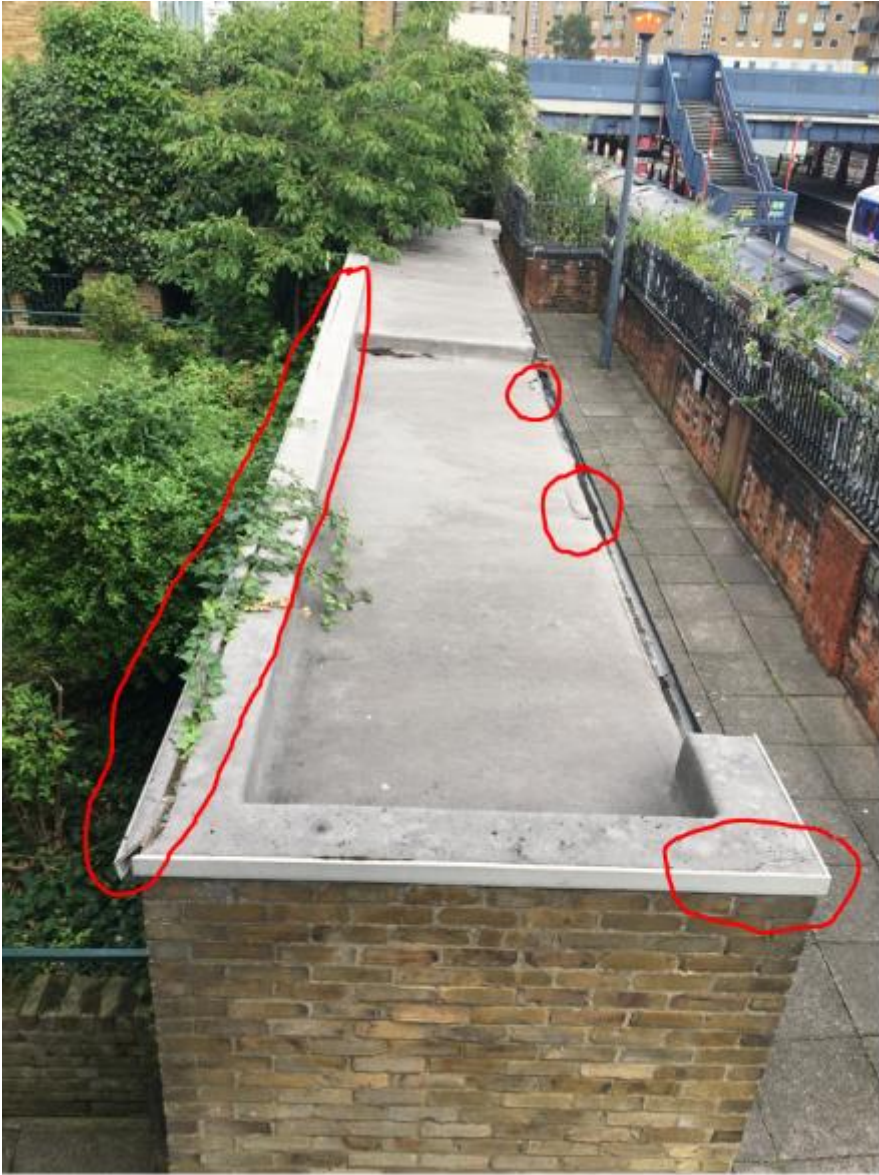
Photo 119. Second pram shed with defective mastic asphalt roof covering.

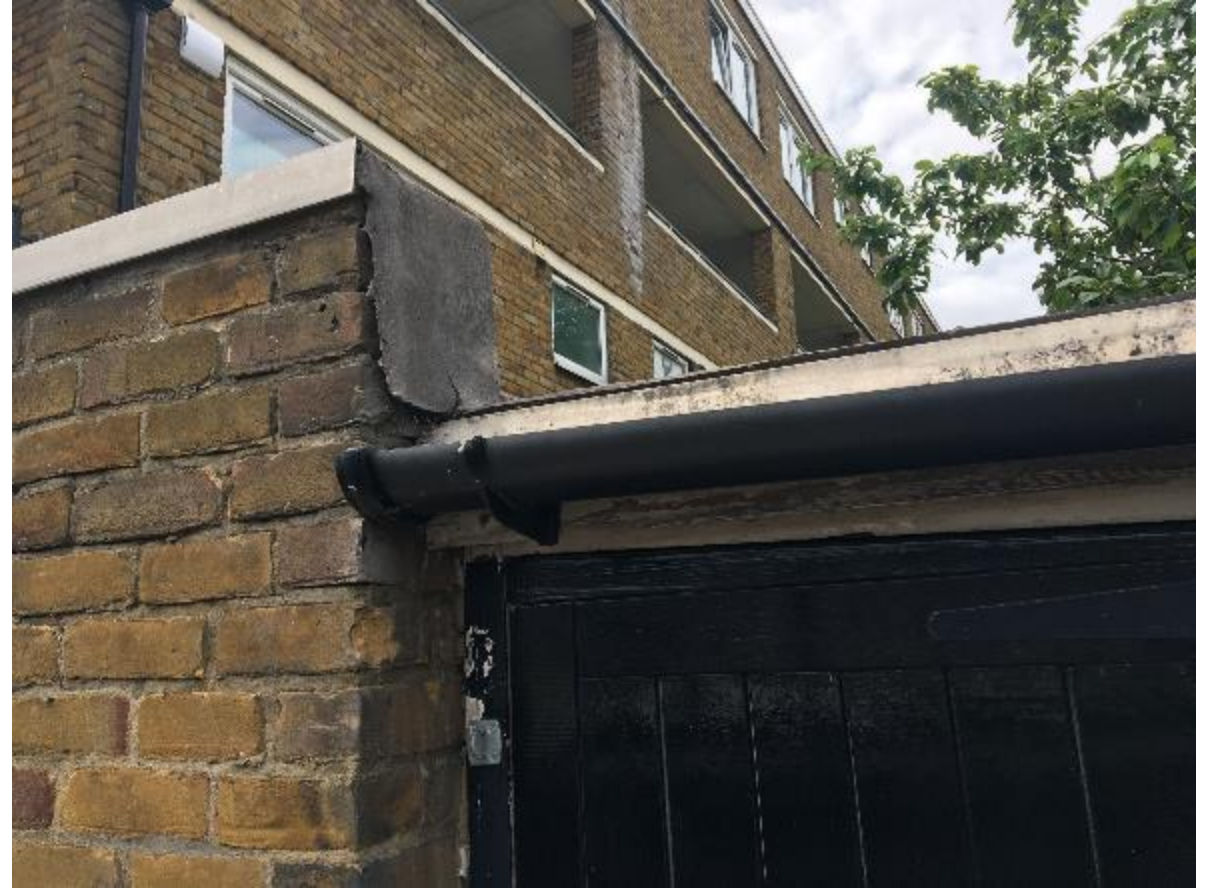
Photo 120. Second pram shed again showing defective mastic asphalt covering.

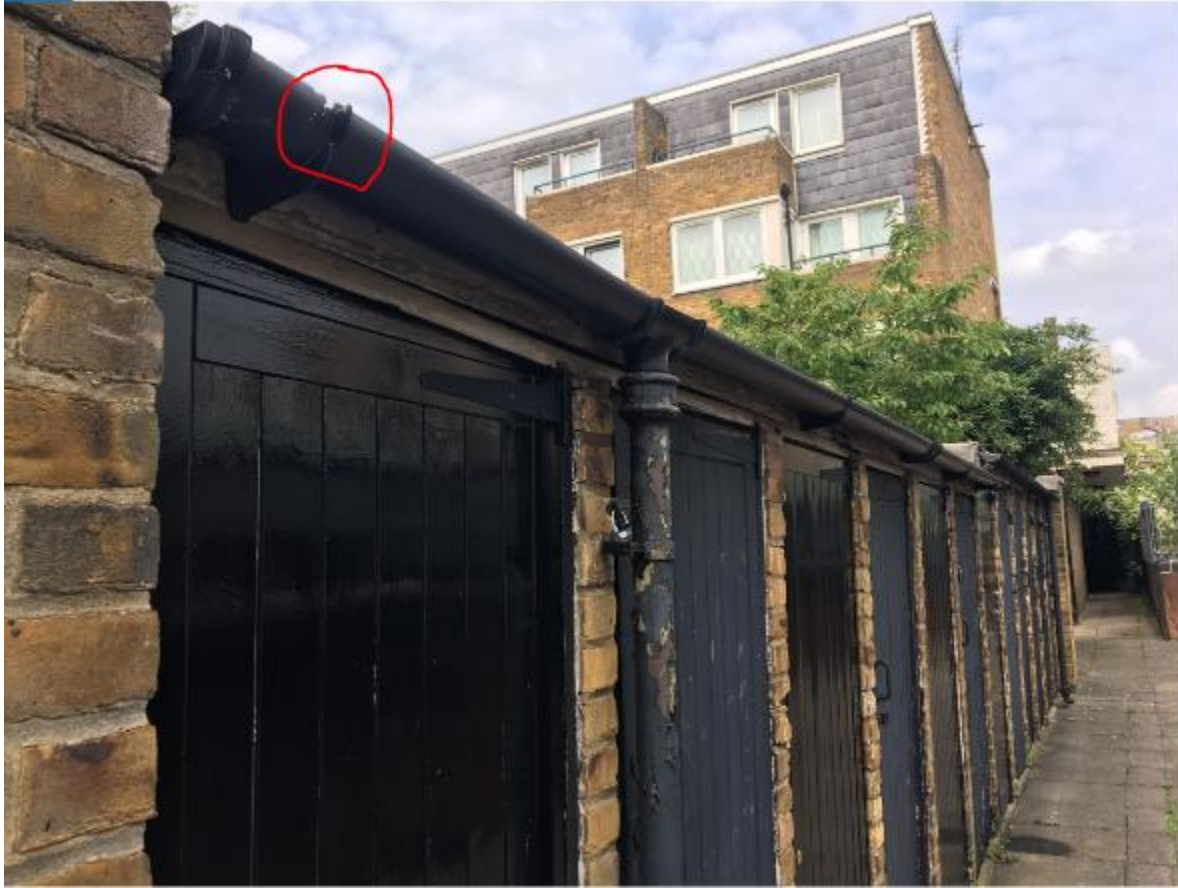
Photo 121. Second pram shed with defective PVCu guttering and failed paintwork to timber fascia and cast-iron downpipe.

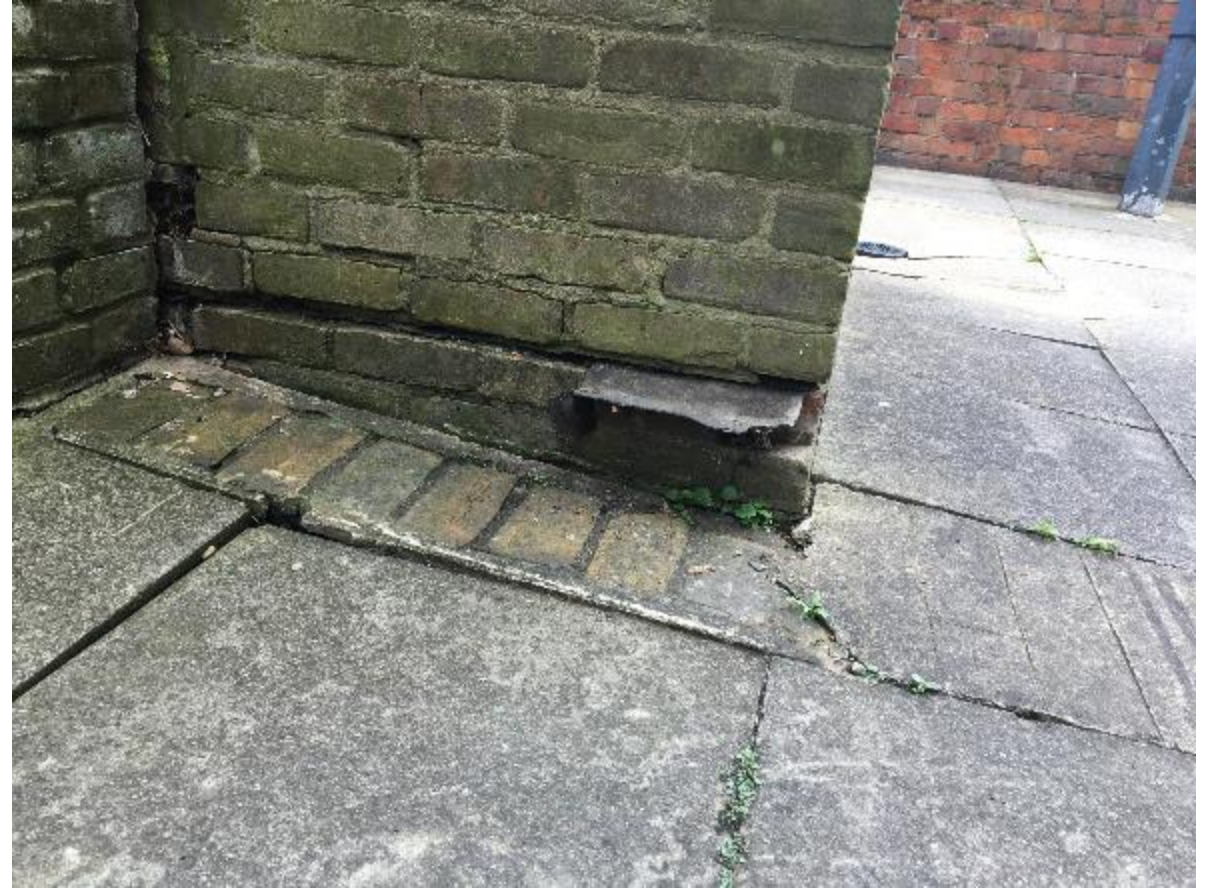
Photo 122. Second pram shed with defective DPC.

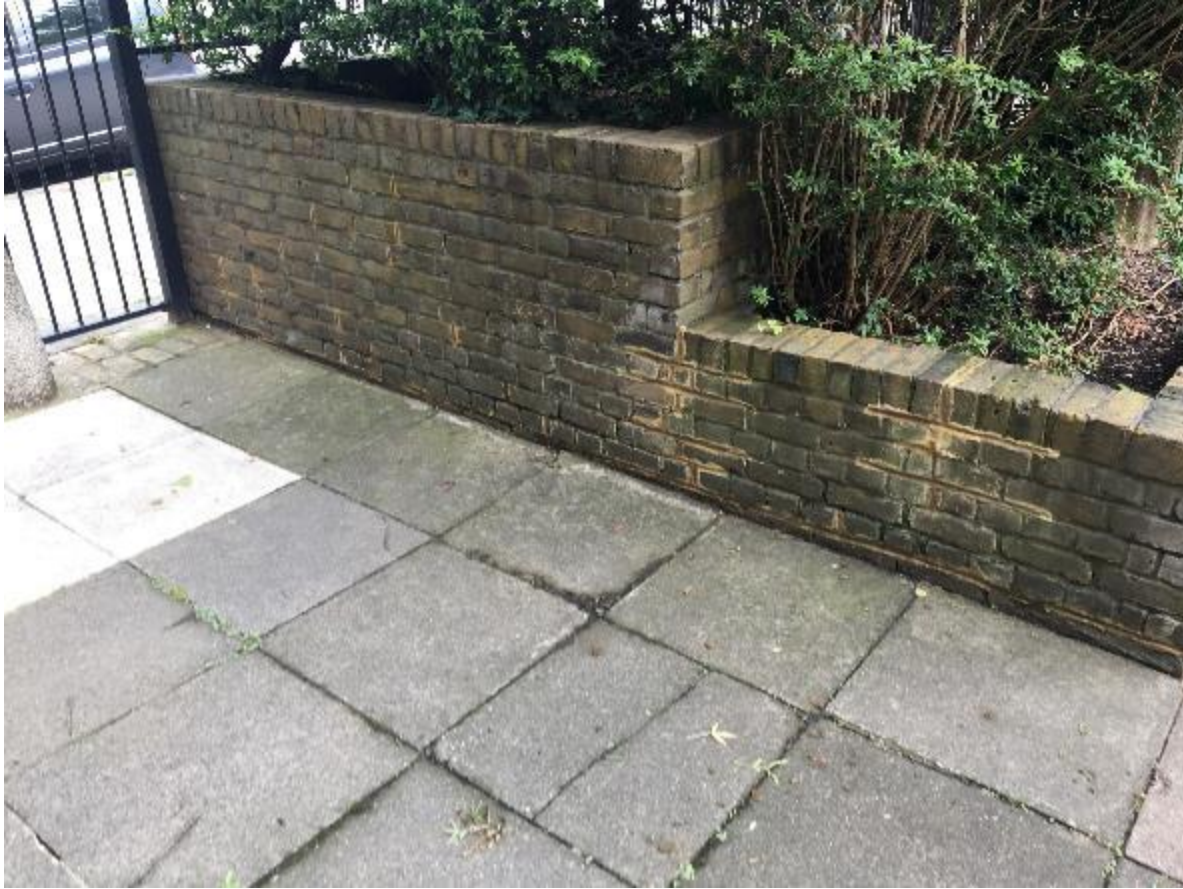
Photo 123. Retaining walls to raised beds showing evidence of previous brickwork repointing although there is more still to do.

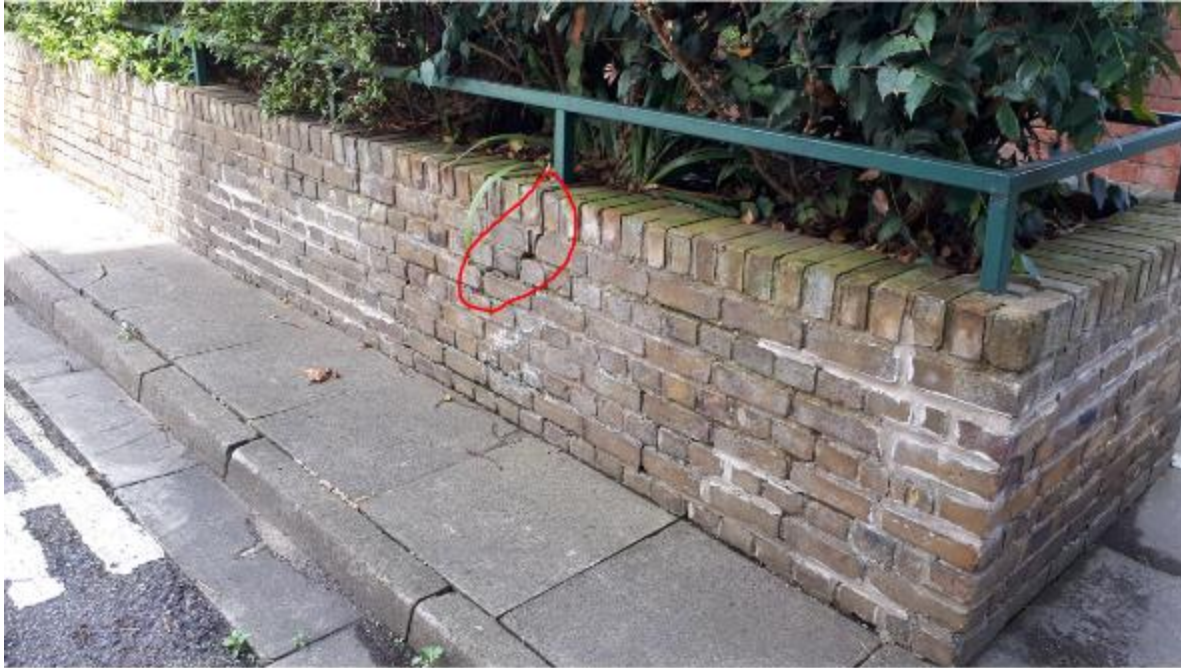
Photo 125. Again, showing retaining walls to raised beds and evidence of previous repointing although there is more still to do. Repointing as and when required is probably the most inexpensive and practical way of tackling the ongoing problem of movement cracking as trees and shrubs continue to grow; that and seasonal cutting back of vegetation and lopping of trees. The use of HeliBars could simply shift the cracking to elsewhere along the walls.

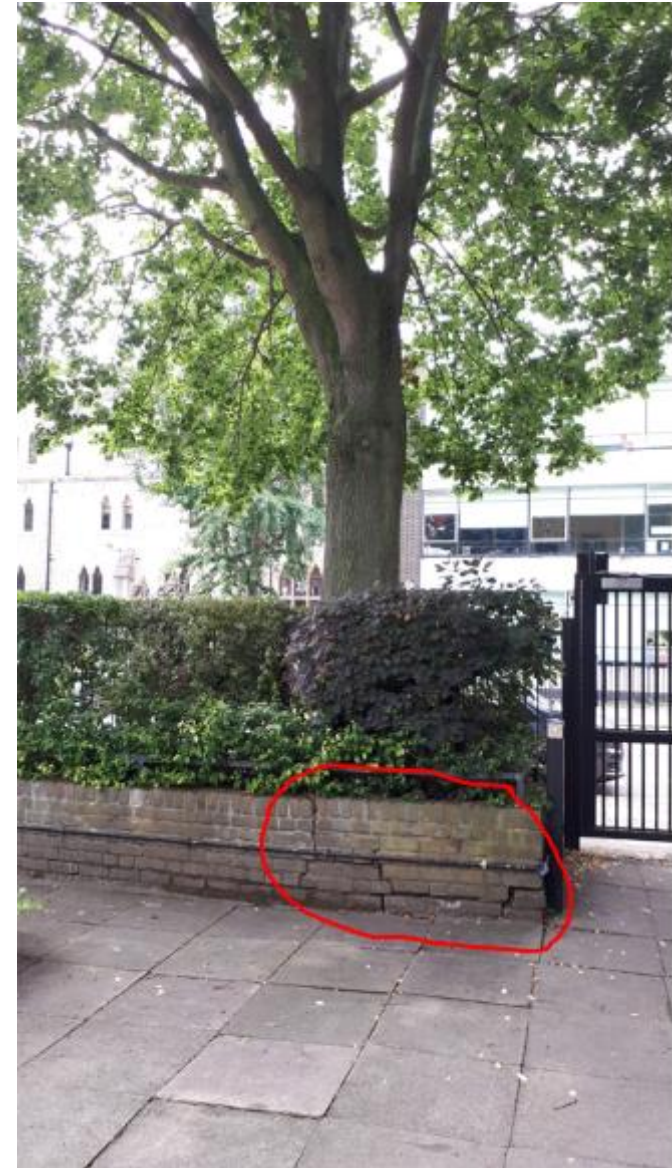
Photo 126. As elsewhere across the Estate, there is little else that can be done other than to keep repointing and re-bedding bricks as well as lop trees, those to public footpaths are assumed to have Preservation Orders.
