**Blandford Estate
Harewood Avenue
London
NW1**

Client Ref: Y100 – Blandford Estate

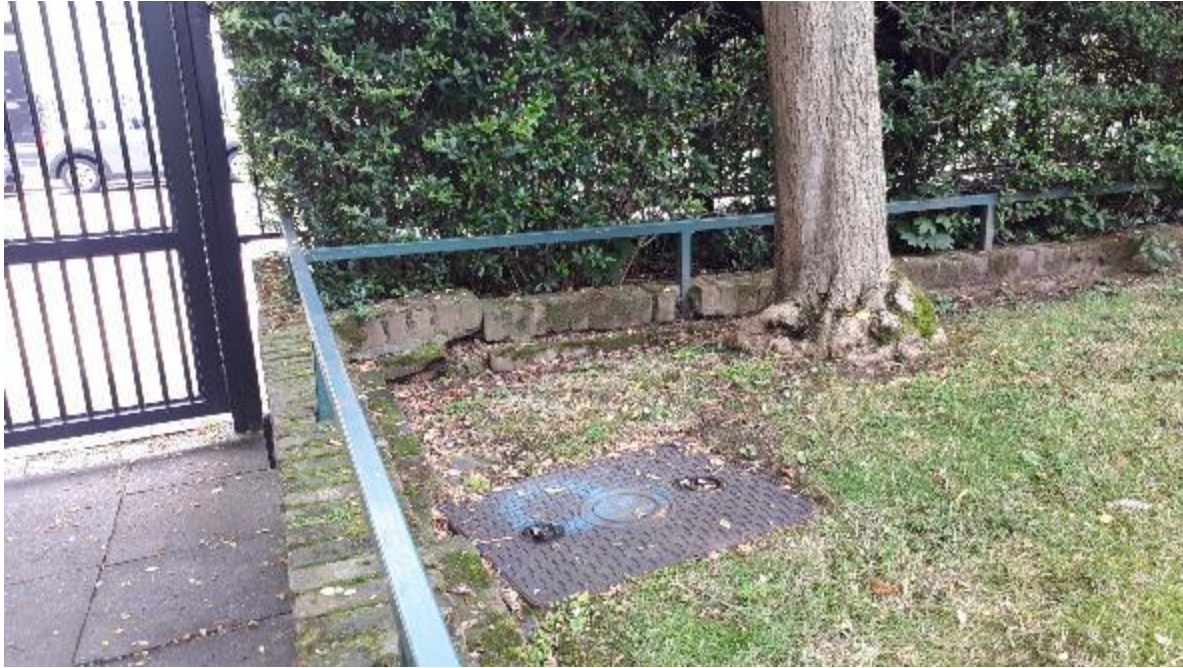
Photo 127. Here one would have to either re-bed the displaced brickwork or demolish the wall as there is a boundary wall behind it. What is a concern, is likely tree root damage to below ground drainage.

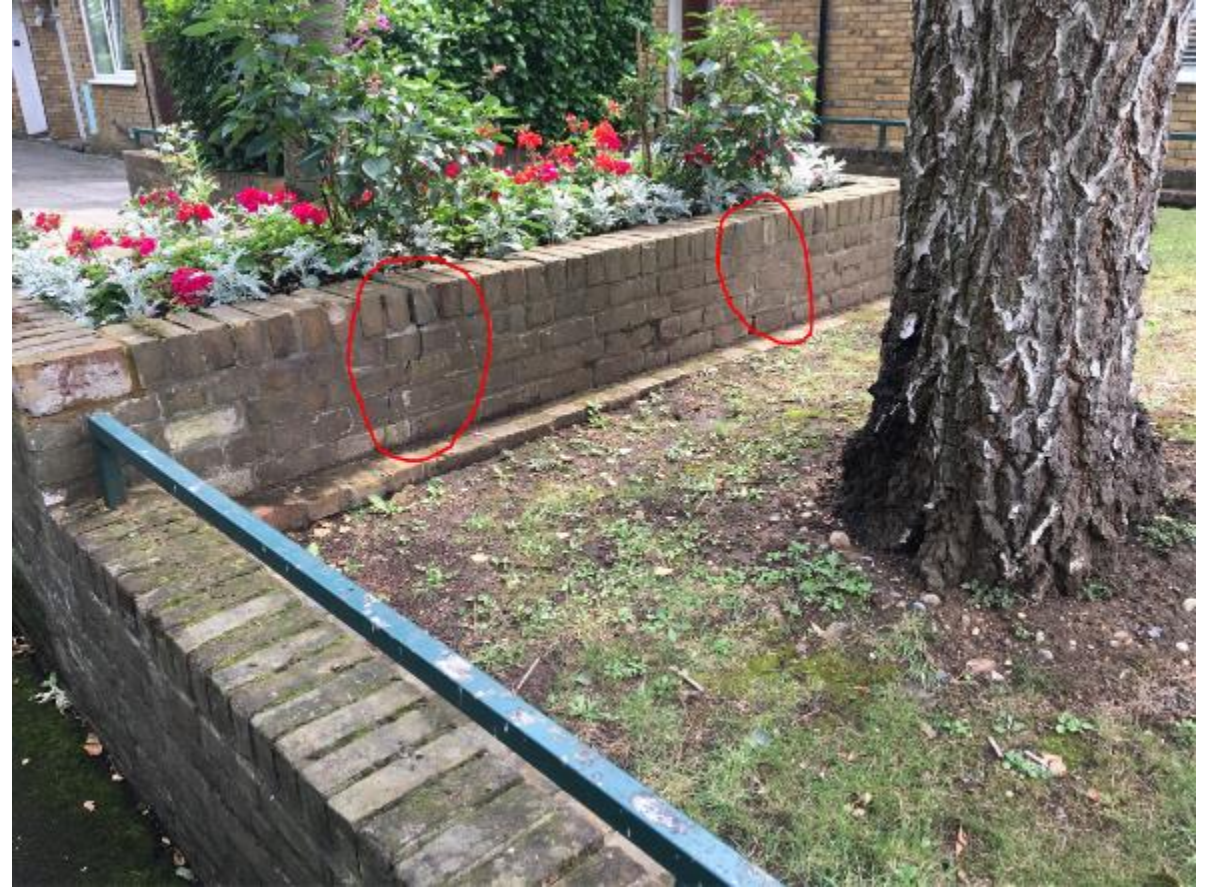
Photo 128. Simply repointing as and when required is probably the most inexpensive and practical way of tackling the ongoing problem of movement cracking. The use of HeliBars could simply shift the cracking elsewhere along the walls.

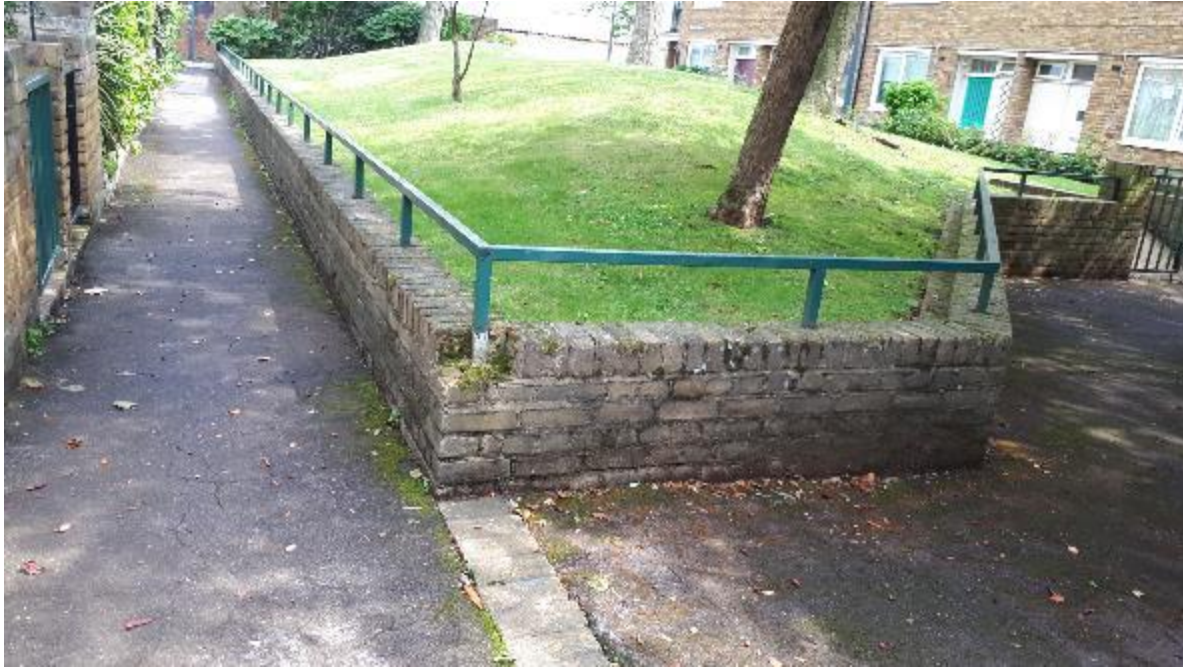
Photo 129. A simple case of replacing a missing brick however, the wall mounted rail needs repainting.

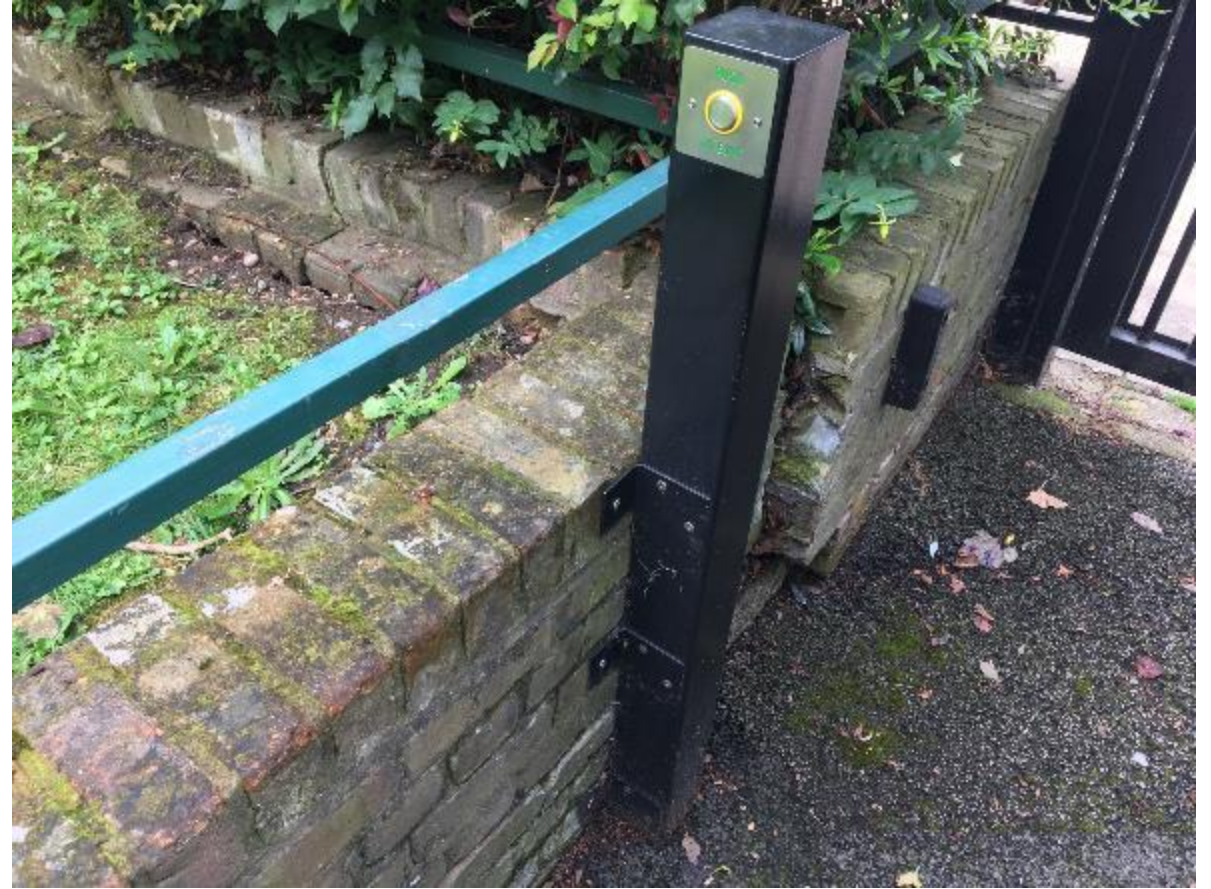
Photo 130. An example of just how much the retaining walls have been displaced.

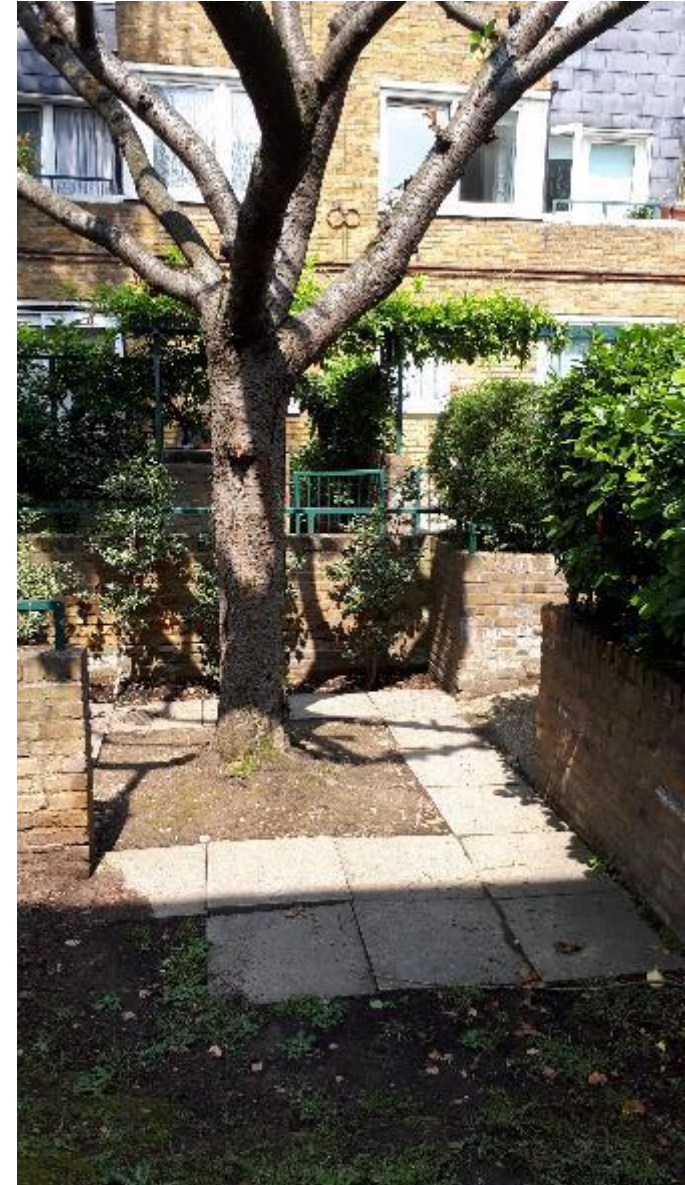
Photo 134. Paving slab heave caused by roots despite tree being lopped, in this case it would be better to replace the paving for grass.

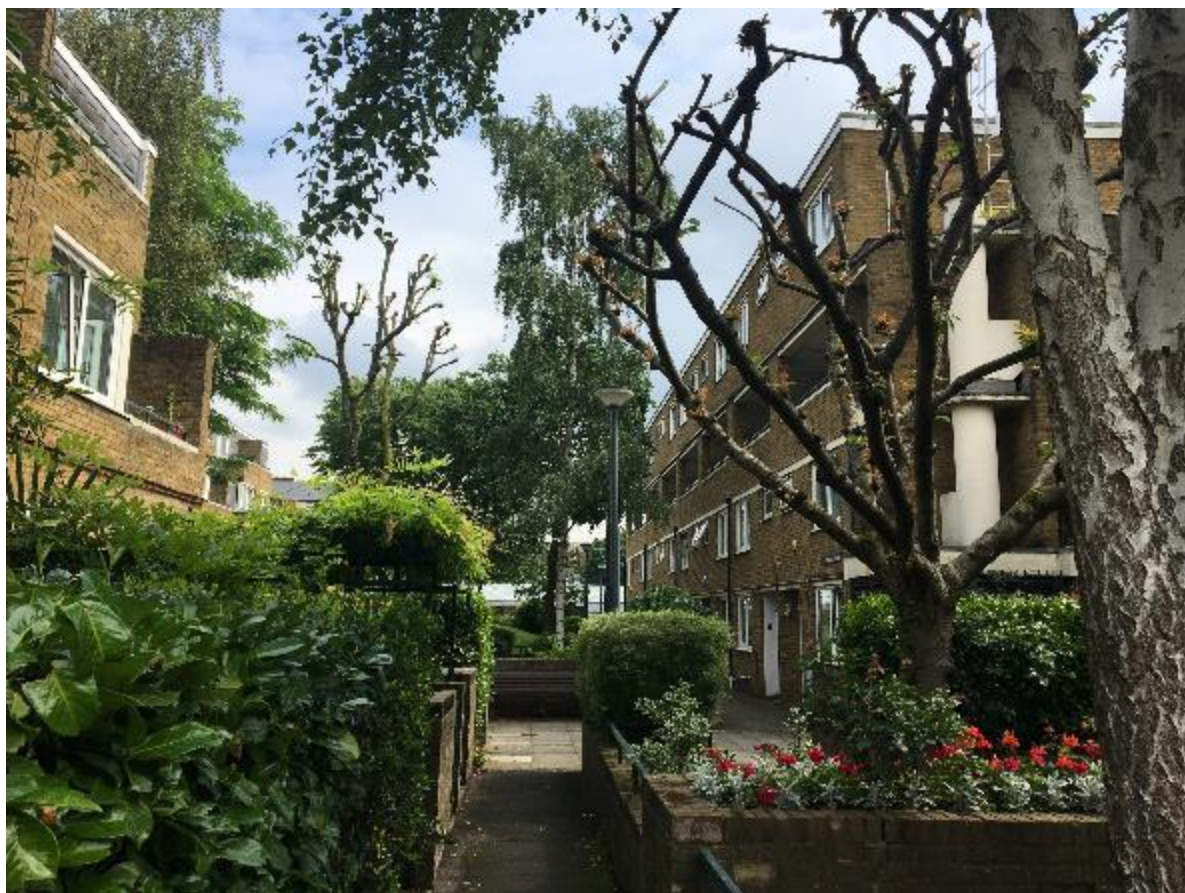
Photo 135. General shot of the Estate's mature trees, certain species can withstand seasonal lopping.

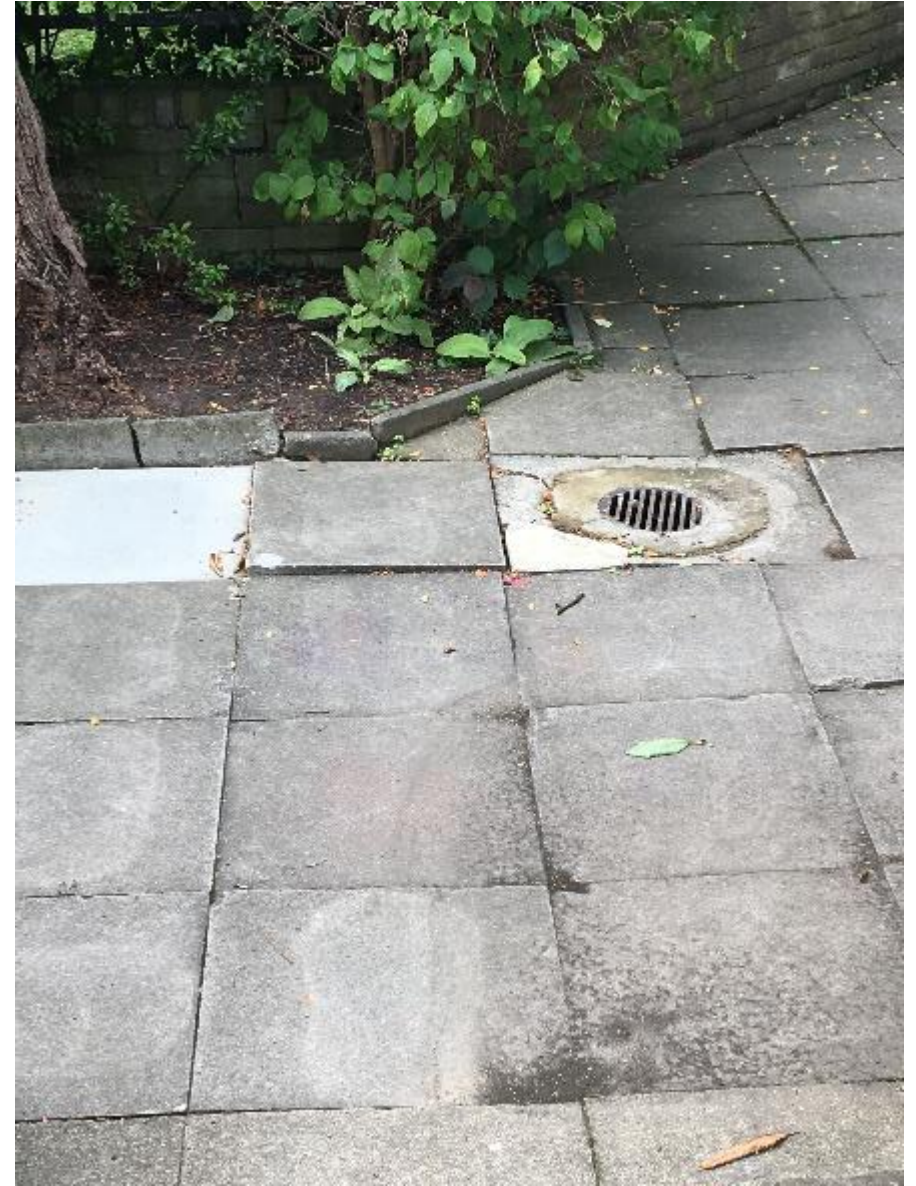
Photo 142. As previous photo but with possible drainage damage.

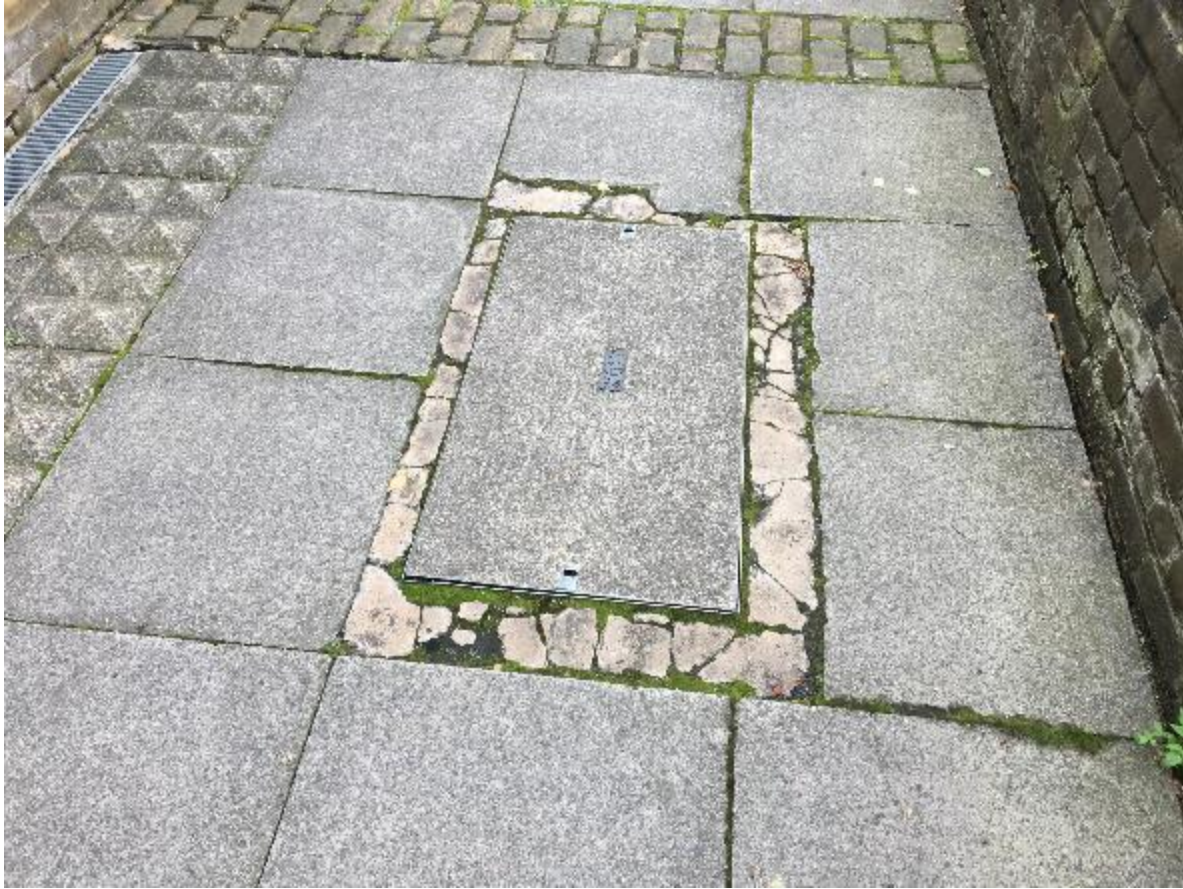
Photo 143. Inspection chamber frame needs re-flaunching.

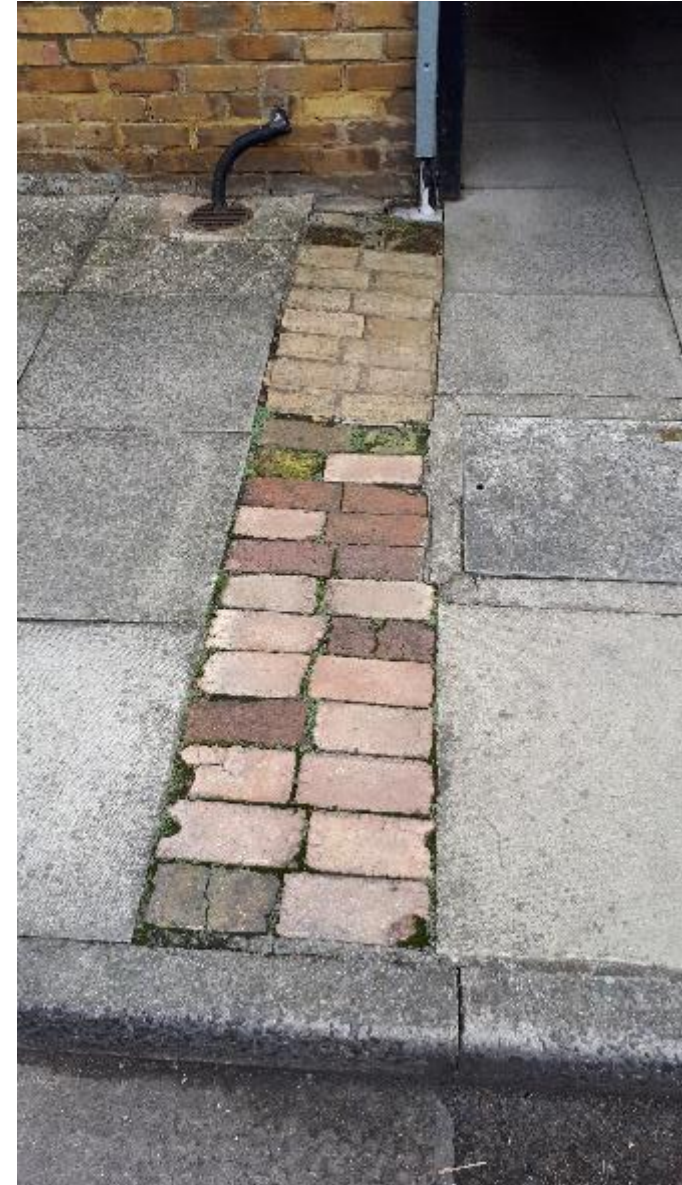
Photo 144. Interesting detail, bricks more susceptible to wear than pavers

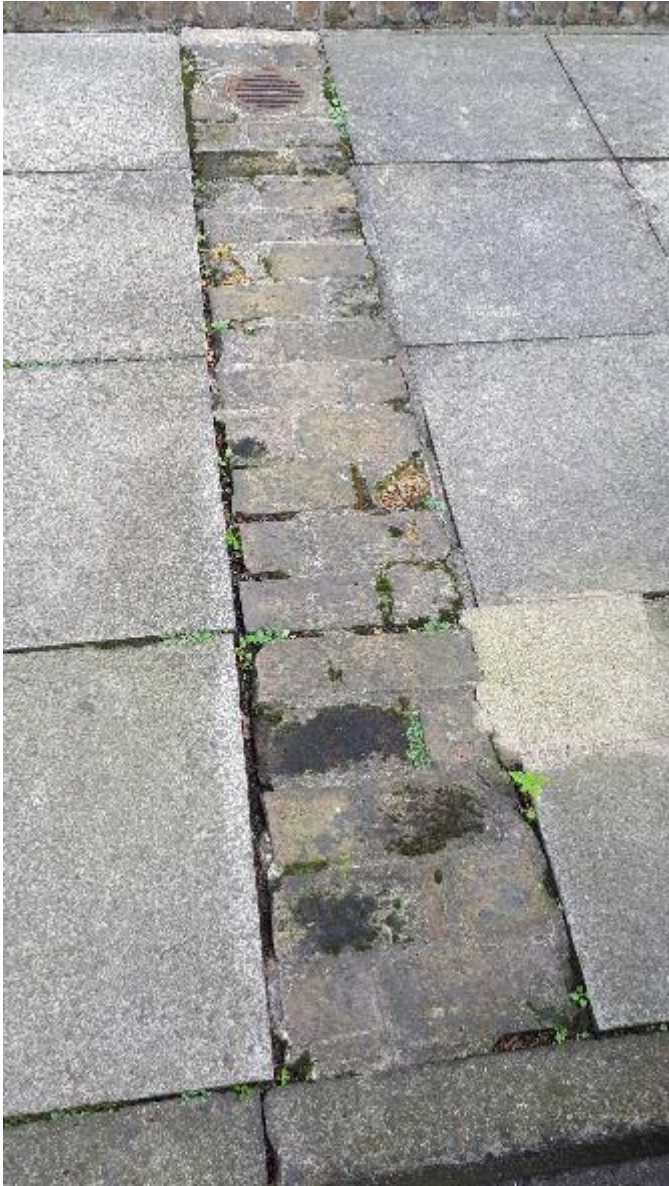
Photo 145. As previous photo.

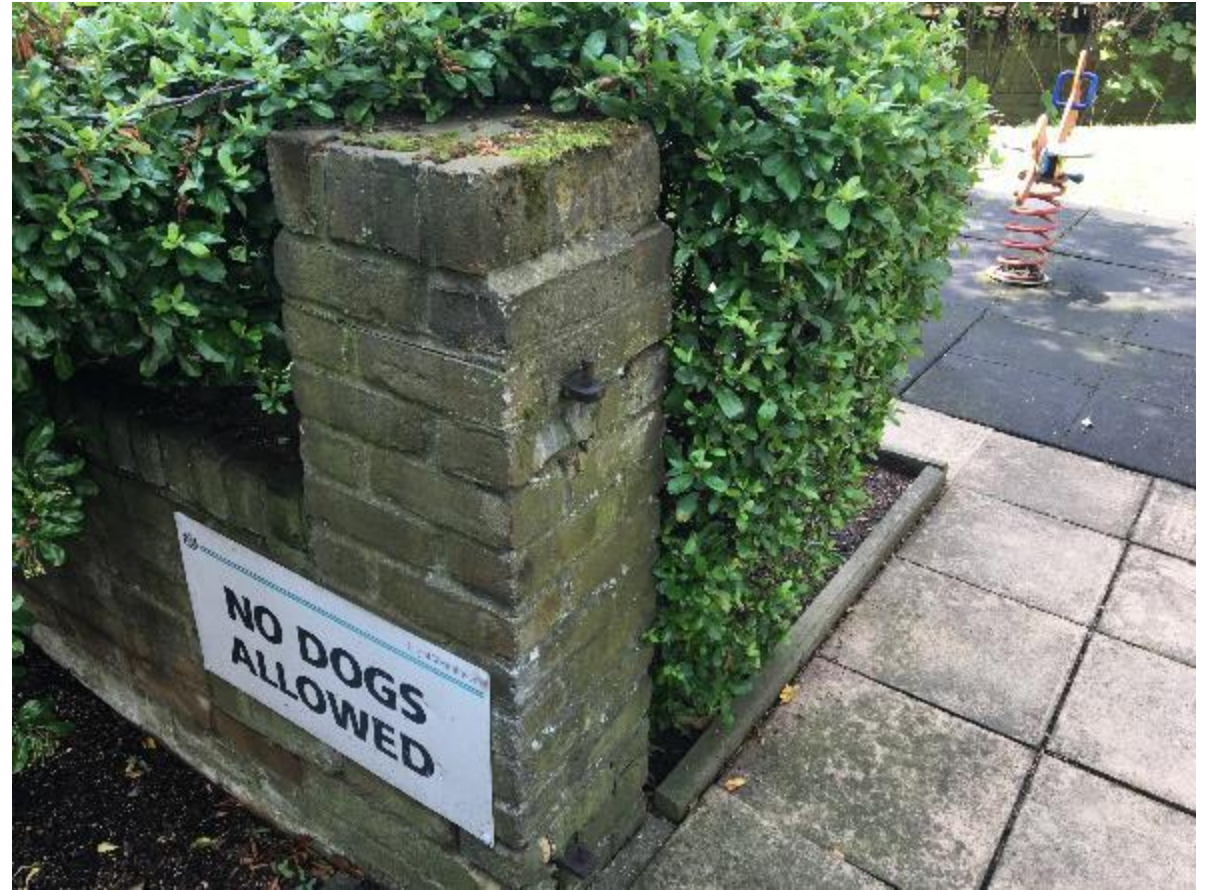
Photo 146. Gate missing from play area.

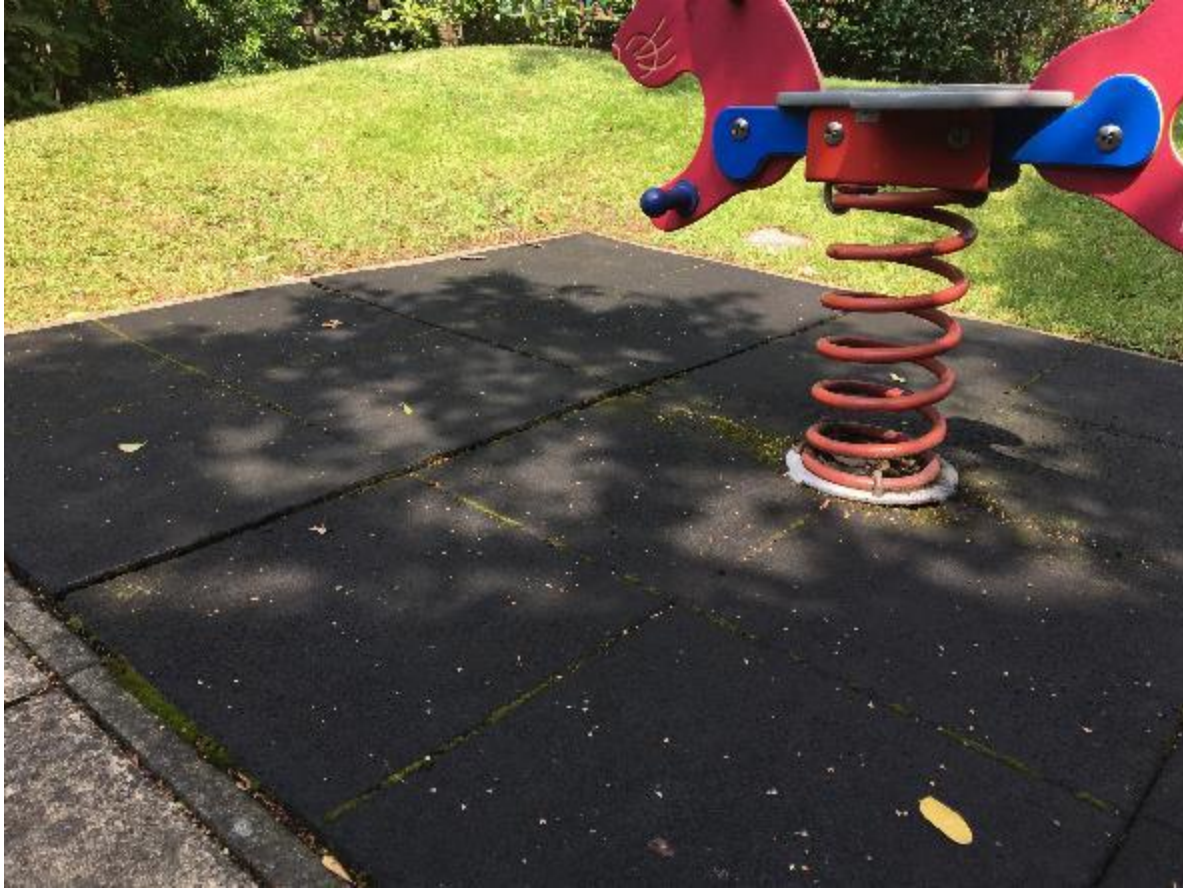
Photo 147. Edges of rubber matting lifting.

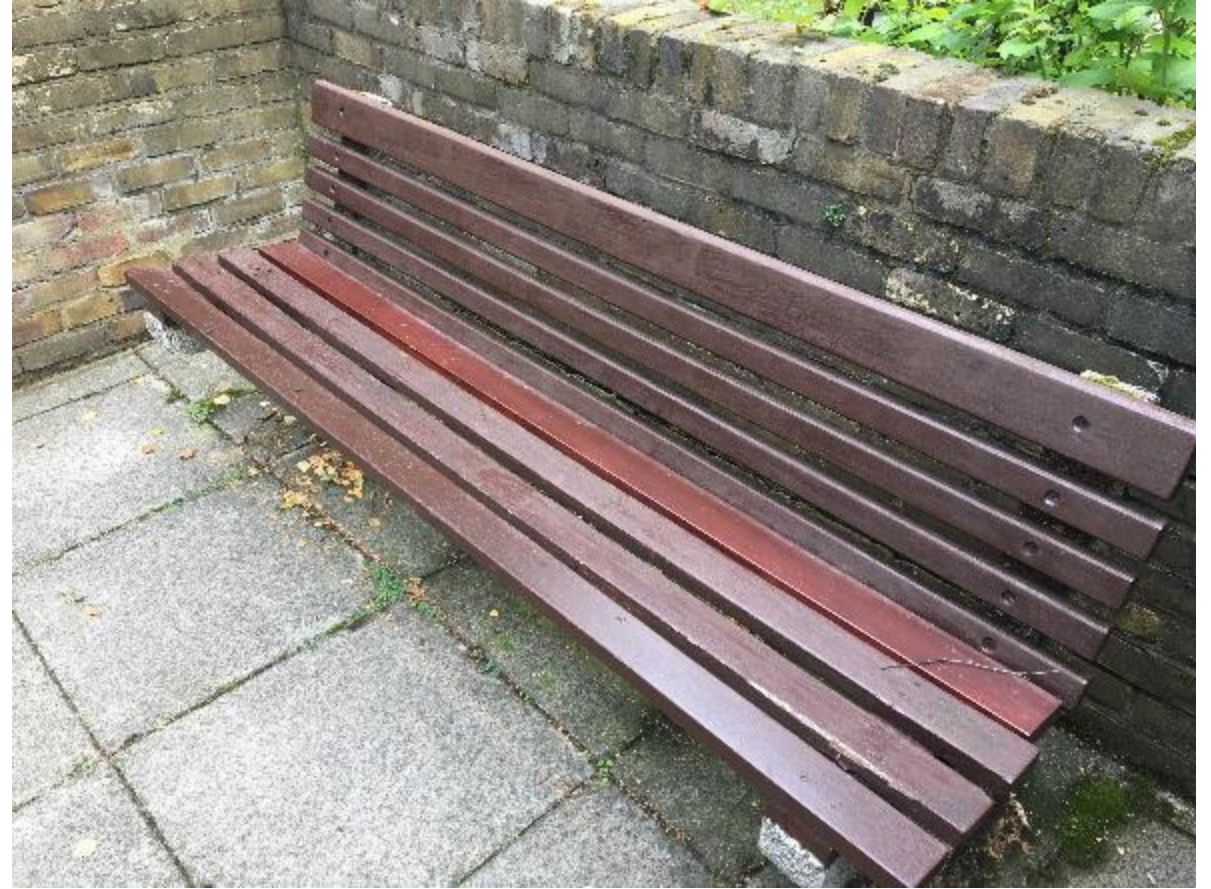
Photo 148. Decorations to bench starting to fail.

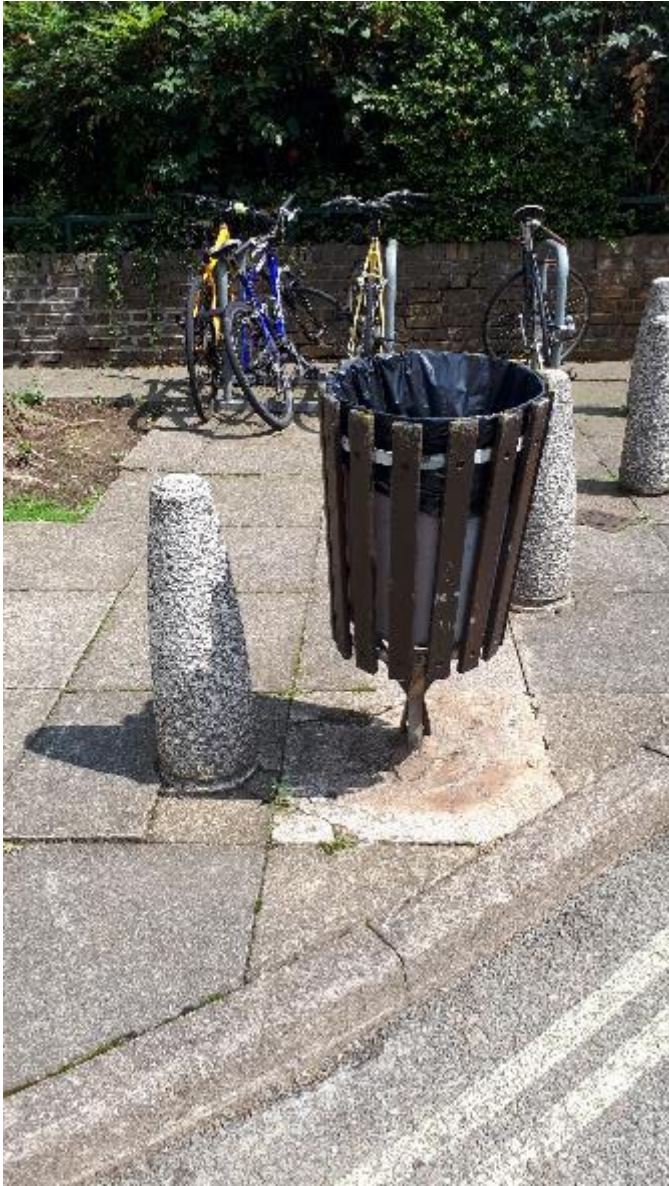
Photo 149. Decorations to litter bin failing.

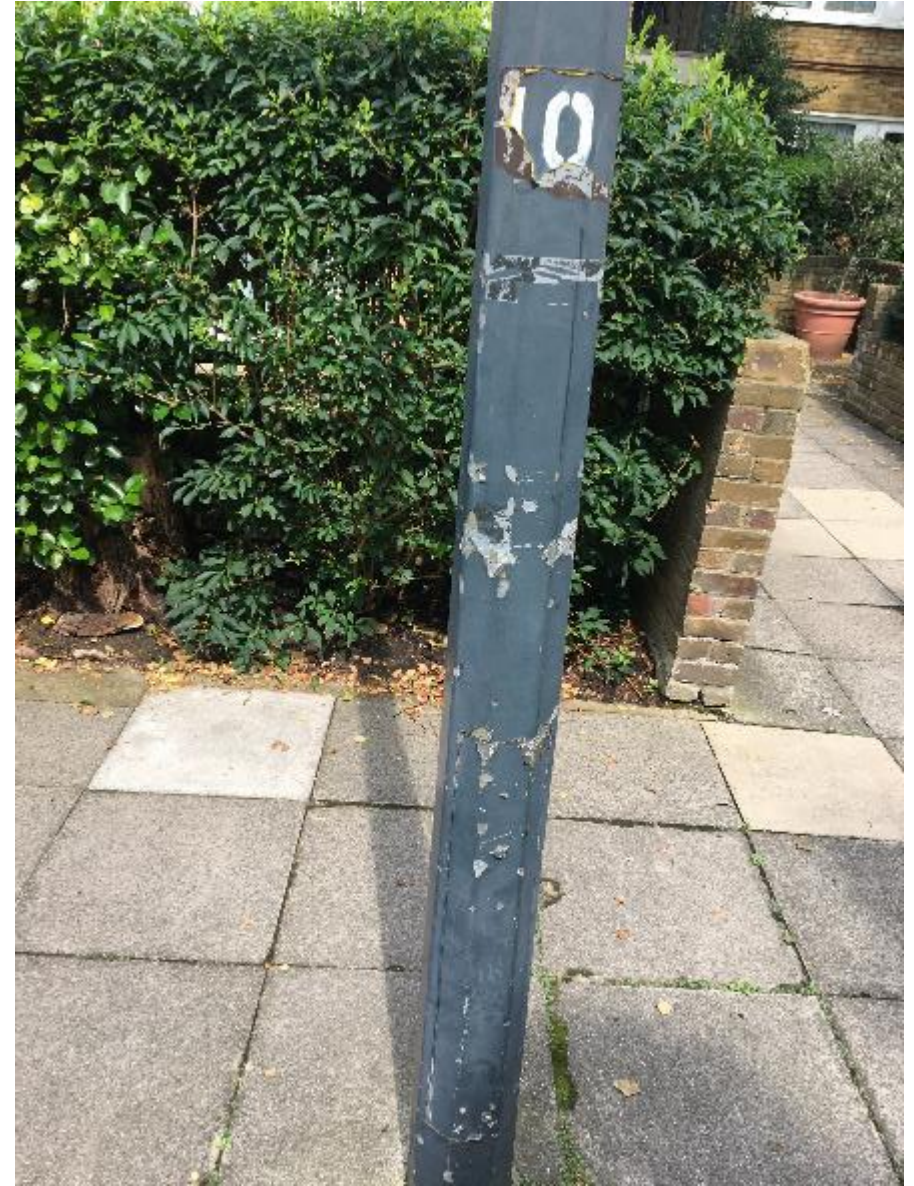
Photo 150. Paintwork to lamp post failing.

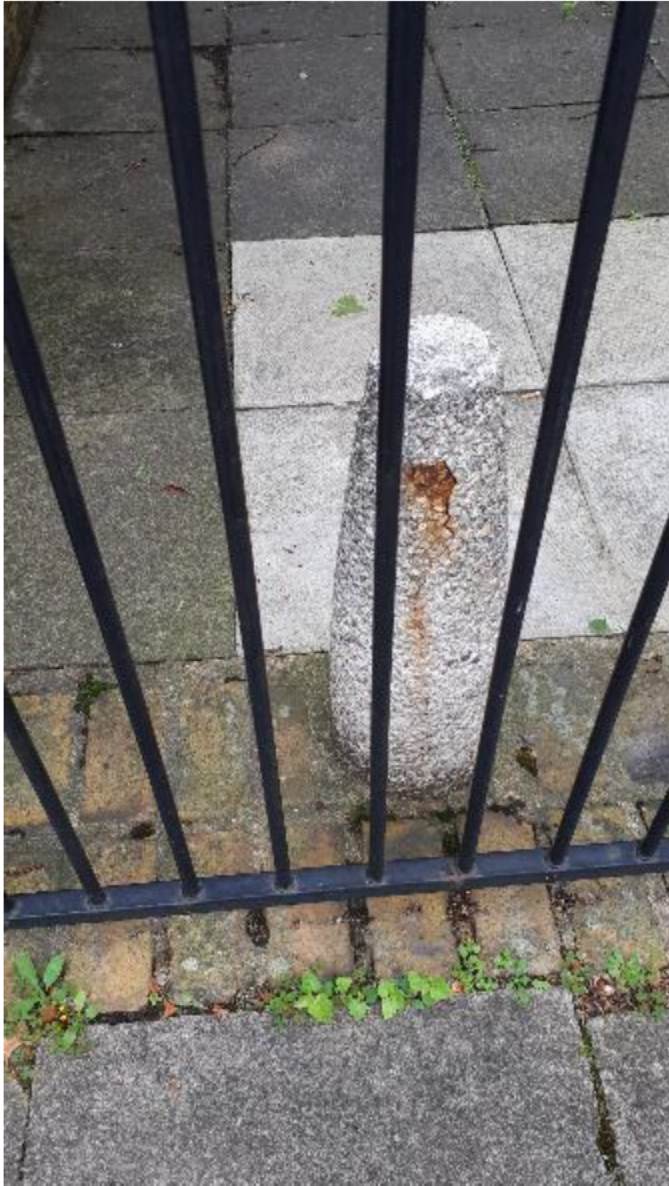
Photo 151. Early signs of rebar corrosion to bollard.

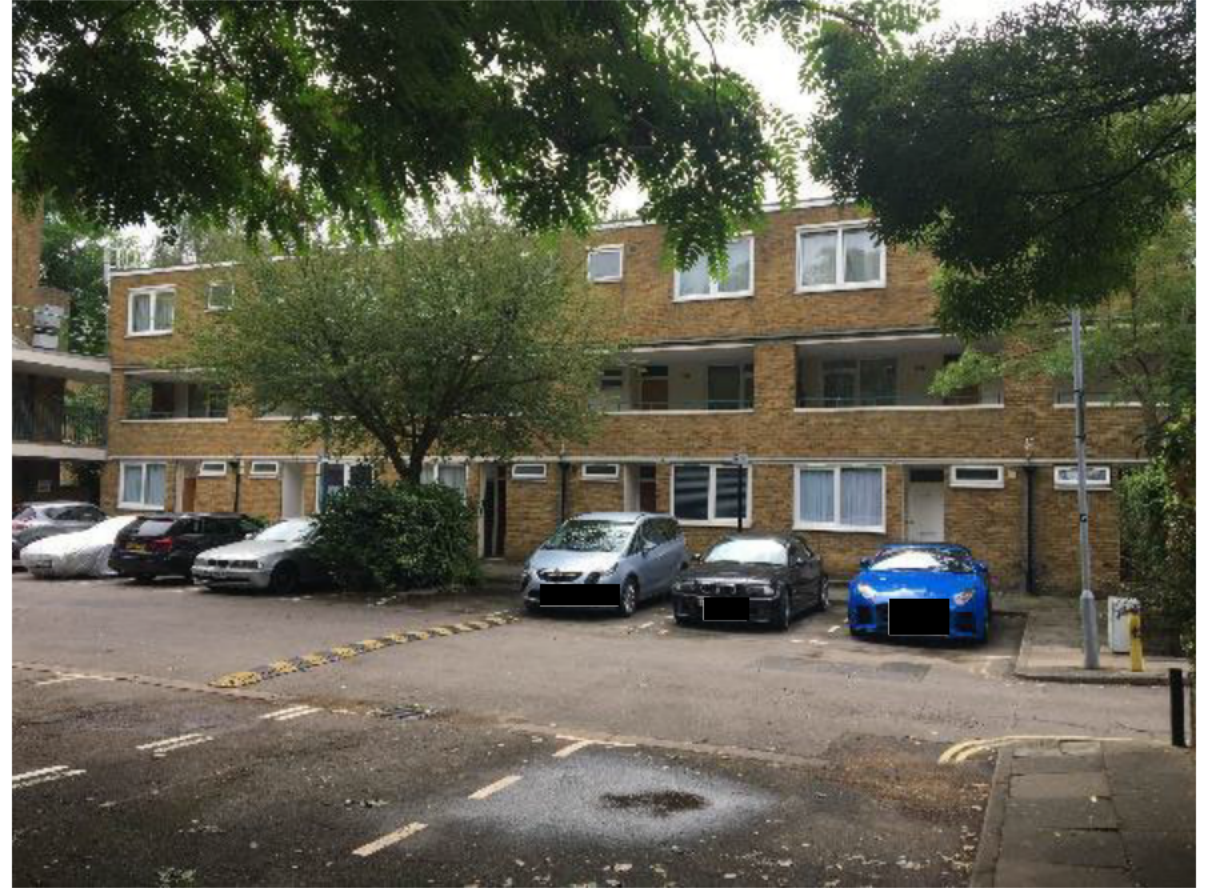
Photo 152. Carpark in front of Mordern Hse where the tarmac is starting to break up particularly near the entrance.

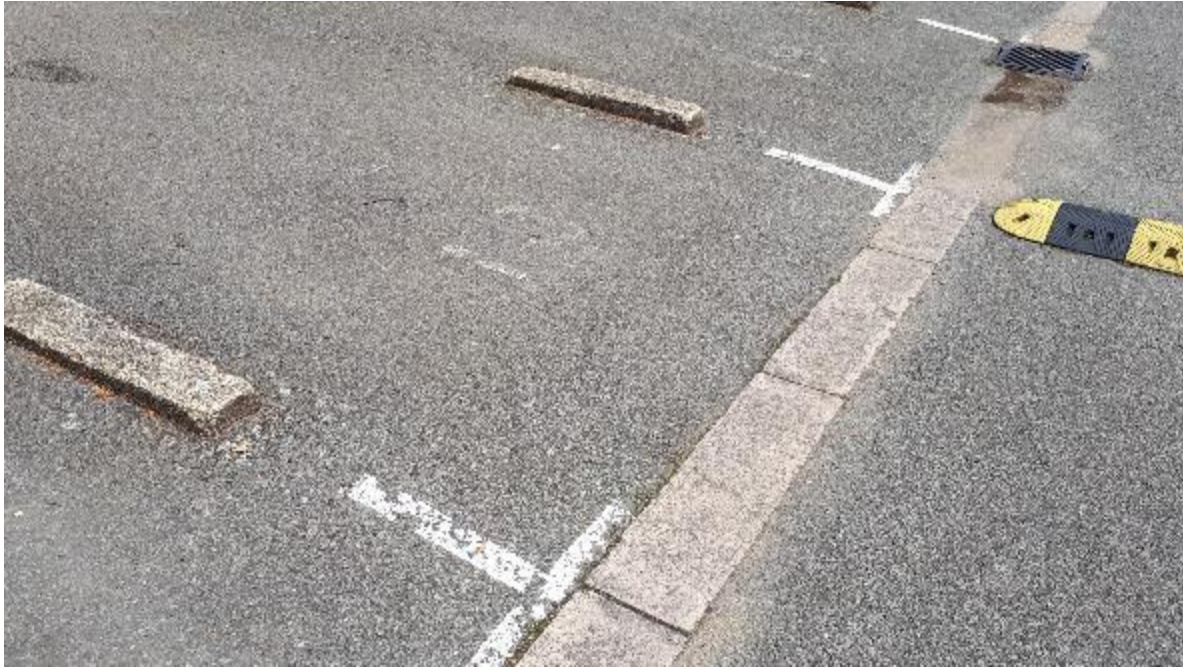
Photo 155. Same carpark where number markings to bays and lines are worn.

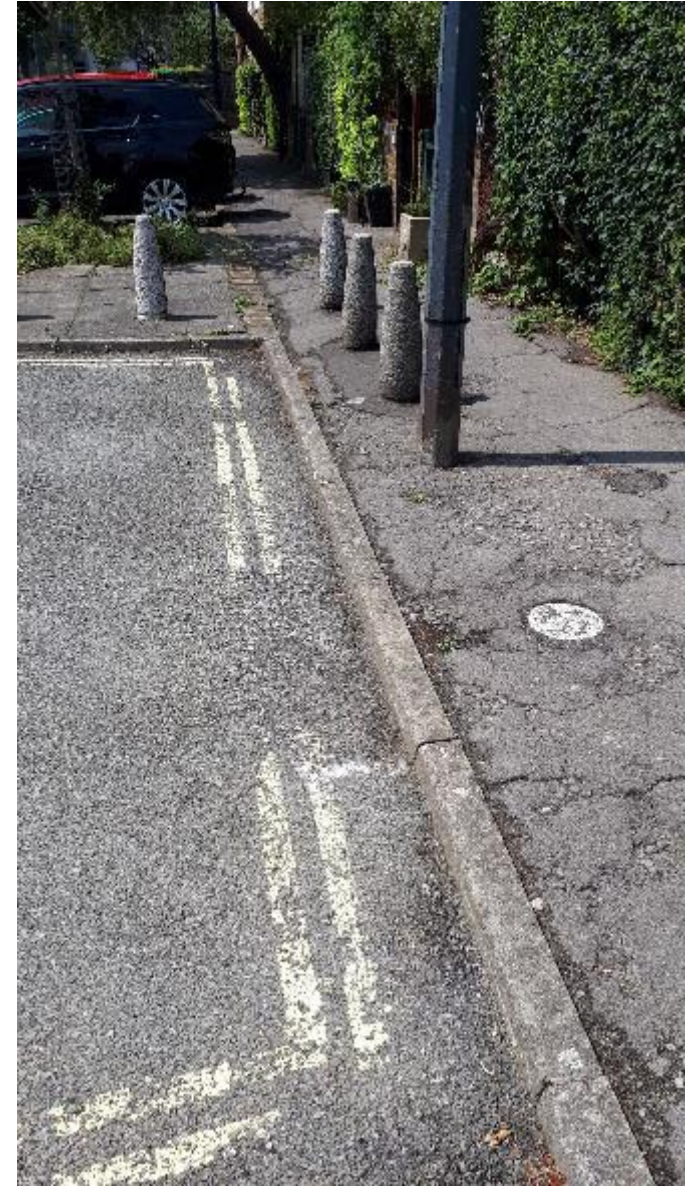
Photo 156. Same carpark where lines are worn, note condition of path and paintwork to lamp post.

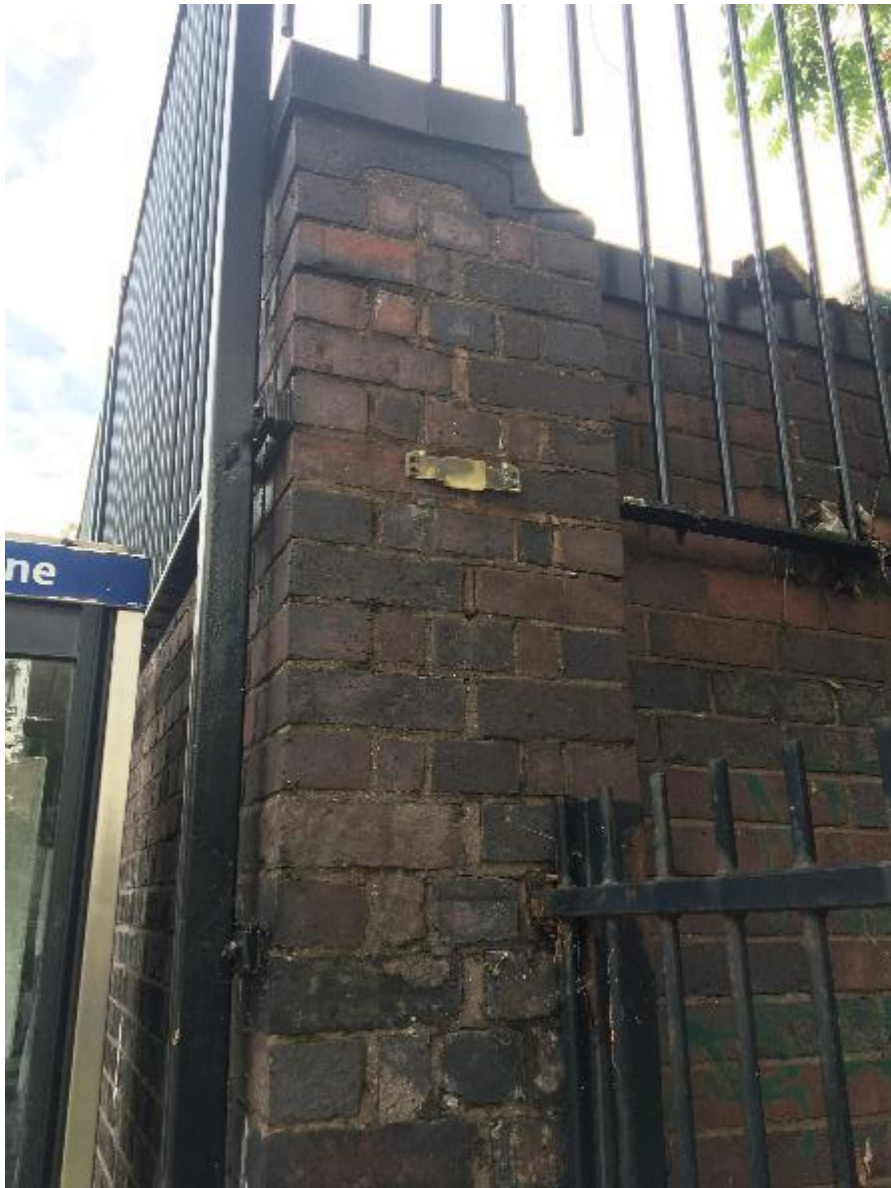
Photo 157. Corner of boundary showing old tell-tale crack monitoring gauge, the surveyor was unsure as to the ownership of this boundary line adjacent the phone box on the corner of Rossmore Rd and Harewood Ave. He was of the opinion that the cracking was not significant, and that any defective brickwork should be re-pointed.

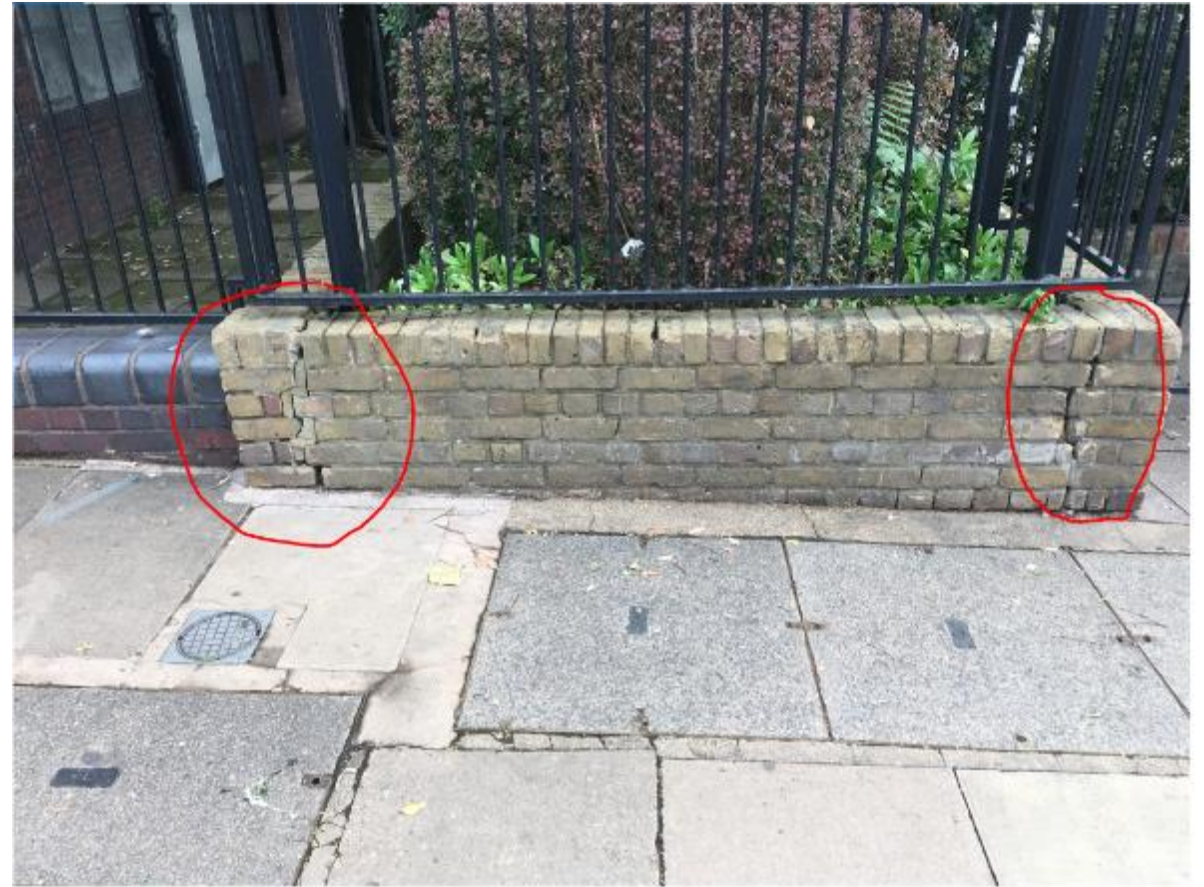
Photo 158. Showing movement cracking to ends of dwarf boundary wall. Given the wall is adjacent a public footpath and the width of the cracking plus evidence of failed historic pointing repairs, the Council should consider using HeliBars to stitch the brick work as a belt and braces approach to rectifying the defect.

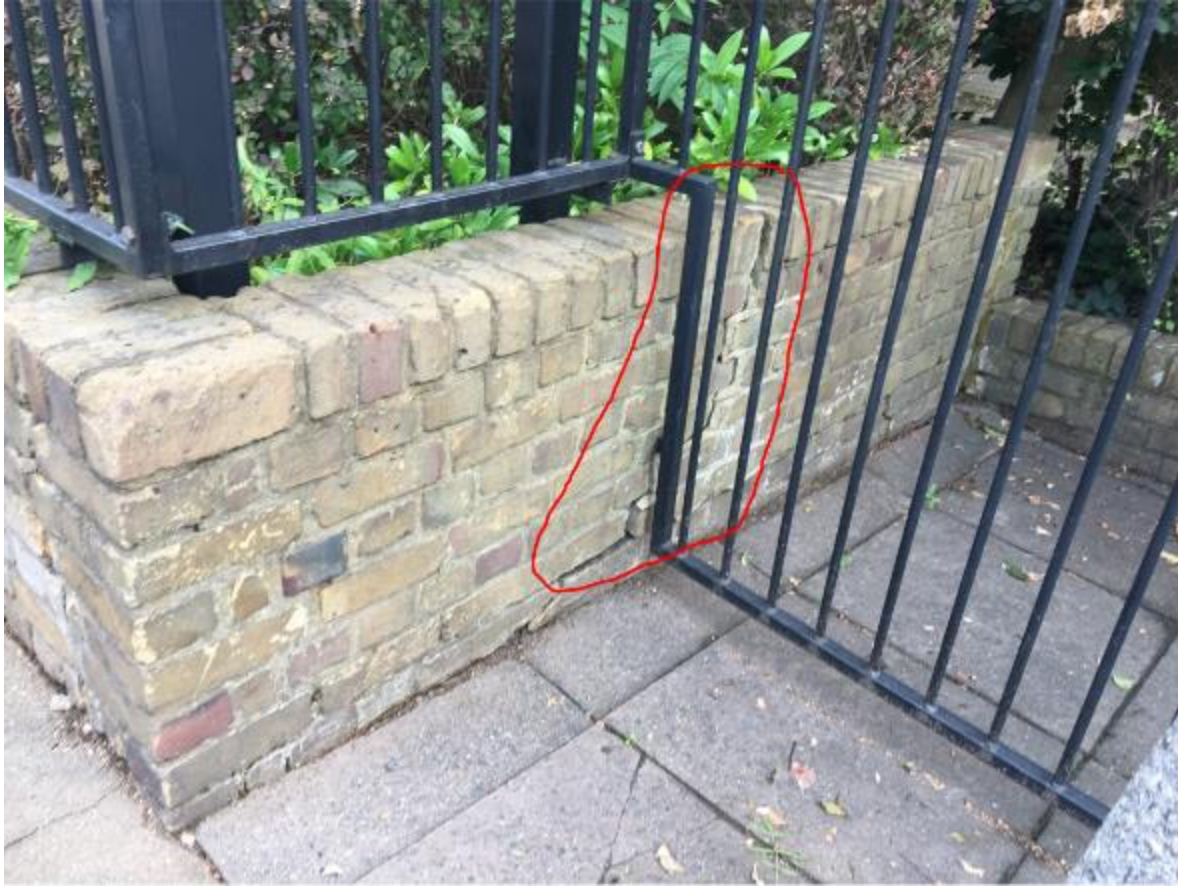
Photo 159. Showing return of same wall.

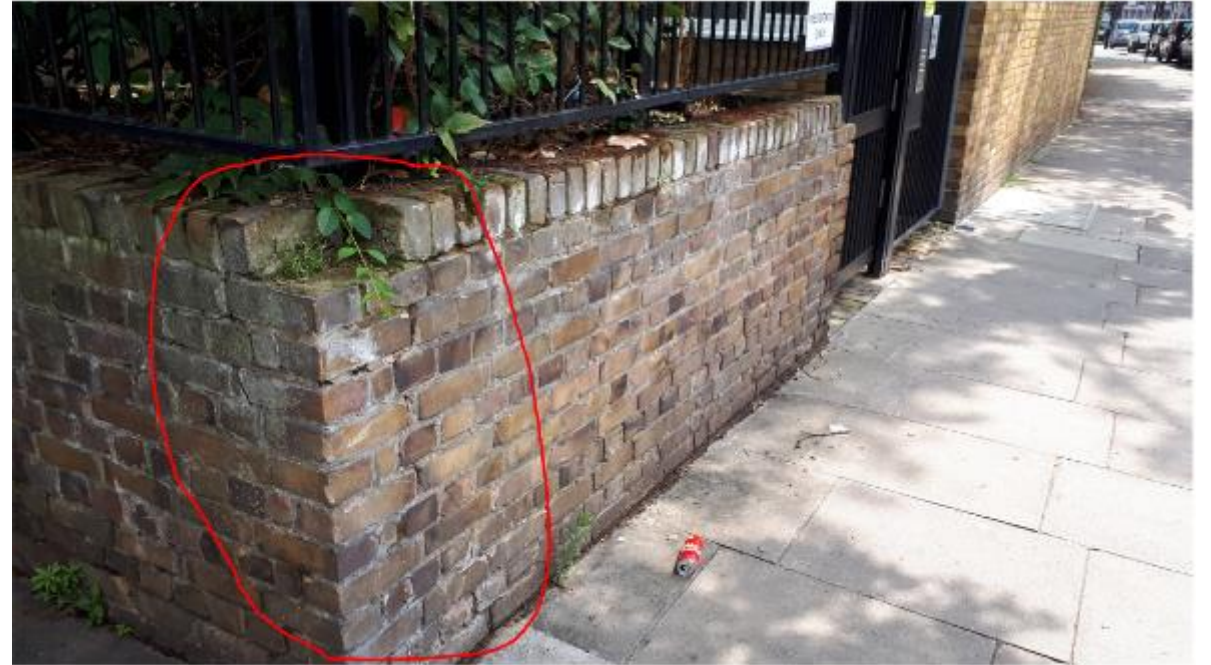
Photo 160. Again, showing movement cracking to ends of a boundary wall. Given the wall is adjacent a public footpath, the Council should consider using HeliBars to stitch the brick work as a belt and braces approach to rectifying the defect; normally one would simply repoint it.
