**Blandford Estate
Harewood Avenue
London
NW1**

Client Ref: Y100 – Blandford Estate

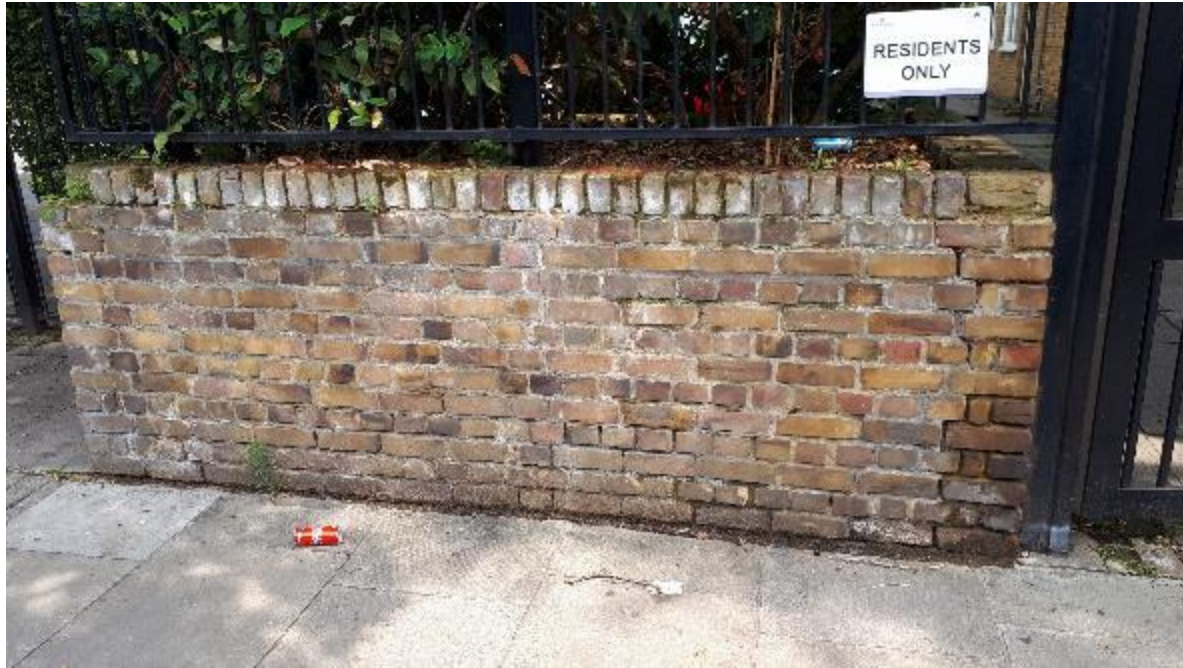
Photo 161. Same wall with defective brickwork.

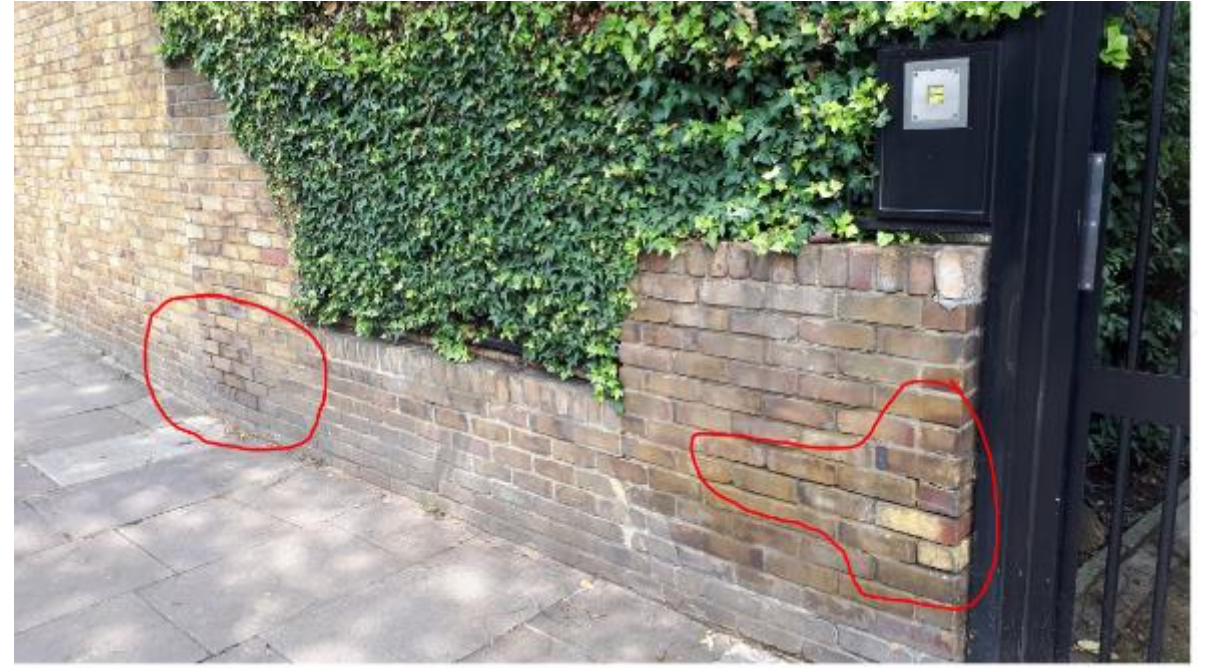
Photo 162. Here it is simply a case of re-pointing defective sections of brickwork.

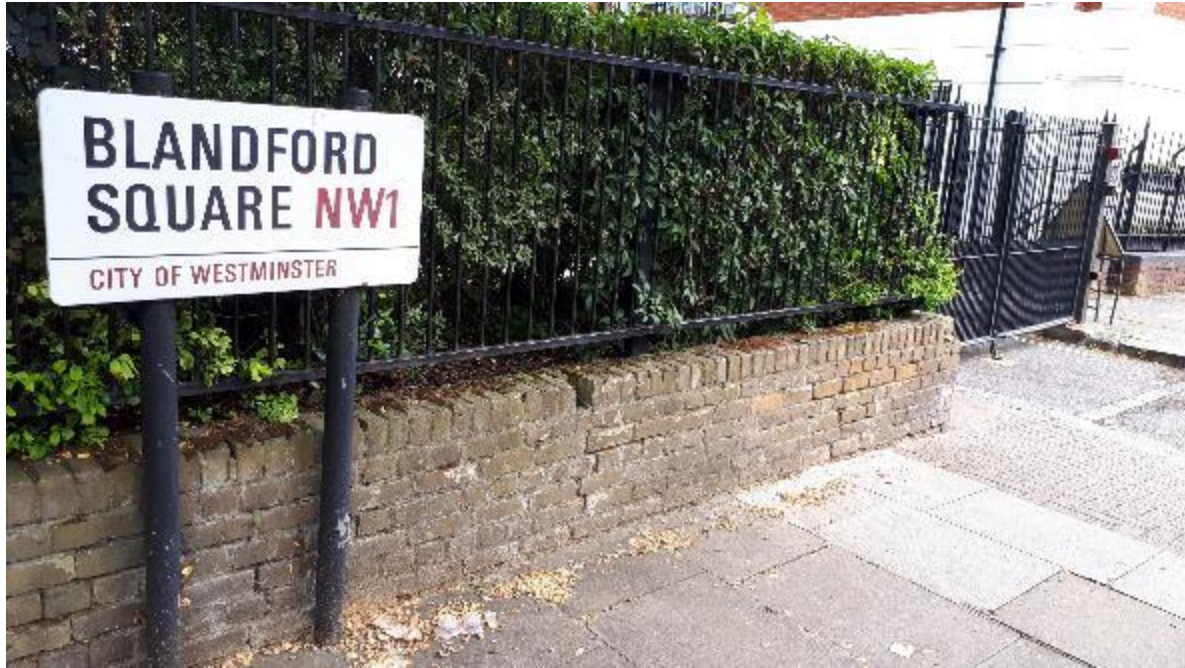
Photo 163. Another example of defective brickwork to the boundary walls.

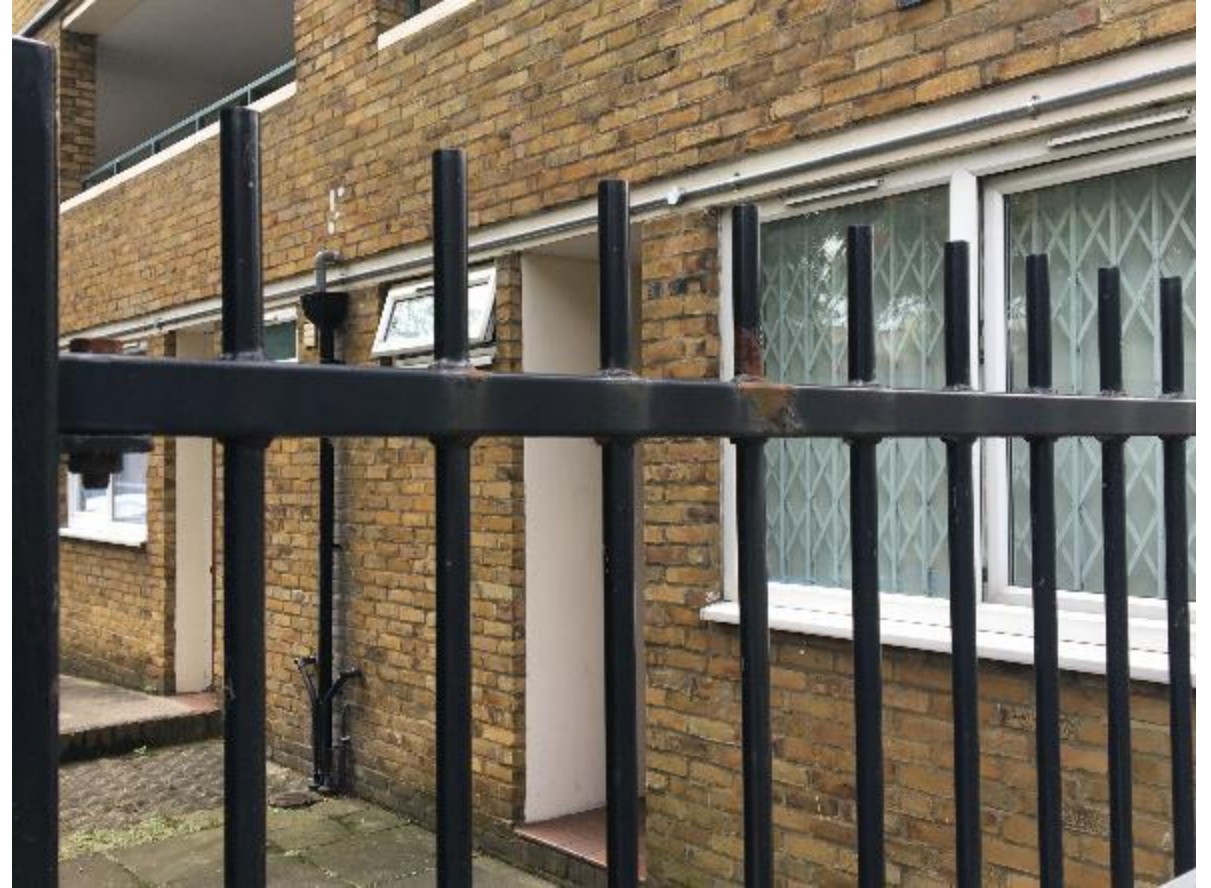
Photo 164. Powder coated paintwork to boundary railings failing.

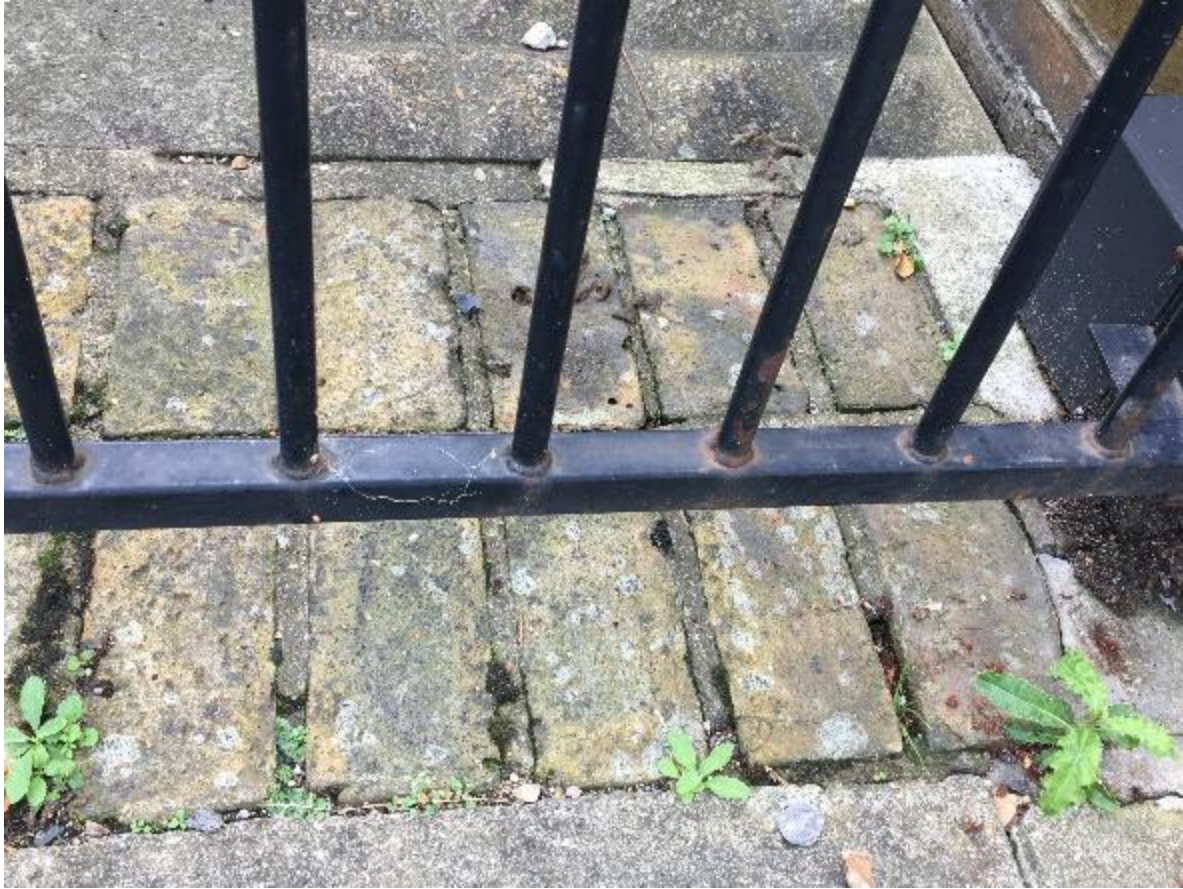
Photo 165. As previous photo.

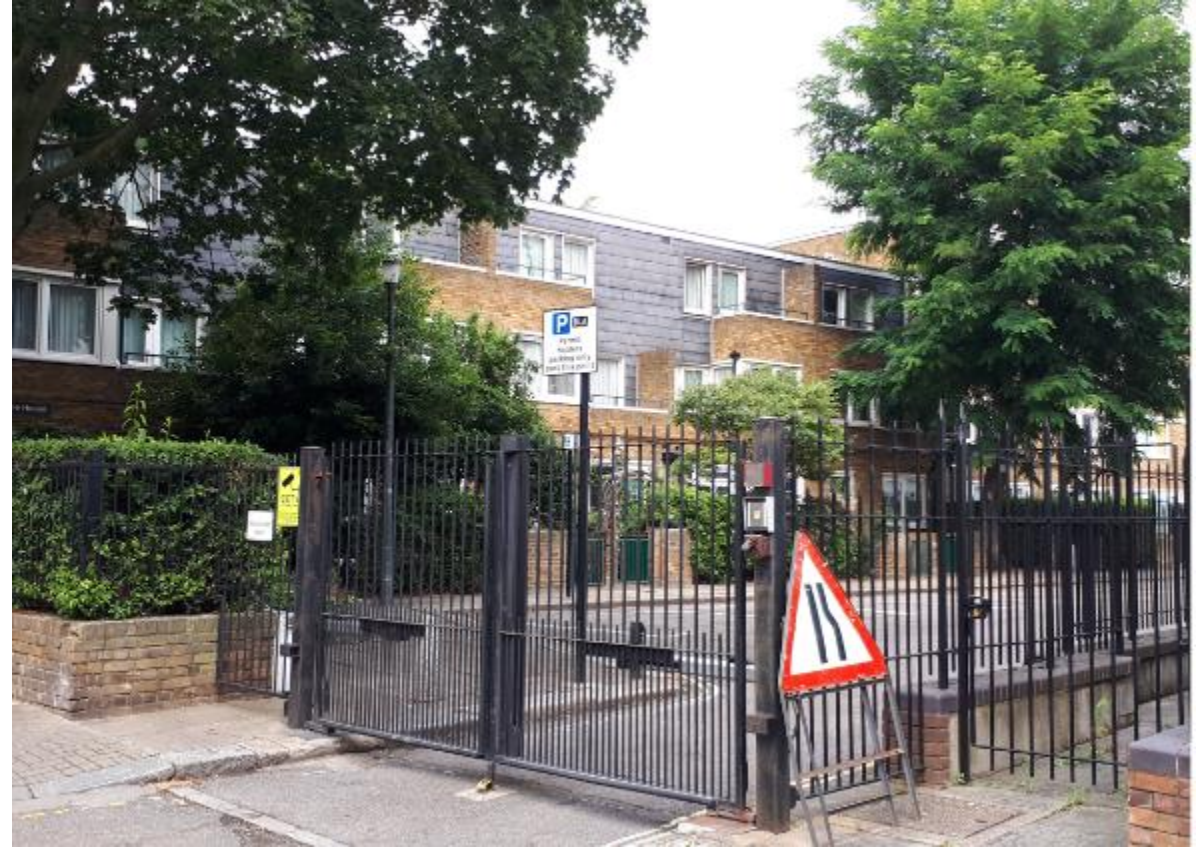
Photo 166. Signs of corrosion to vehicular gates.

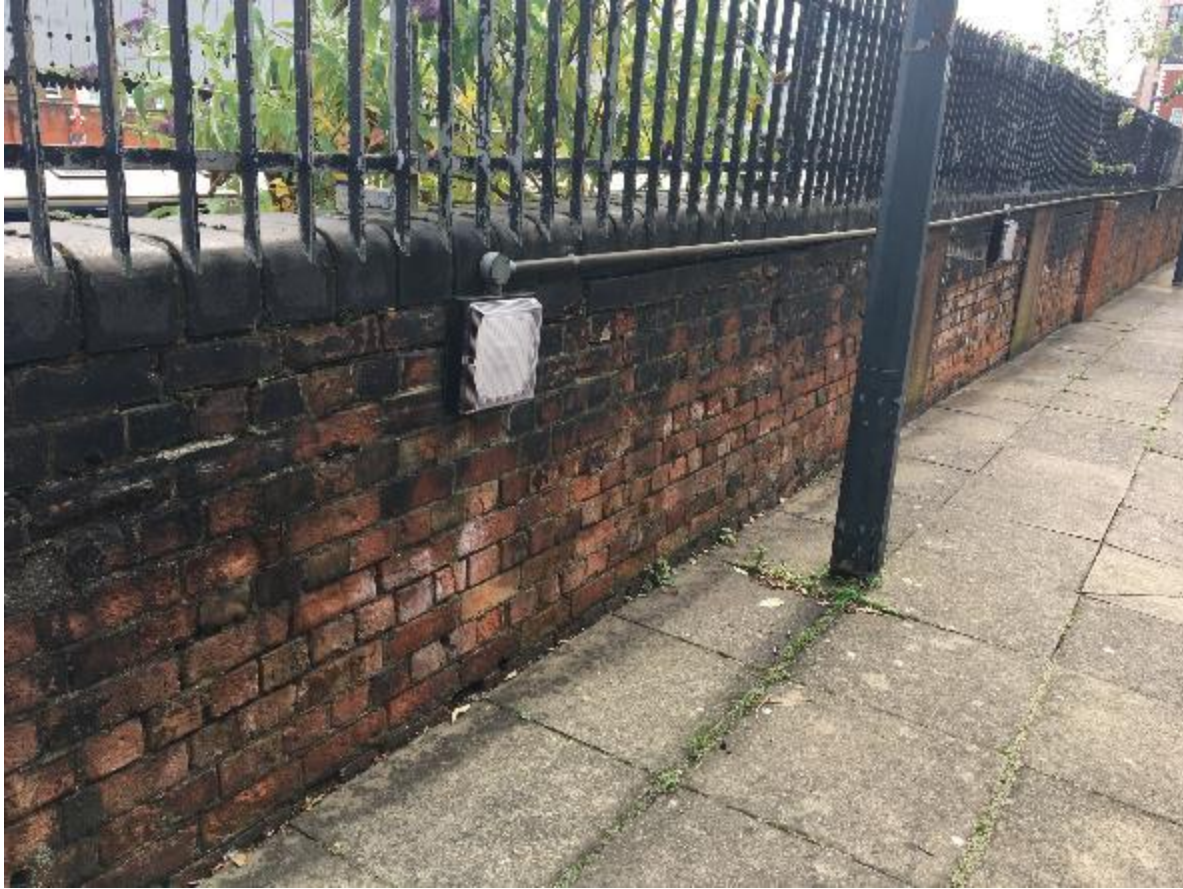
Photo 167. Defective pointing and spalling bricks to boundary wall adjacent railway as well as failing paintwork to railings.

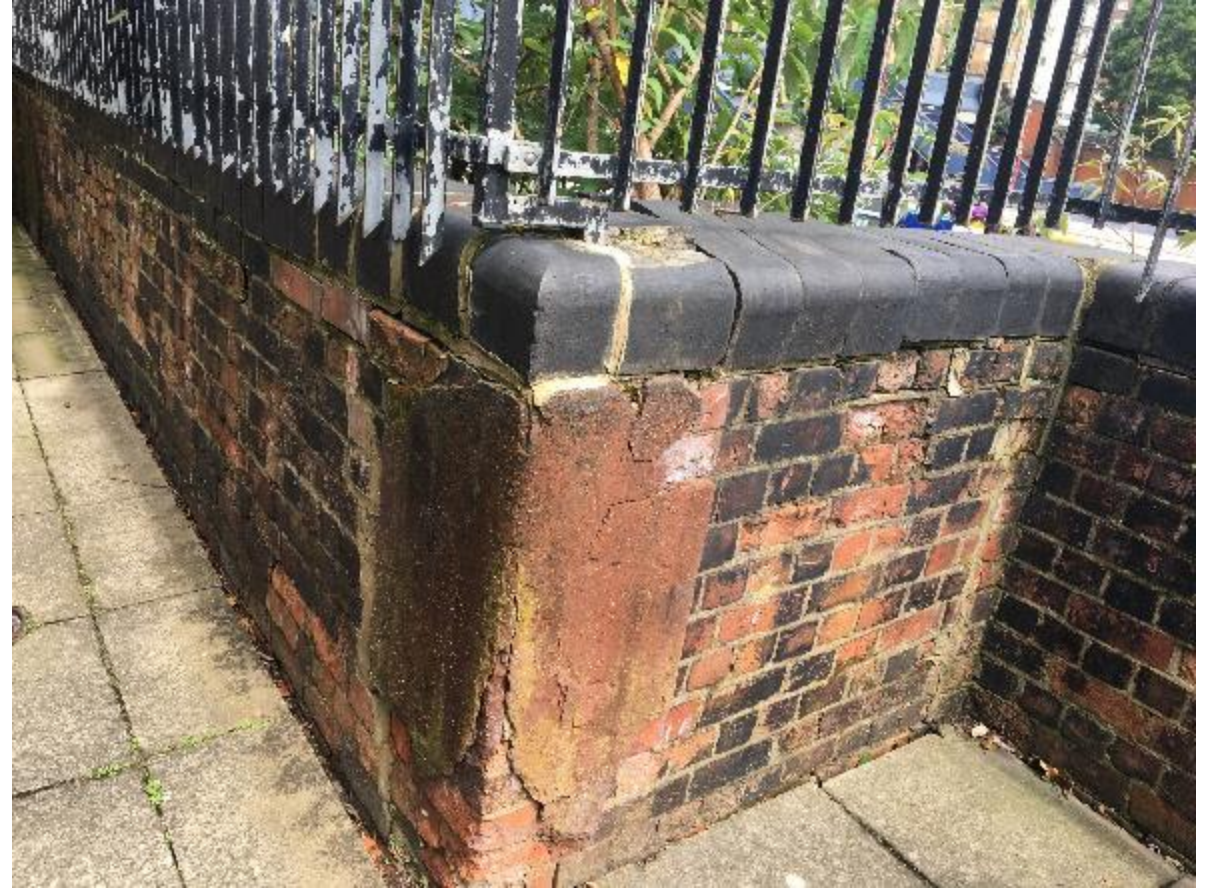
Photo 168. Same boundary wall this time showing displaced copings.

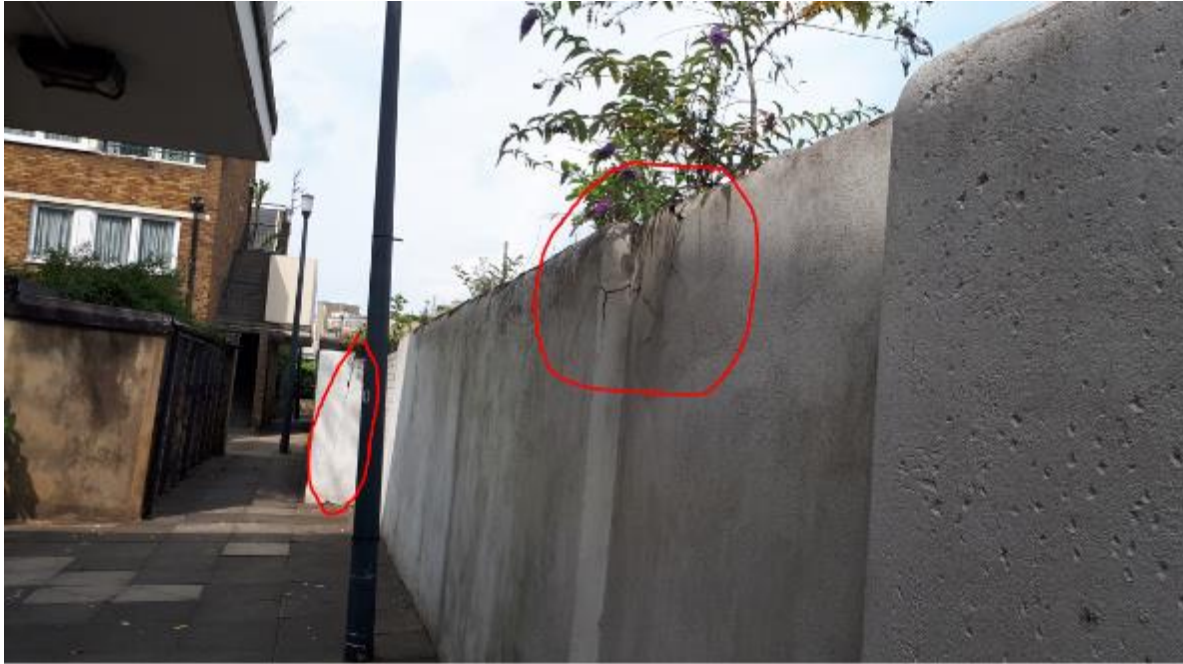
Photo 169. Showing failed render finishes to same boundary wall.
